# **Hackensack Meadowlands Tide Gates Inspection Report**

**The National Flood Insurance Program  
Community Rating System**

**The New Jersey Meadowlands Commission  
One DeKorte Park Plaza  
Lyndhurst, New Jersey**

**March 27, 2006**

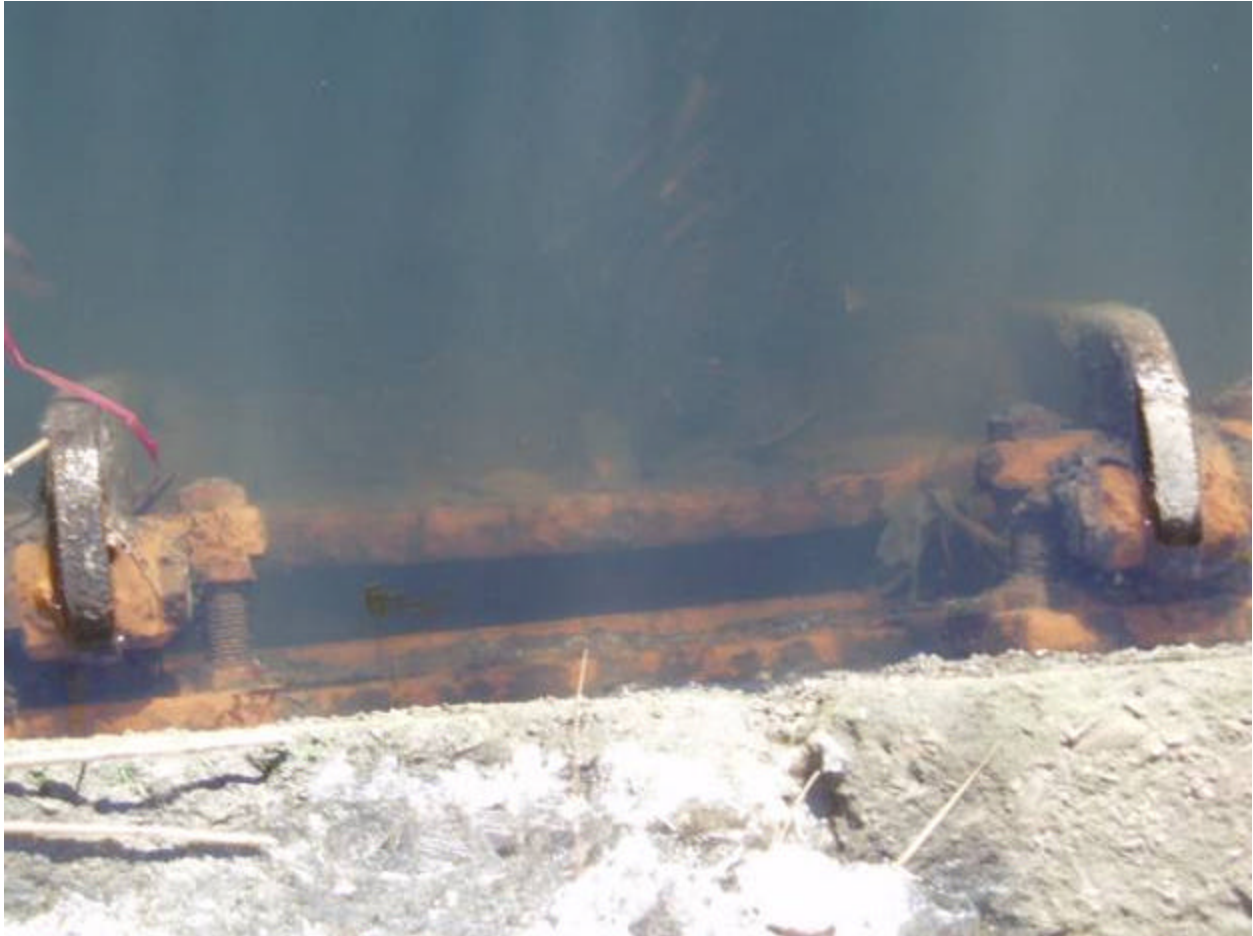
**Photo 1 Description: 1 steel flap gate**

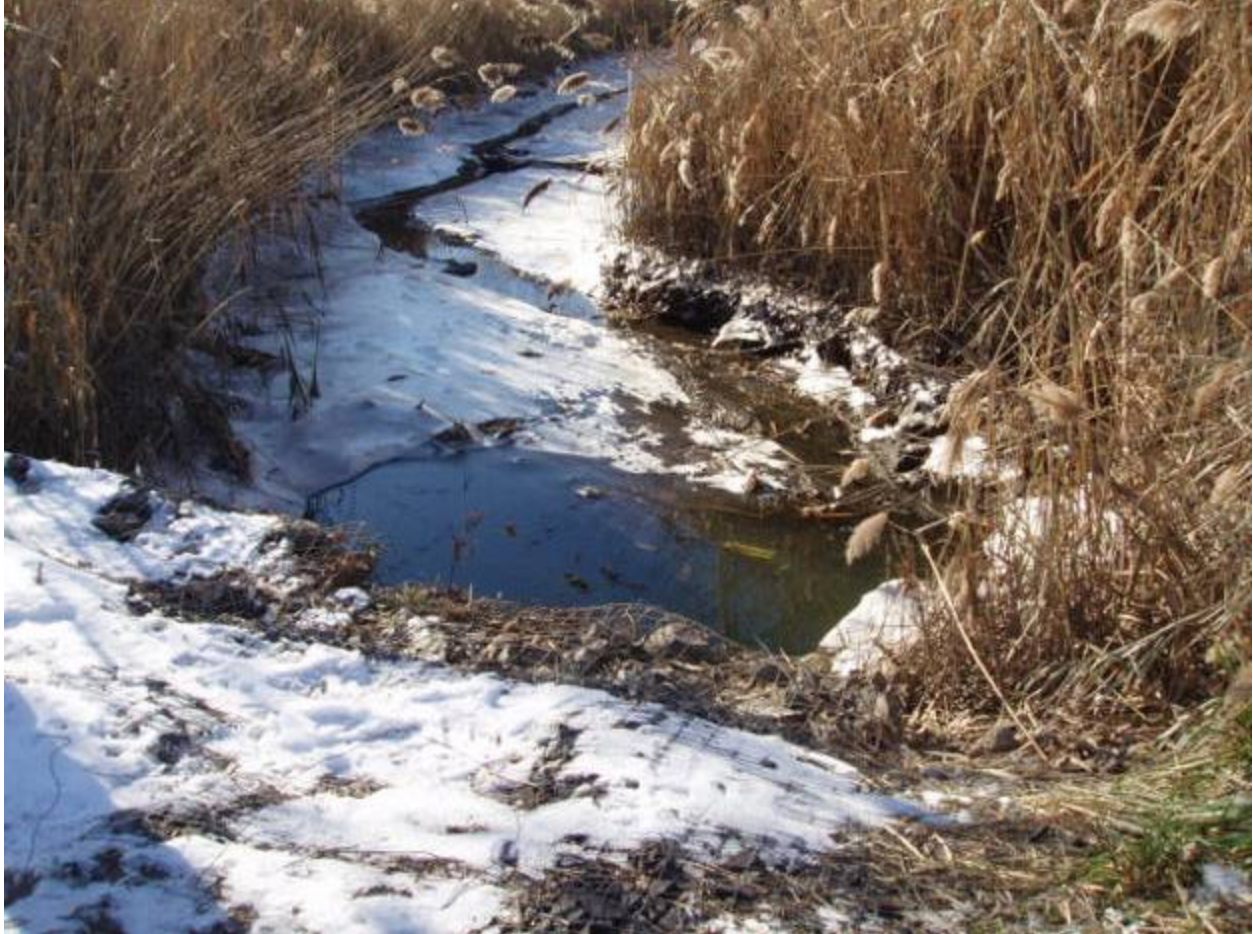
**Photo 2 Description: Downstream view from tide gate**

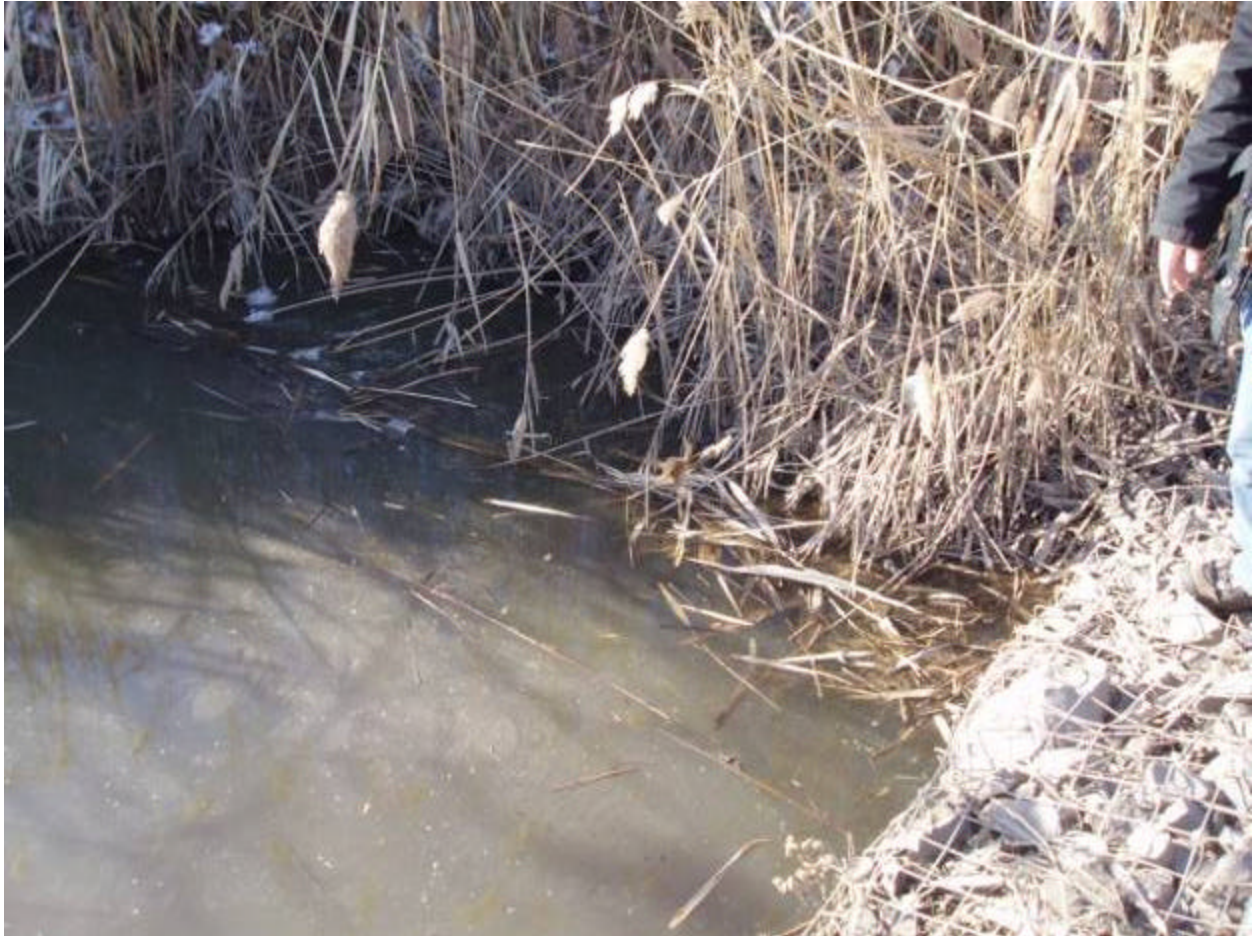
The gate appears to be working during high tide conditions. The storm sewer in the area need to be maintained regularly due to the build up of sedimentation.

**Photo 1 Description: Location of steel flap gate**

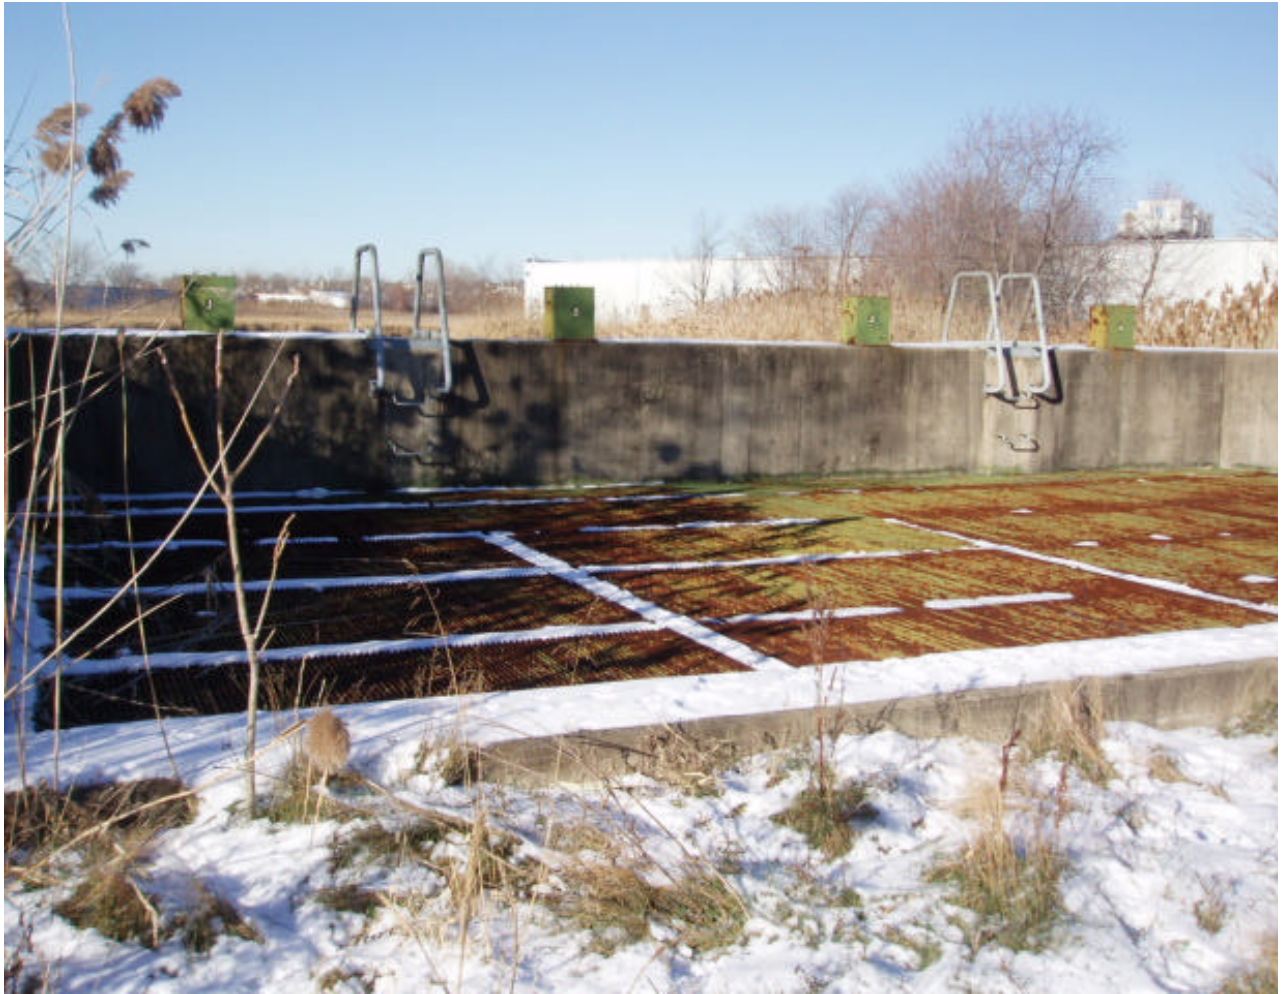
**Photo 1 Description: Tide gate structure**

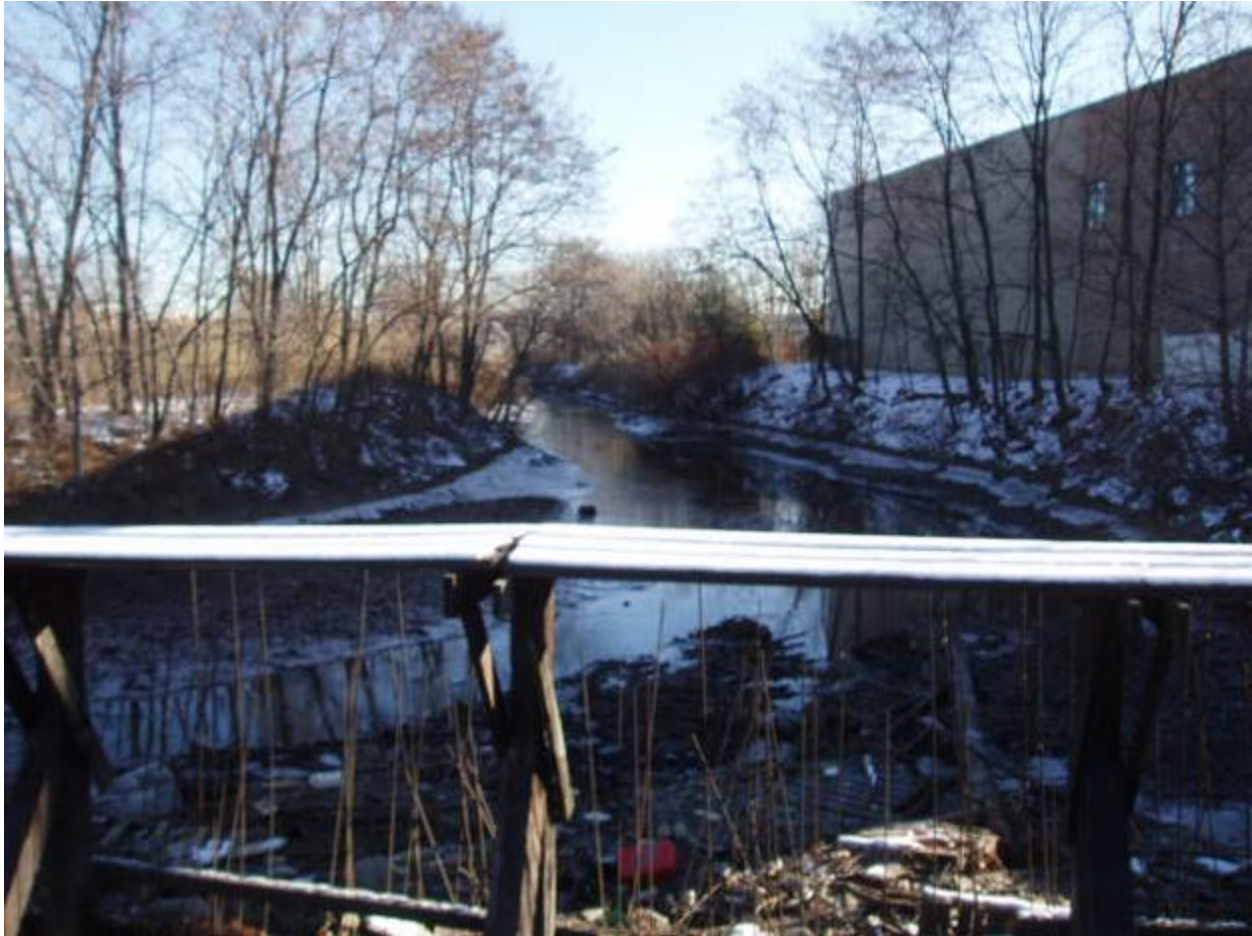
The trash rack needs immediate repair and cleaning. Debris has collected and blocks the flow of water through the gates. The roadway is also in need of repair due to settling above the tide gates.

**Photo 3 Description:** Upstream view from tide gates and view of the trash rack system

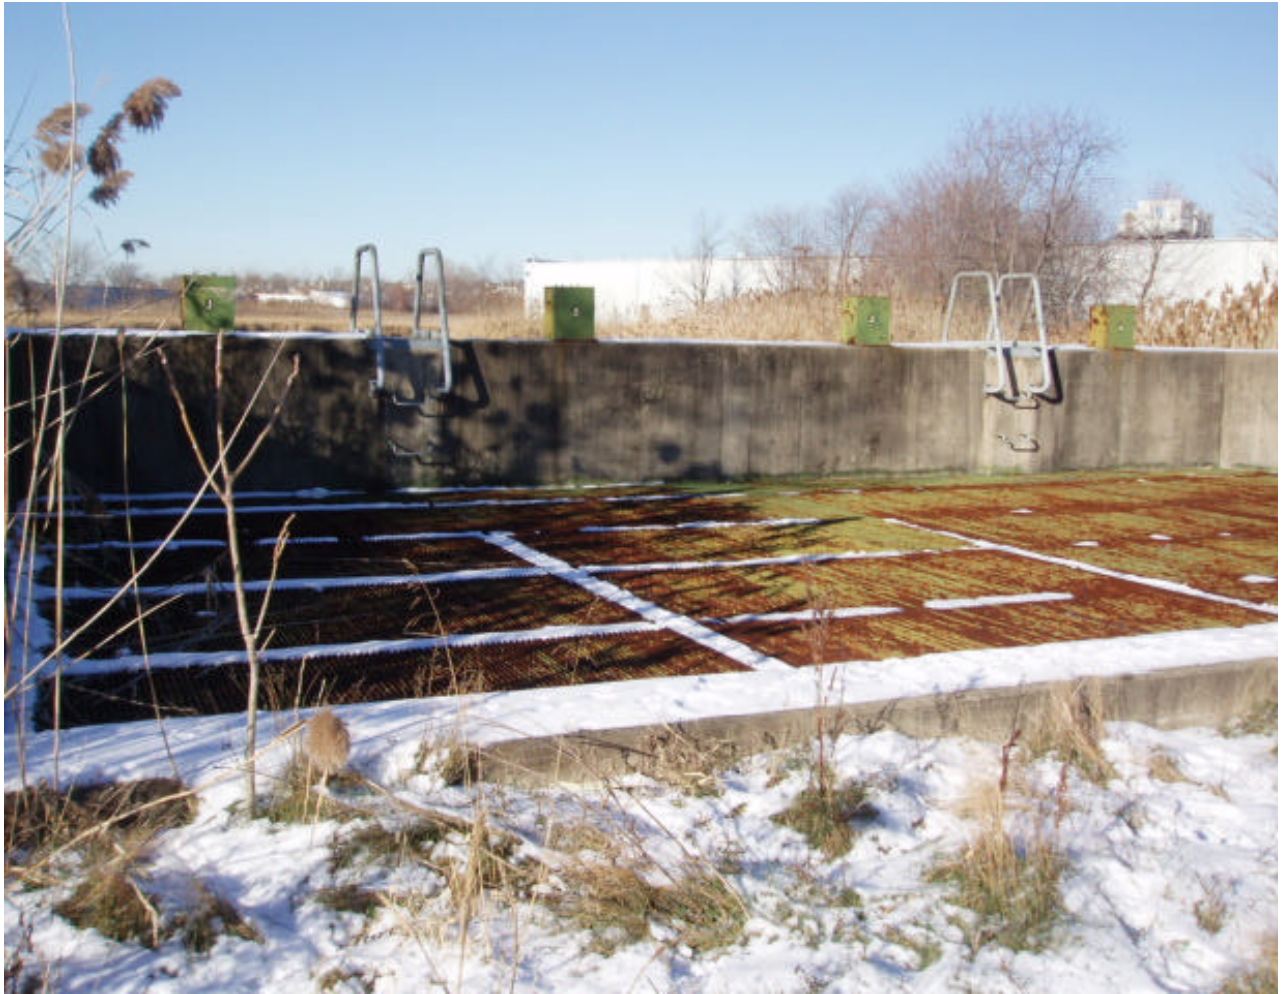
The tide gates are malfunctioning and not seating properly, specifically tide gates two and four. The water is entering through the gates and entering the upstream system during high tide conditions.

**Photo 1 Description: Tide gate structure**

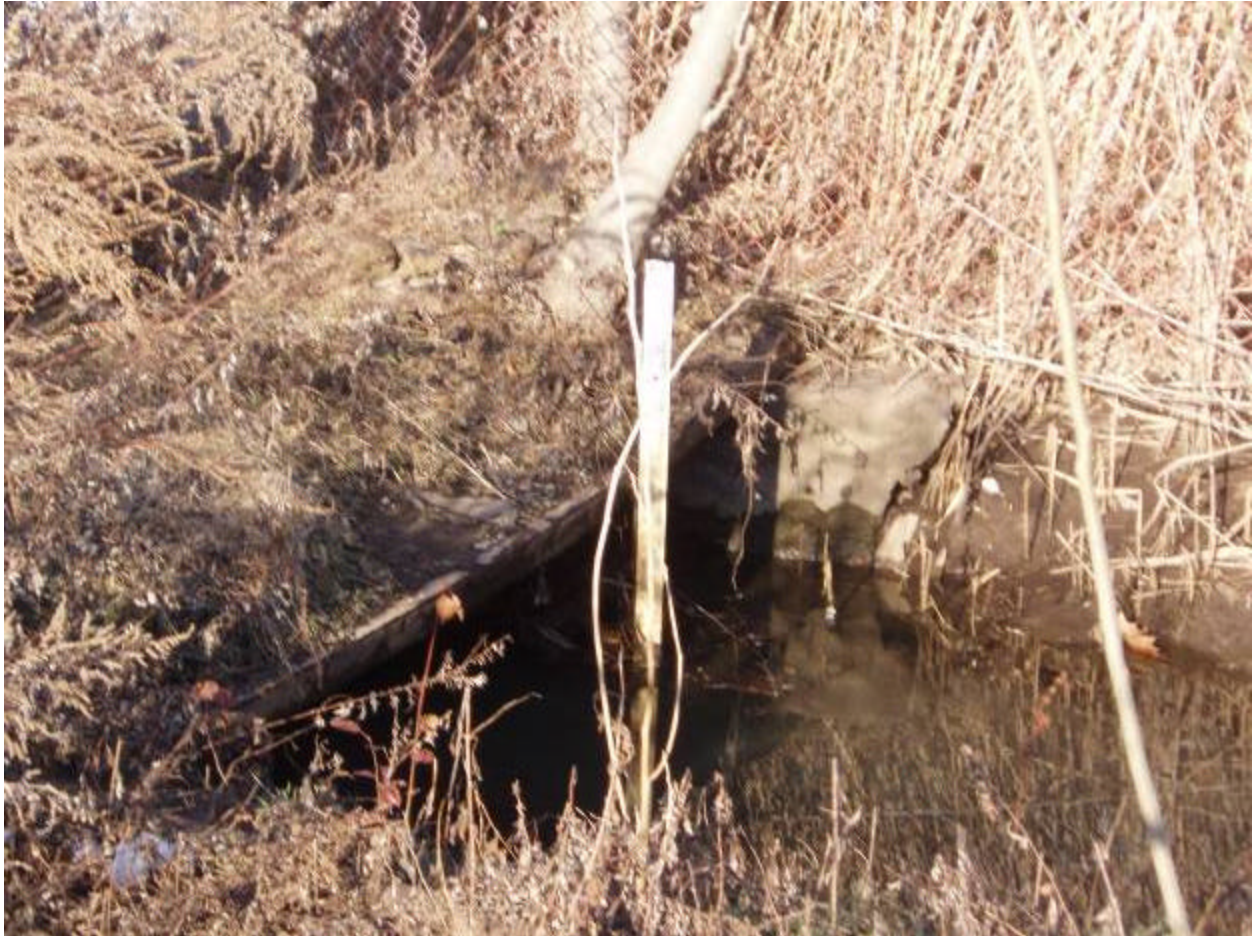
**Photo 1 Description:** Remains of existing tide gate structure

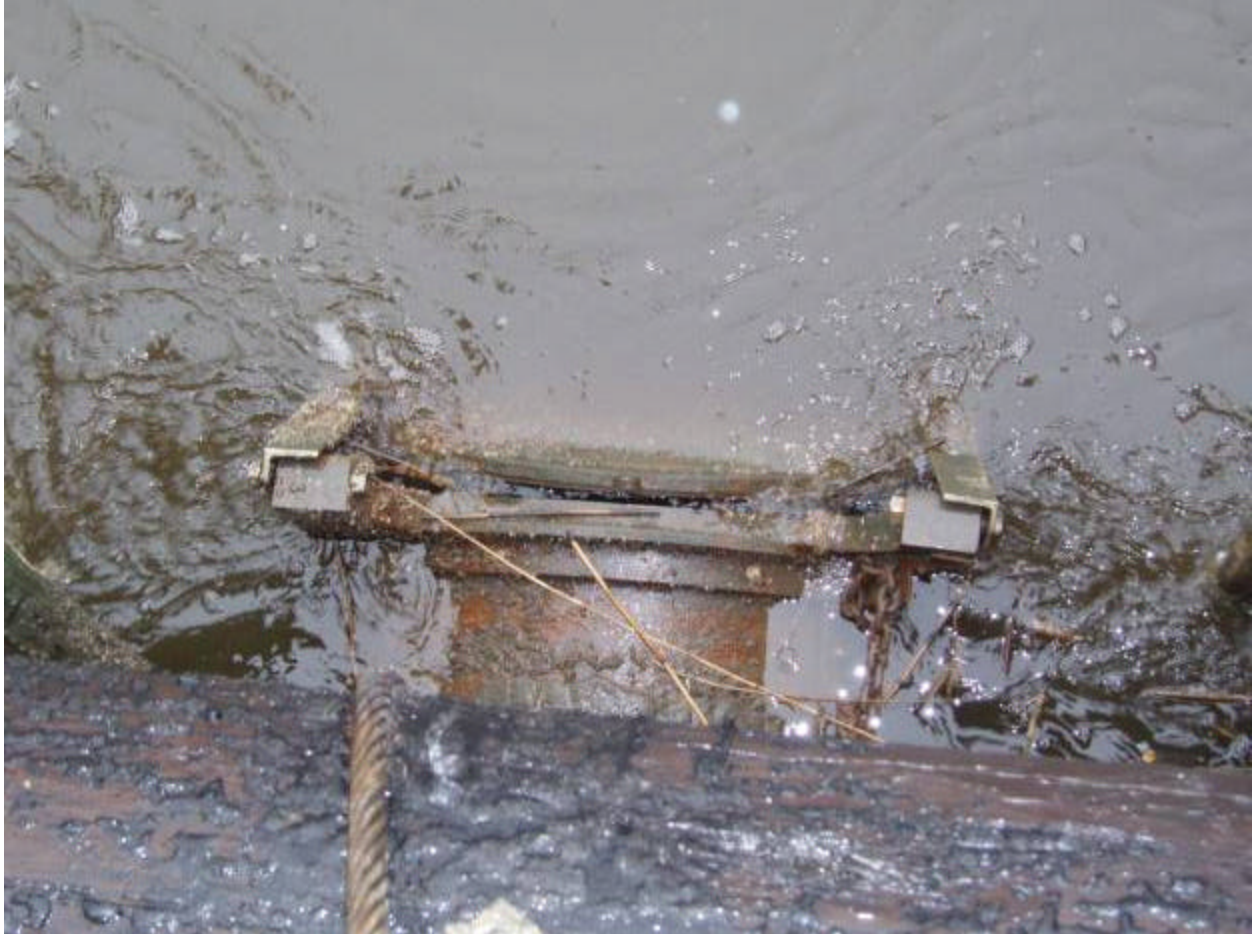
**Photo 1 Description:** Tide gate shown in the open position

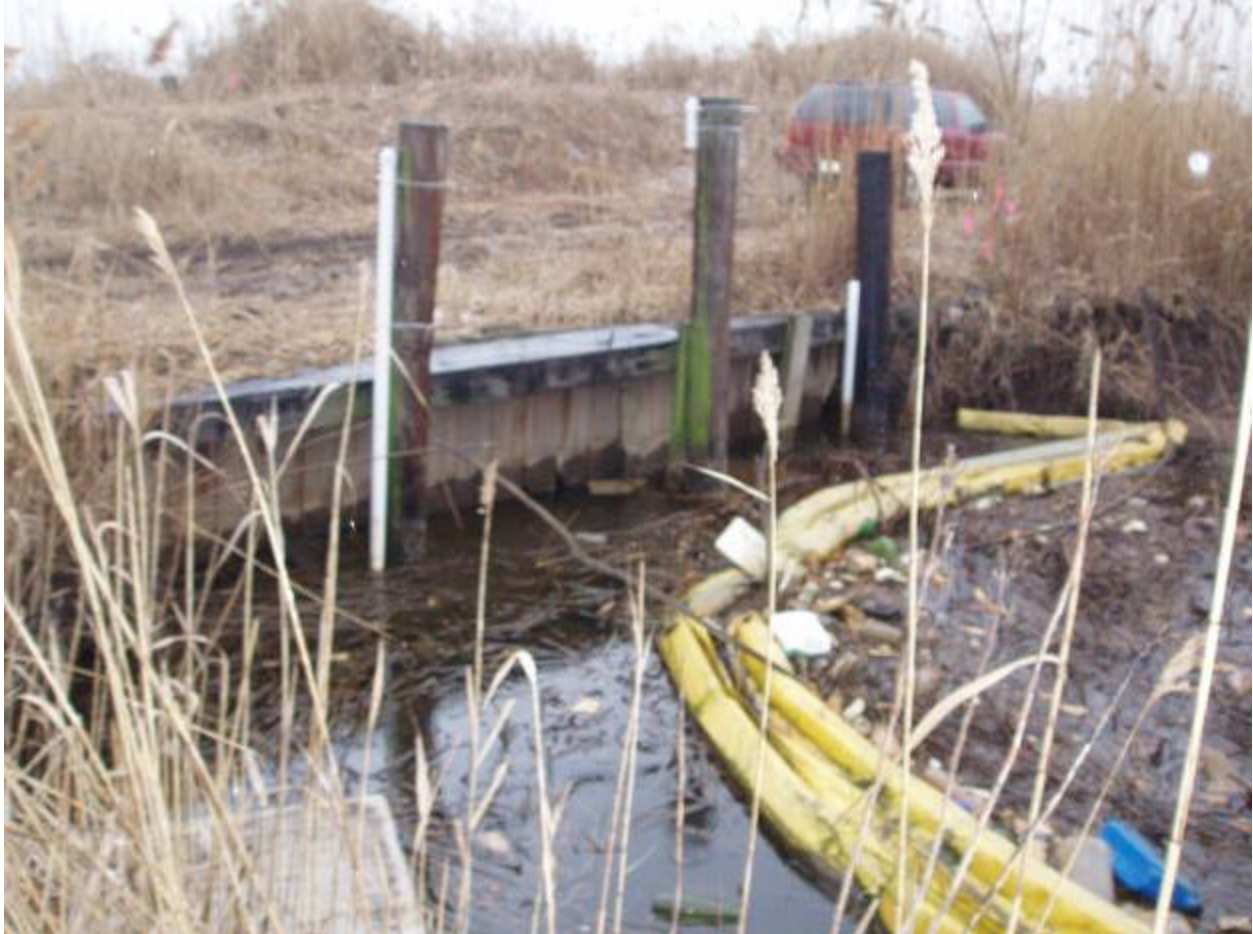
**Photo 1 Description: Trash rack system**

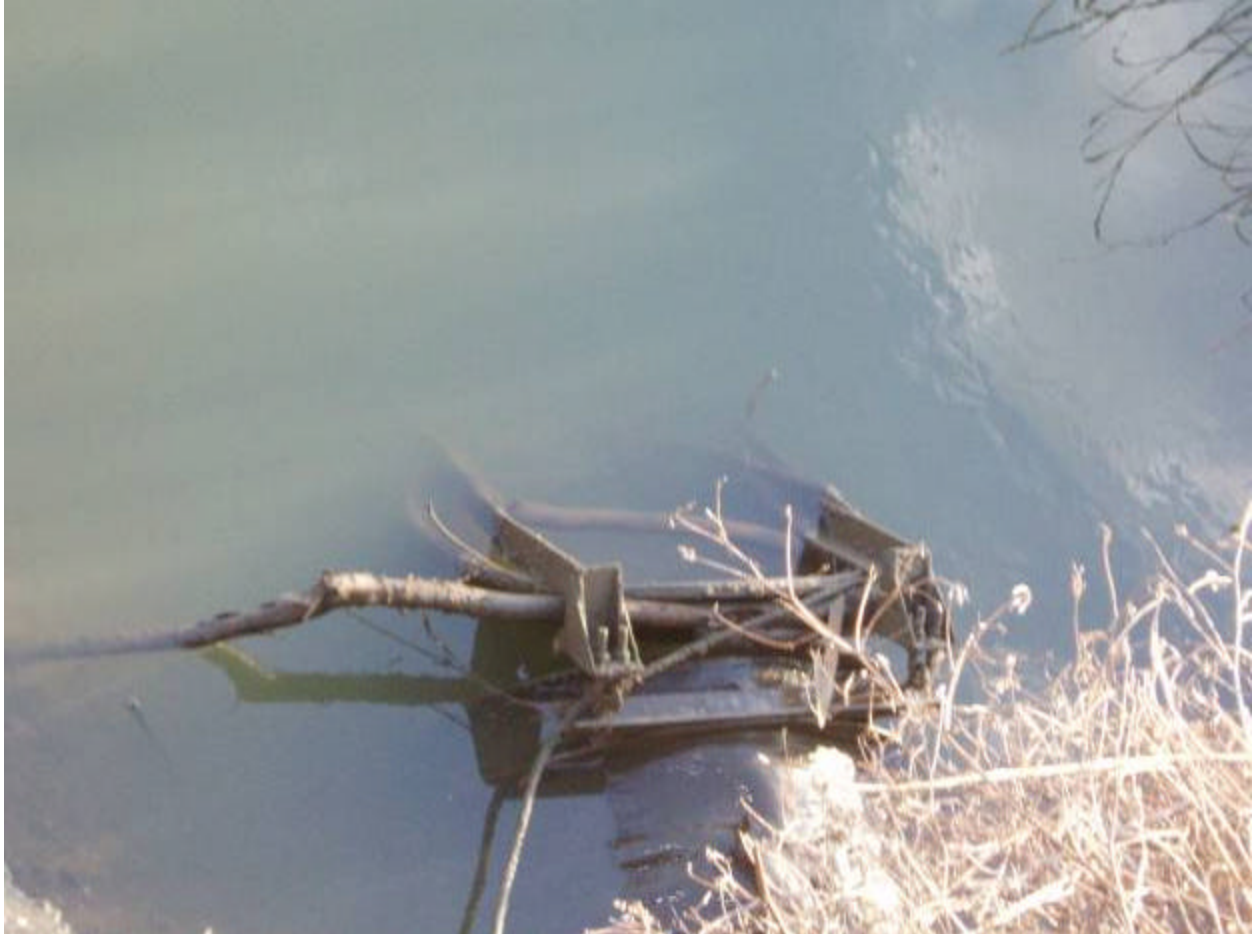
**Photo 1 Description:** Tide gate shown with debris keeping it from closing properly

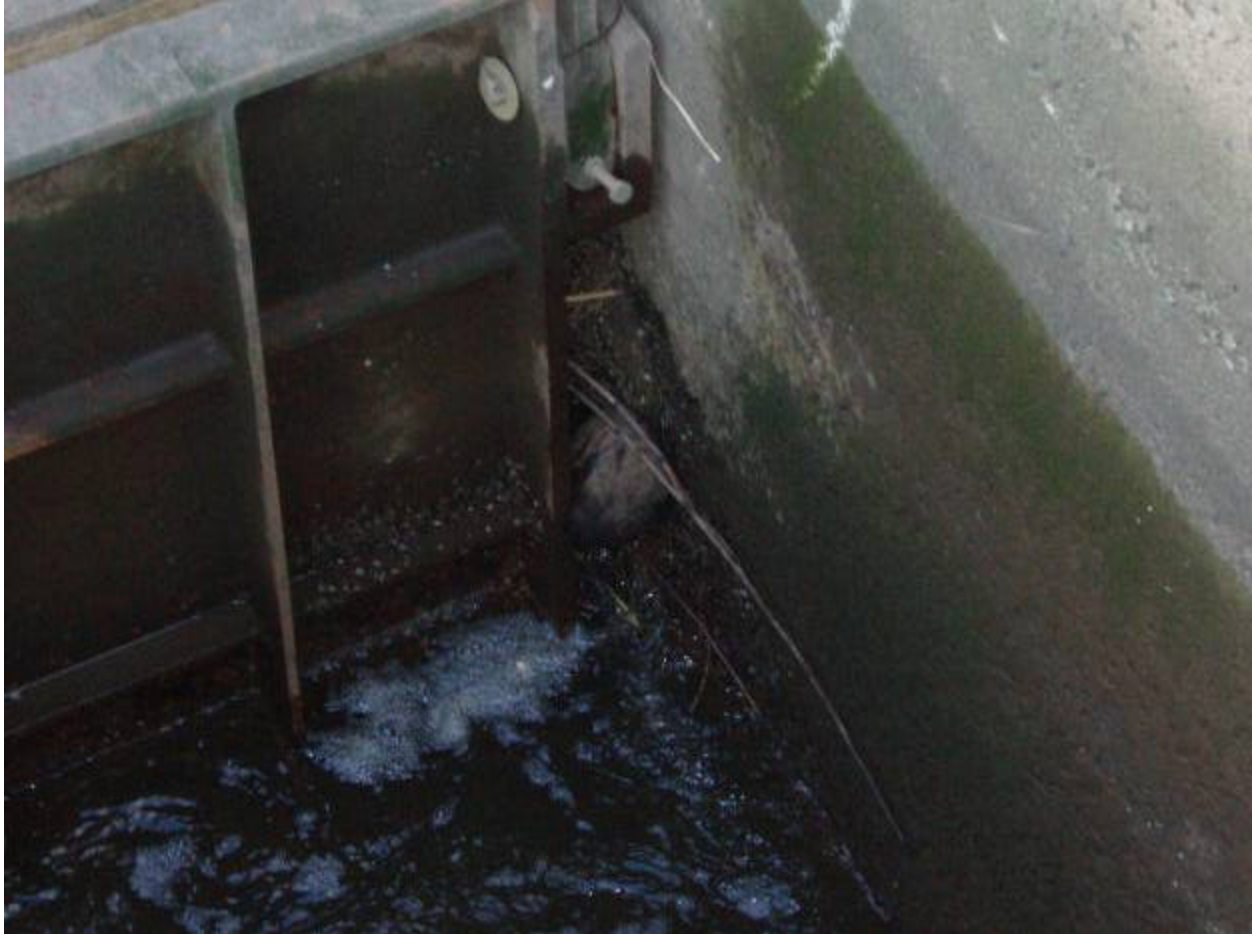
**Photo 2 Description:** Debris (rock) shown lodged in-between the gate keeping it ajar

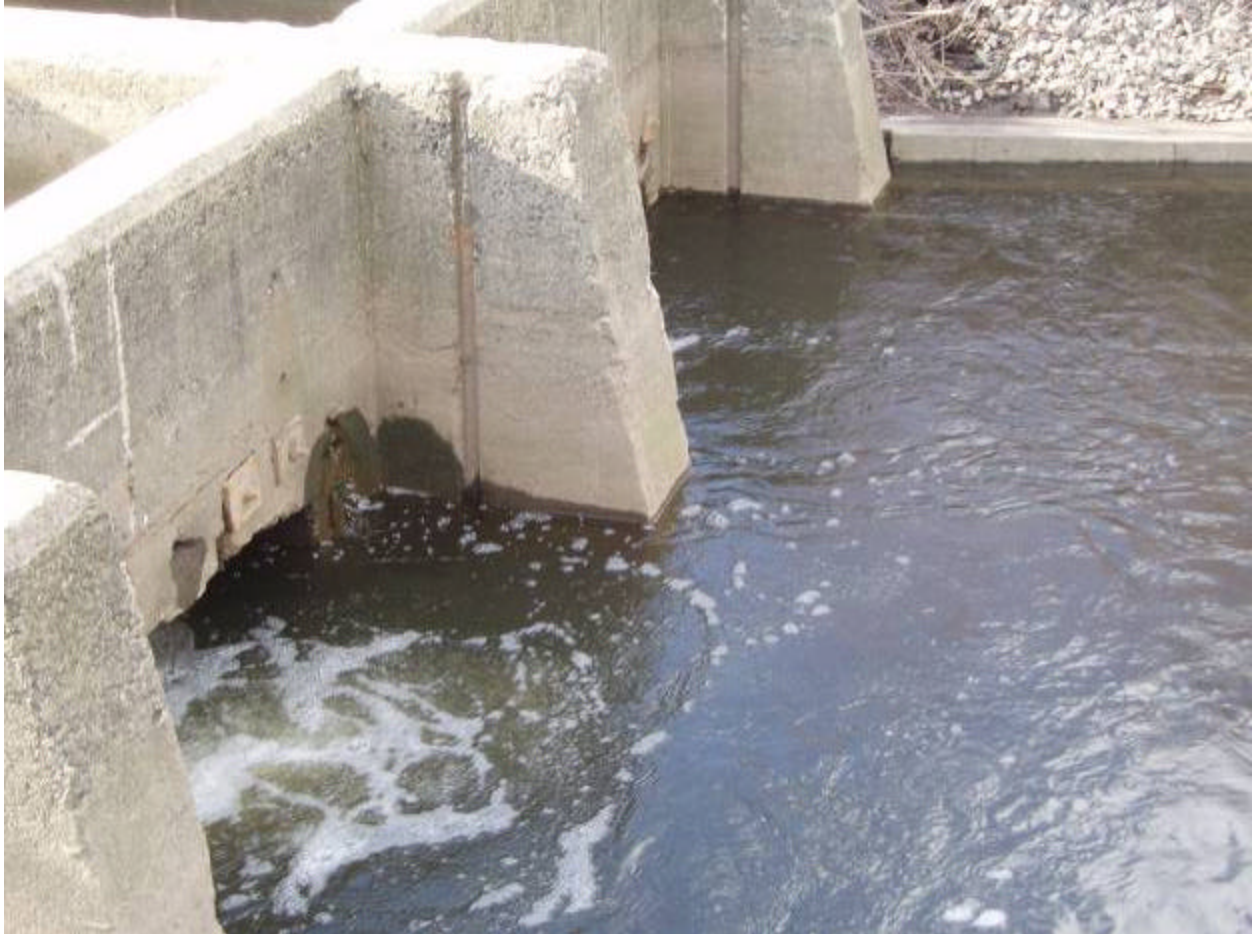
**Photo 1 Description:** Notice water (bubbles) traveling upstream of the tide gate during high tide conditions

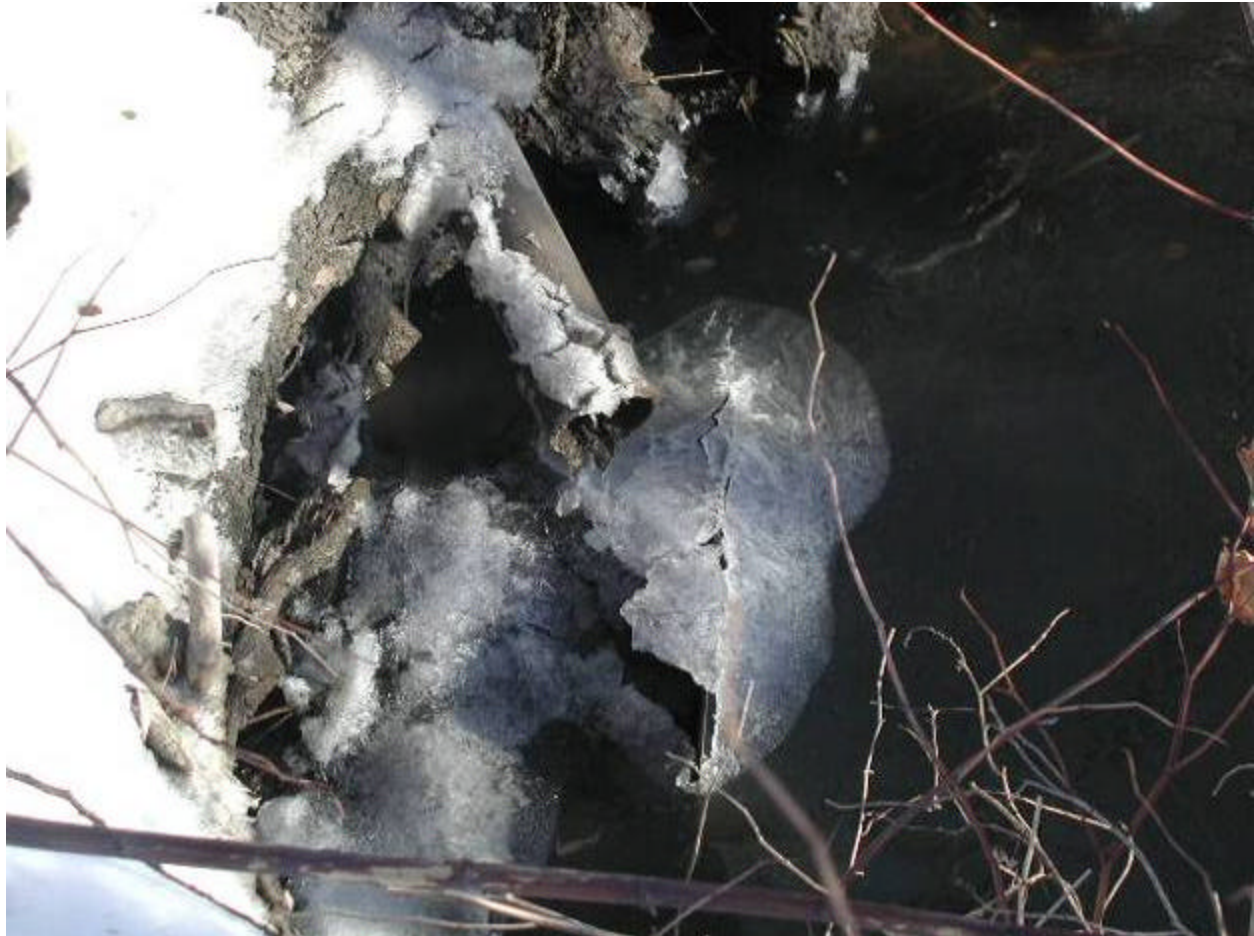
**Photo 1 Description:** Tide gate structure shown during ice conditions

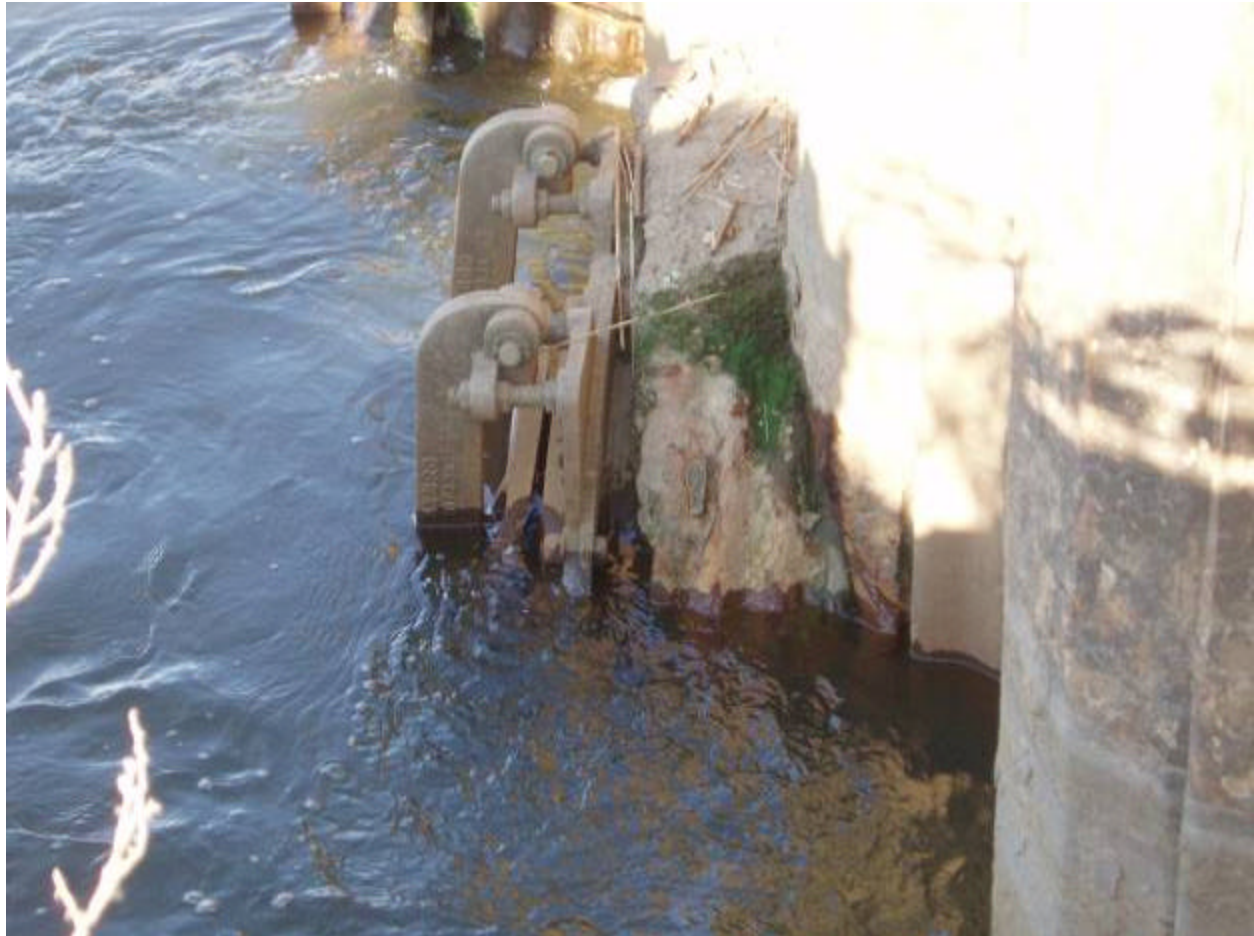
**Photo 1 Description: Metal flap gate shown closed**
