Hackensack Meadowlands Floodplain Management Plan

The National Flood Insurance Program Community Rating System Activity 510 Guidelines

The New Jersey Meadowlands Commission One DeKorte Park Plaza Lyndhurst, New Jersey

October 24, 2005

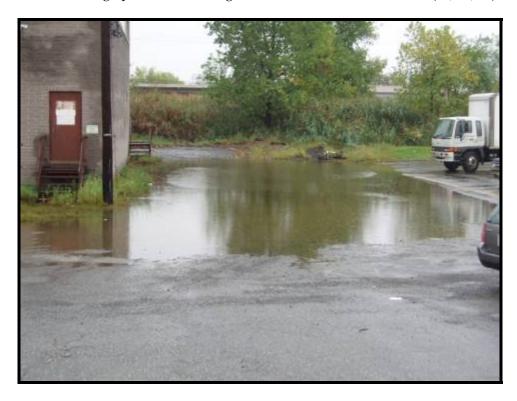
4. Flooding condition at 462 Barell Avenue (10/14/05)

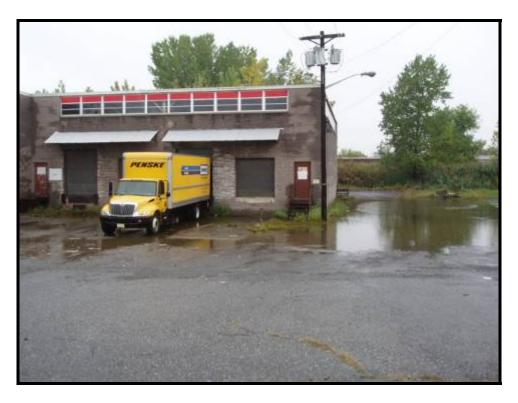
5. Flooding condition at 462 Barell Avenue (10/14/05)

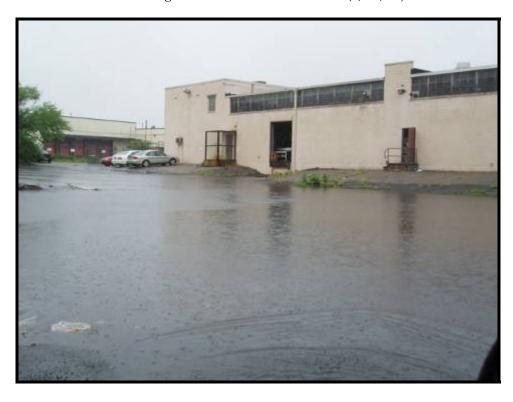
6. Flooding condition behind 705 Commercial Avenue (7/08/05)

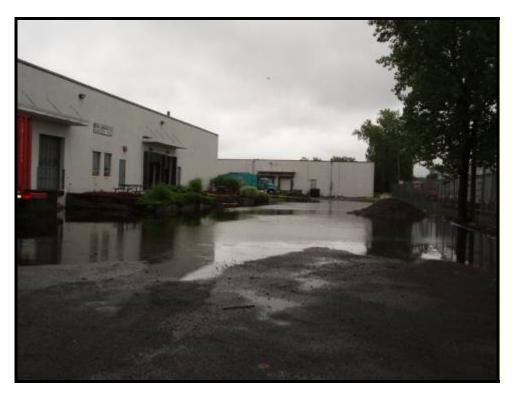
7. Flooding conditions at 745 Gotham Parkway in rear of the property (7/08/05)

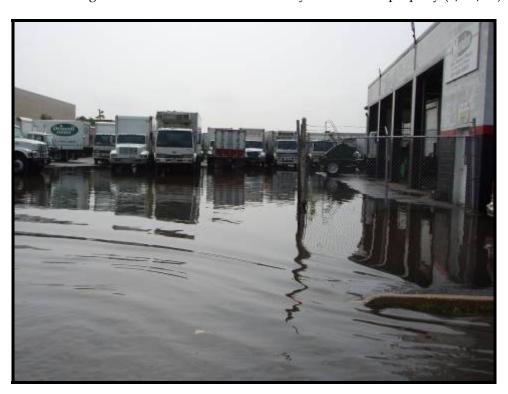
8. Flooding conditions in the truck yard at 120 Kero Road (6/10/05)

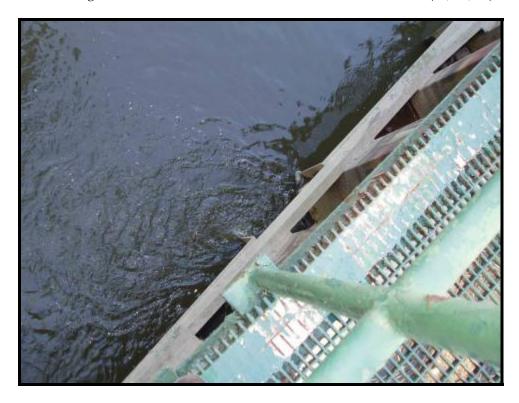
2. Boils observed upstream of West Riser Tide Gate during a tide change (10/06/05)

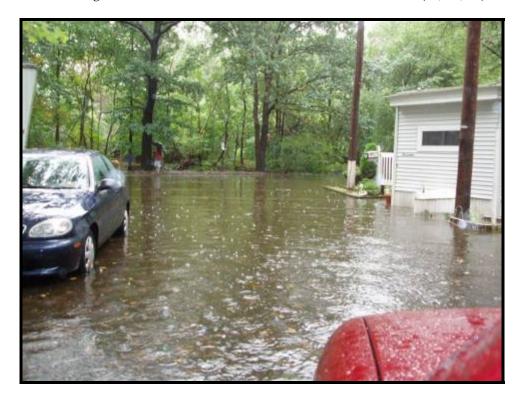
2. Flooding condition at Southeast of the mobile home area (10/14/05)

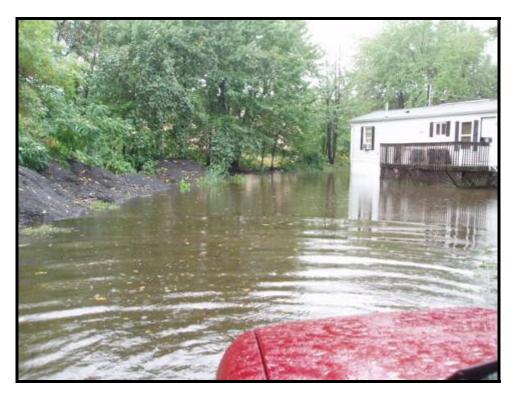
3. Flooding condition along the edge of the mobile home area (10/14/05)

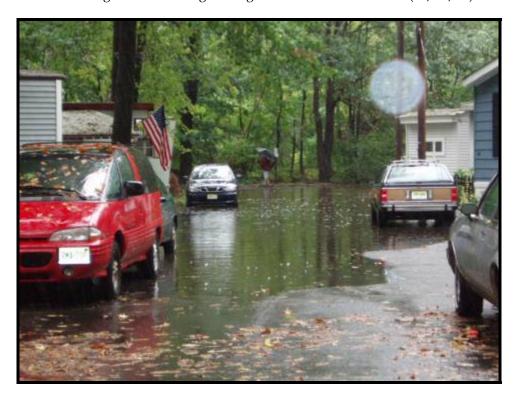
4. Flooding over the roadway in the mobile home area (10/14/05)

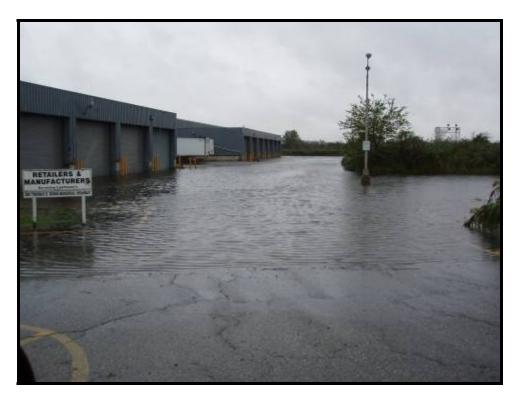
5. Flooding condition in loading docks at 299 Thomas E. Dunn Memorial Highway (10/14/05)

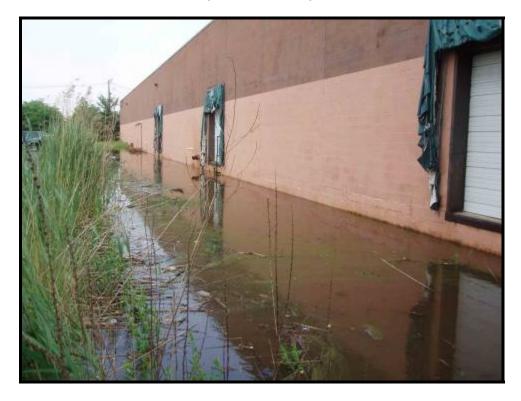
1. Flooding condition behind 360 Murray Hill Parkway (6/10/05)

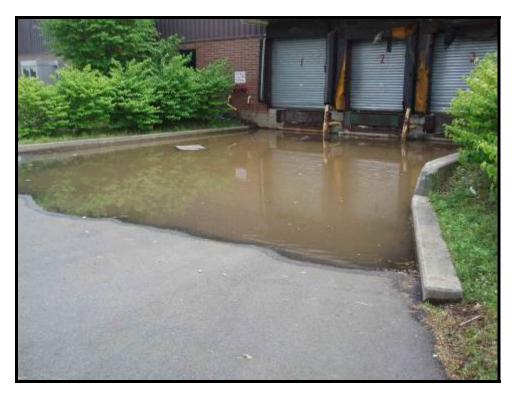
2. Flooding condition at loading docks on Madison Circle Drive (6/10/05)

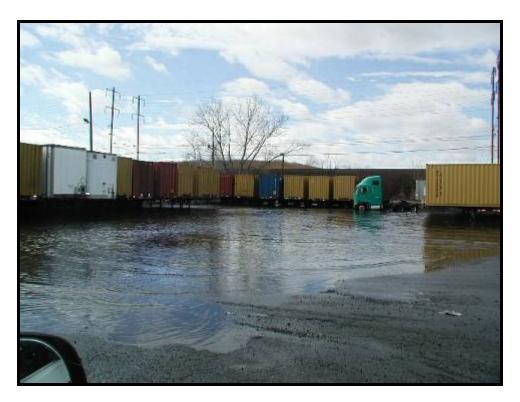
3. Flooding condition at the truck yard of 996 Belleville Turnpike (3/29/05)

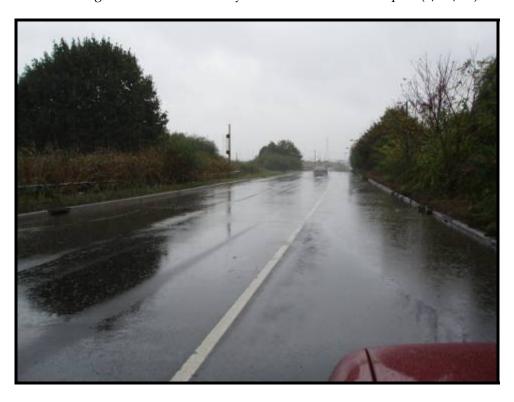
4. Ponding conditions on the shoulder of Belleville Turnpike (10/14/05)

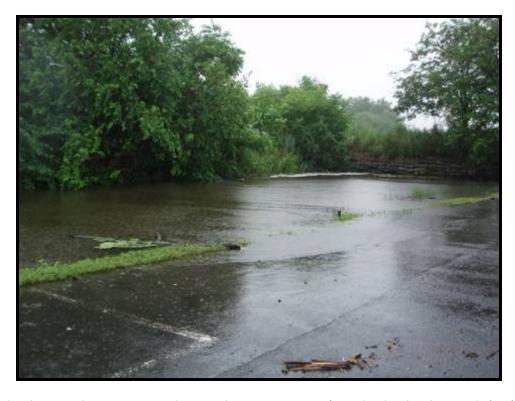
8. Flooding condition at 350 Gotham Parkway upstream of Peach Island Tide Gate (7/08/05)

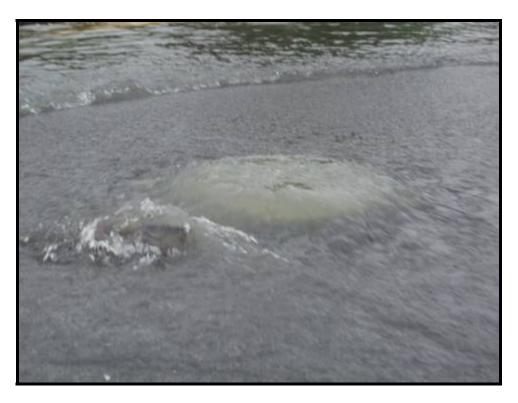
3. Surcharge condition for an inlet on 91st Street (10/14/05)

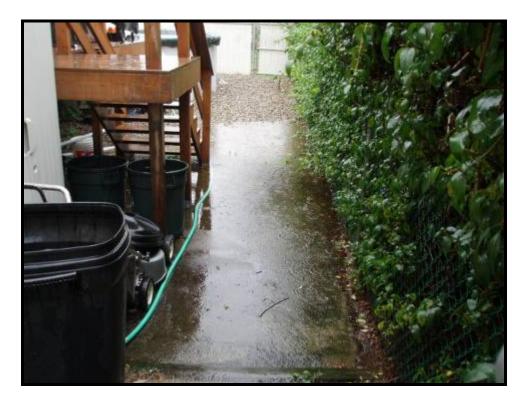
3. Ponding in the backyard of 15 Mill Ridge Road (10/14/05)
