Drumthwacket Garden Inventory, Assessment and Immediate Action Plan

EXECUATIVE SUMMARY

EXISTING CONDITIONS SITE PLAN

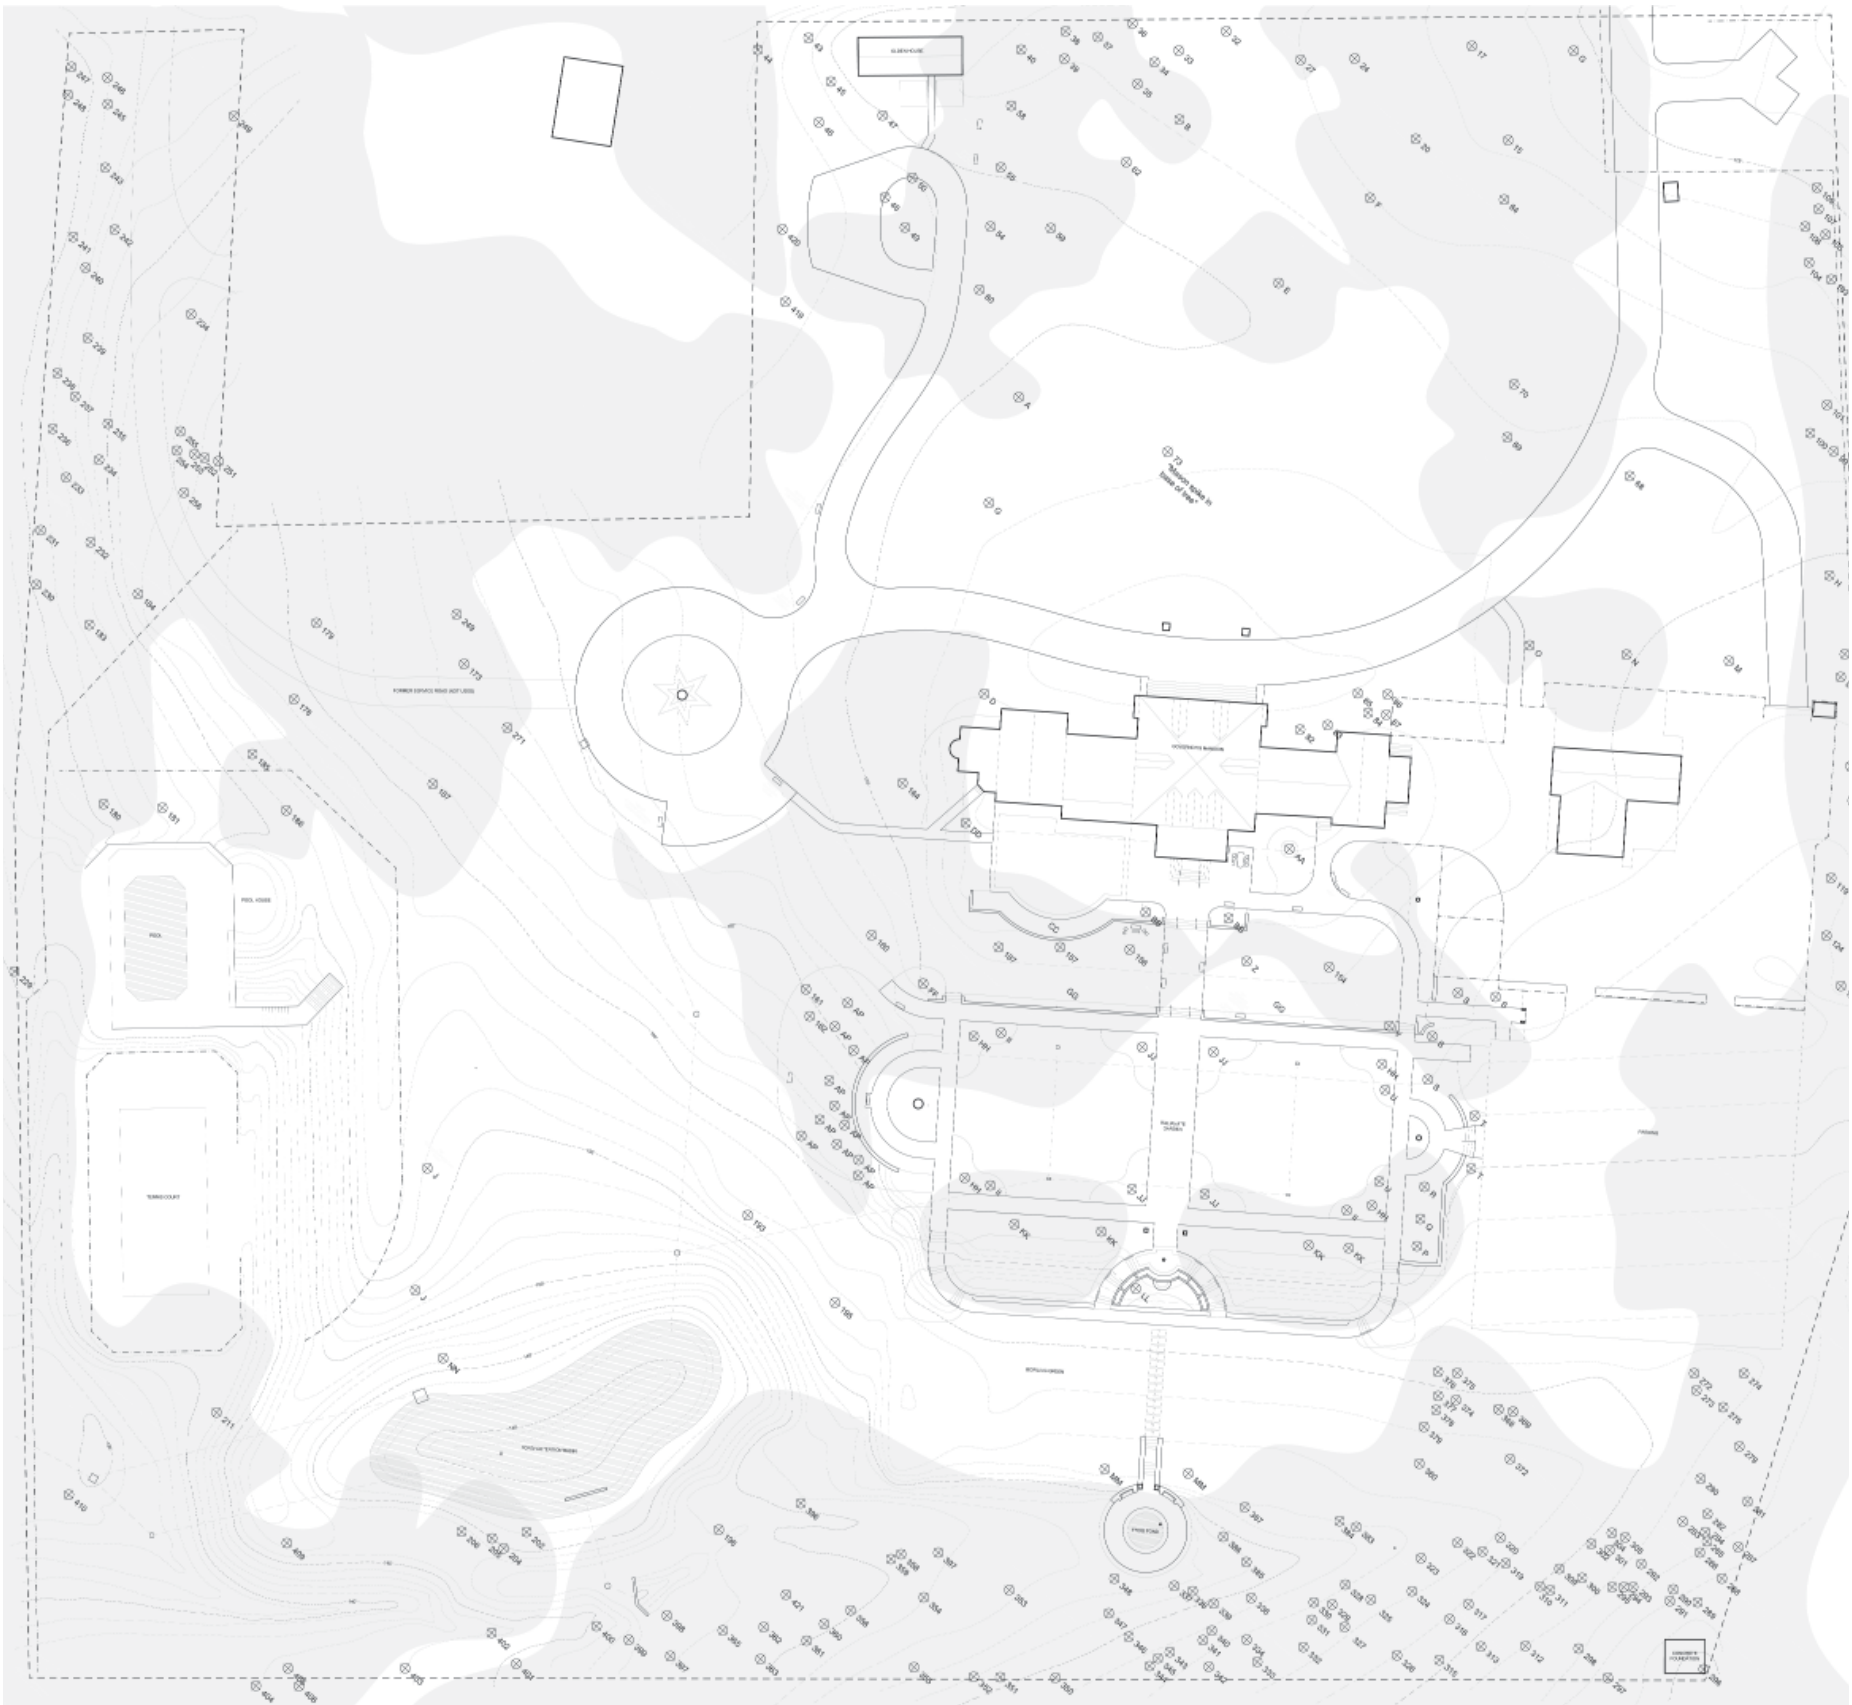
Existing Conditions Plan (Left) represents a “best fit” combination of 5 existing plans including: Google Earth aerial photographs (2017), ArcMap aerial photographs (2017), HMR Architects (formerly Holt & Morgan) site survey and tree inventory (1967), HMR Architects’ Detention Basin Site Plan “as built” (1992), and Pleasant Run Nursery’s Italianate Garden Redevelopment Concept Plan (1992). Measurements and adjustments were made b CUES’s staff over the course of 3 site visits between June and July of 2018

Existing Conditions – The combination of aerial photographs, detailed site surveys and field corrections has contributed to the development of a representative existing conditions plan that serves as the template for Drumthwacket's Garden Bed Diagram and Water-Flow Diagram. Proportions and layout offer a firm understanding of design principles and current physical conditions. While this plan is not intended for construction, it offers the most thorough understanding of the site since 1967. From this input general understanding of spatial and ecological processes can be derived including: tree canopy coverage, the identification and location of significant tree specimens, architectural elements, garden layout and design, impervious surface areas and topographic lines displayed in one-foot intervals.

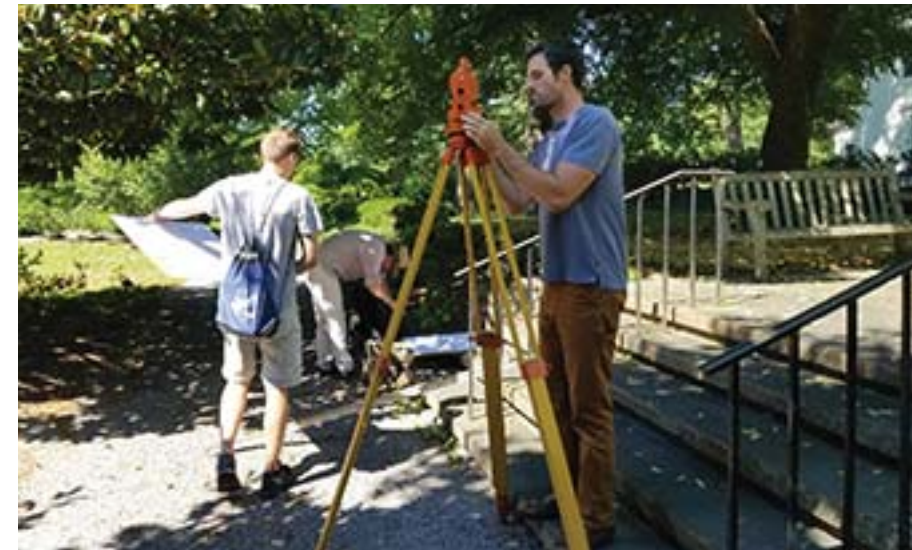
CUES team surveying the Italianate Garden

conditions and gather more precise layout dimensions of the formal Italianate garden, several site visits were conducted by CUES employees between June and August of 2018. Measurements made in the field using traditional surveying equipment (tape measure, builder's level, and ranging rod) were used to reference distances to "hard" infrastructure including, the main building (mansion) and the corners and edges of walls, roads and pathways. Further topographic and layout figures were created by recording twenty spot-elevations along the Italianate garden's central spine; from the base of the mansion's back door to the southern edge of the Frog Pond's patio. From the evaluation of multiple spot-elevations grade changes (slope) and topographic lines were interpolated, connecting the topography of the Italianate Garden to the ones represented in both of HMR's previous surveys.

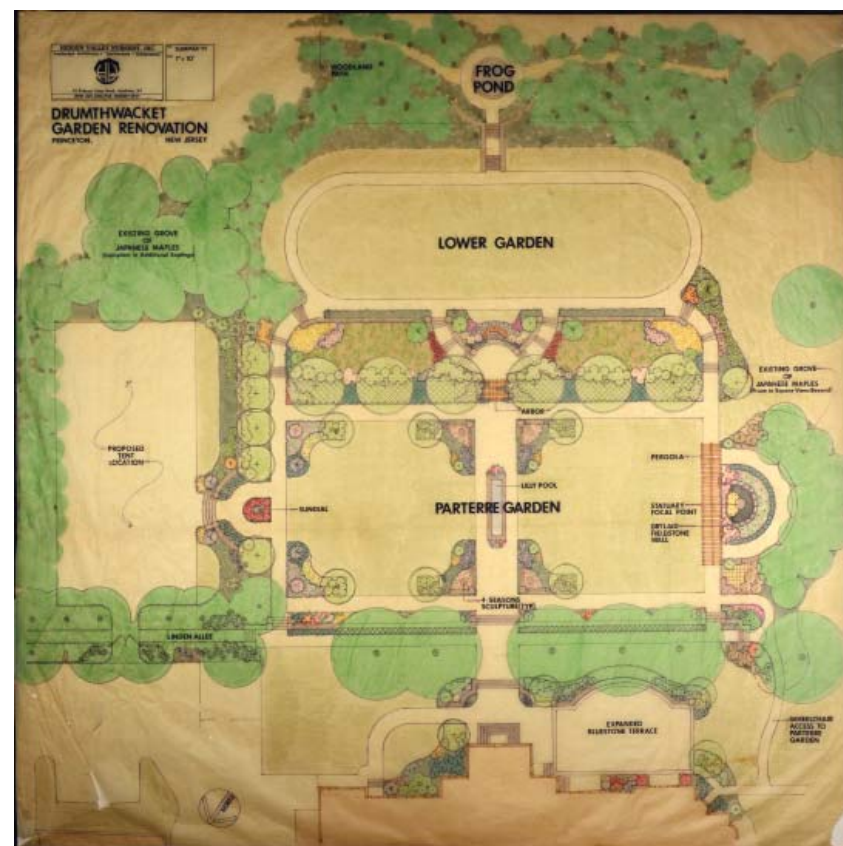
Hand drawn 1991 plan (marker and ink on trace) done by Hidden Valley

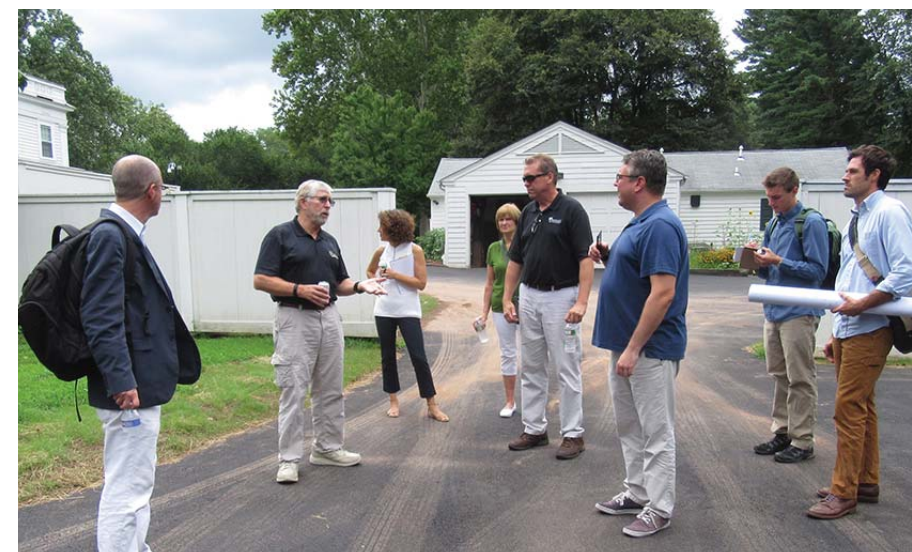
Bartlett Tree Experts, The Drumthwacket Foundation, and the CUES team discussing the new parking lot.

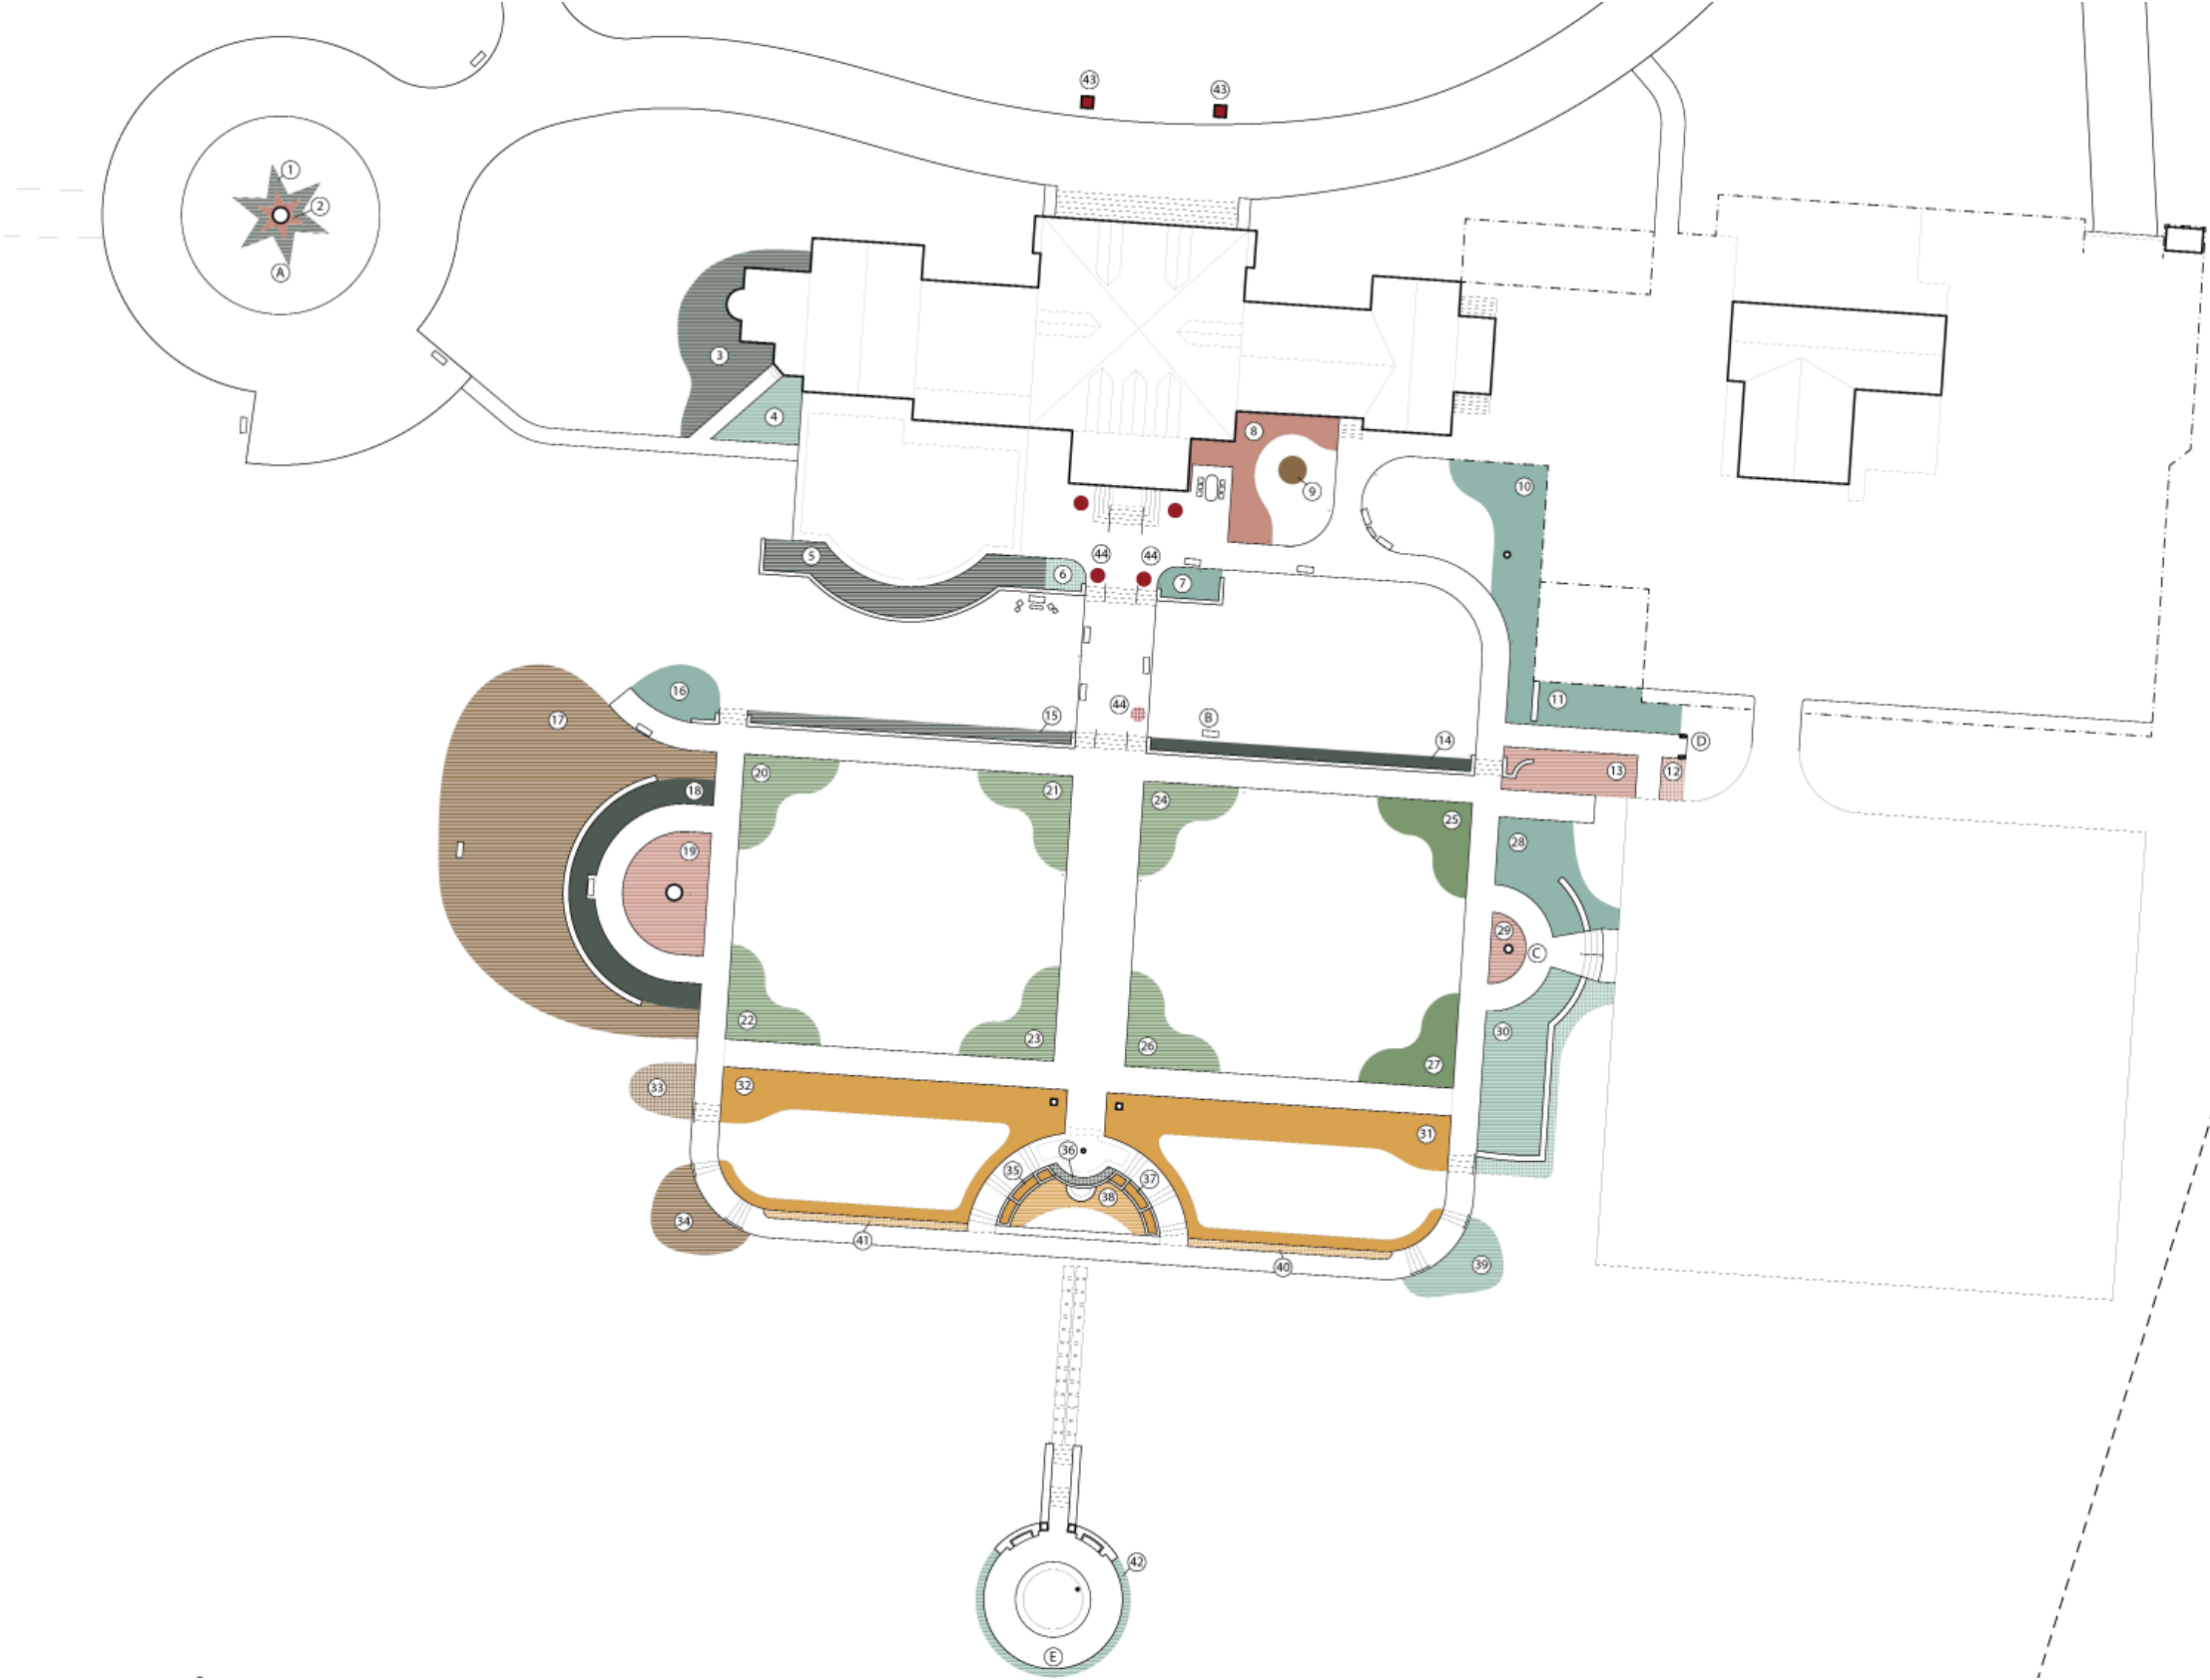
EXISTING PLANTING BEDS AND CONDITIONS

Because such a wide ranging aggregation of groups and individuals represent various skill levels, time investments and dedication, CUES created a Garden Planting and Elements diagram to begin a strategy of garden inventory and analysis. Several visits were conducted between May and August of 2018 to familiarize CUEs employees with the intricacies of the landscape and to begin analysis on the existing conditions of the garden elements. Photographs were taken regularly to witness the changing conditions of both plant-life and maintenance schedules within the garden beds themselves. It quickly became clear that the scope of this investigation would target the main features seen by the thousands of annual visitors in tours given by the Drumthwacket Foundation as feedback from the foundation suggests these areas harbor the main historical artifacts, are most commonly appreciated or photographed and are situated within the grounds regularly utilized for events. This scope overlaps with the range of the Middlesex master gardener's program and puts significant weight on the Italianate terrace garden.

to "degraded", hatch patterns represent a spectrum of garden-bed quality to ensure that upkeep is addressed on a priority basis.

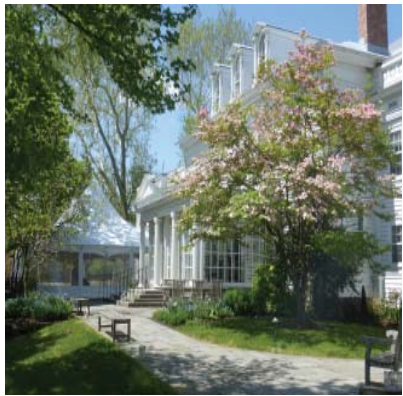
Type : Rose Base

- 2. Perennials
- 8. Roses, Hydrangea, Canna lily, Sedum, Holly, Perennials etc.
- 12. Roses
- 13. Roses, Magnolia, Yew etc.
- 19. Lavender, Roses, Boxwood
- 29. Lilyturf, Roses (very poor condition)

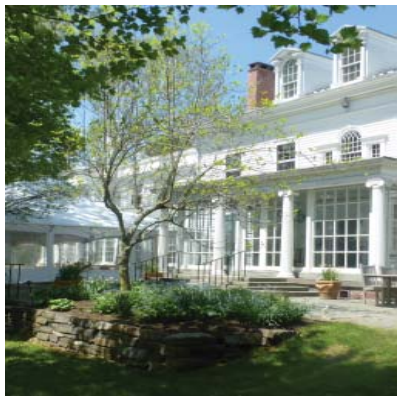
Type : Perennials (Shade)

- 4. Stewartia
- 6. Hosta, Yews
- 7. Magnolia, Hosta, Perennials
- 10. Crabapple, Holly, Azalea
- 11. Magnolia, Ferns
- 16. Japanese Maple, Oakleaf Hydrangea, Perennials
- 28. Ivy, Katsura
- 30. Katsura, Vinca, Holly
- 39. Cherry, Maple
- 42. Pachysandra, Ferns

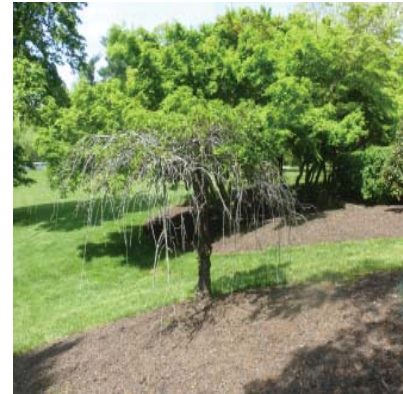
Type : Misc. Mulched Bed

- 9. Dogwood
- 17. Maples, Holly, Perennials
- 33. Cherry (very poor health)
- 34. Blue Fescue (mostly barren)

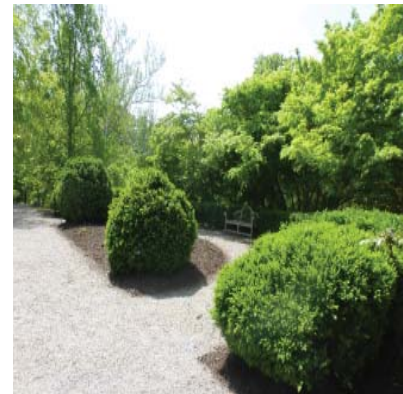
Type : Hedge

- 1. Boxwood
- 3. Boxwood
- 5. Hosta, Lily, Yews (deer grazed)
- 14. Red tipped Photinia, Boxwood, Vinca
- 15. Boxwood, Vinca
- 18. Boxwood Hedge
- 36. Boxwood

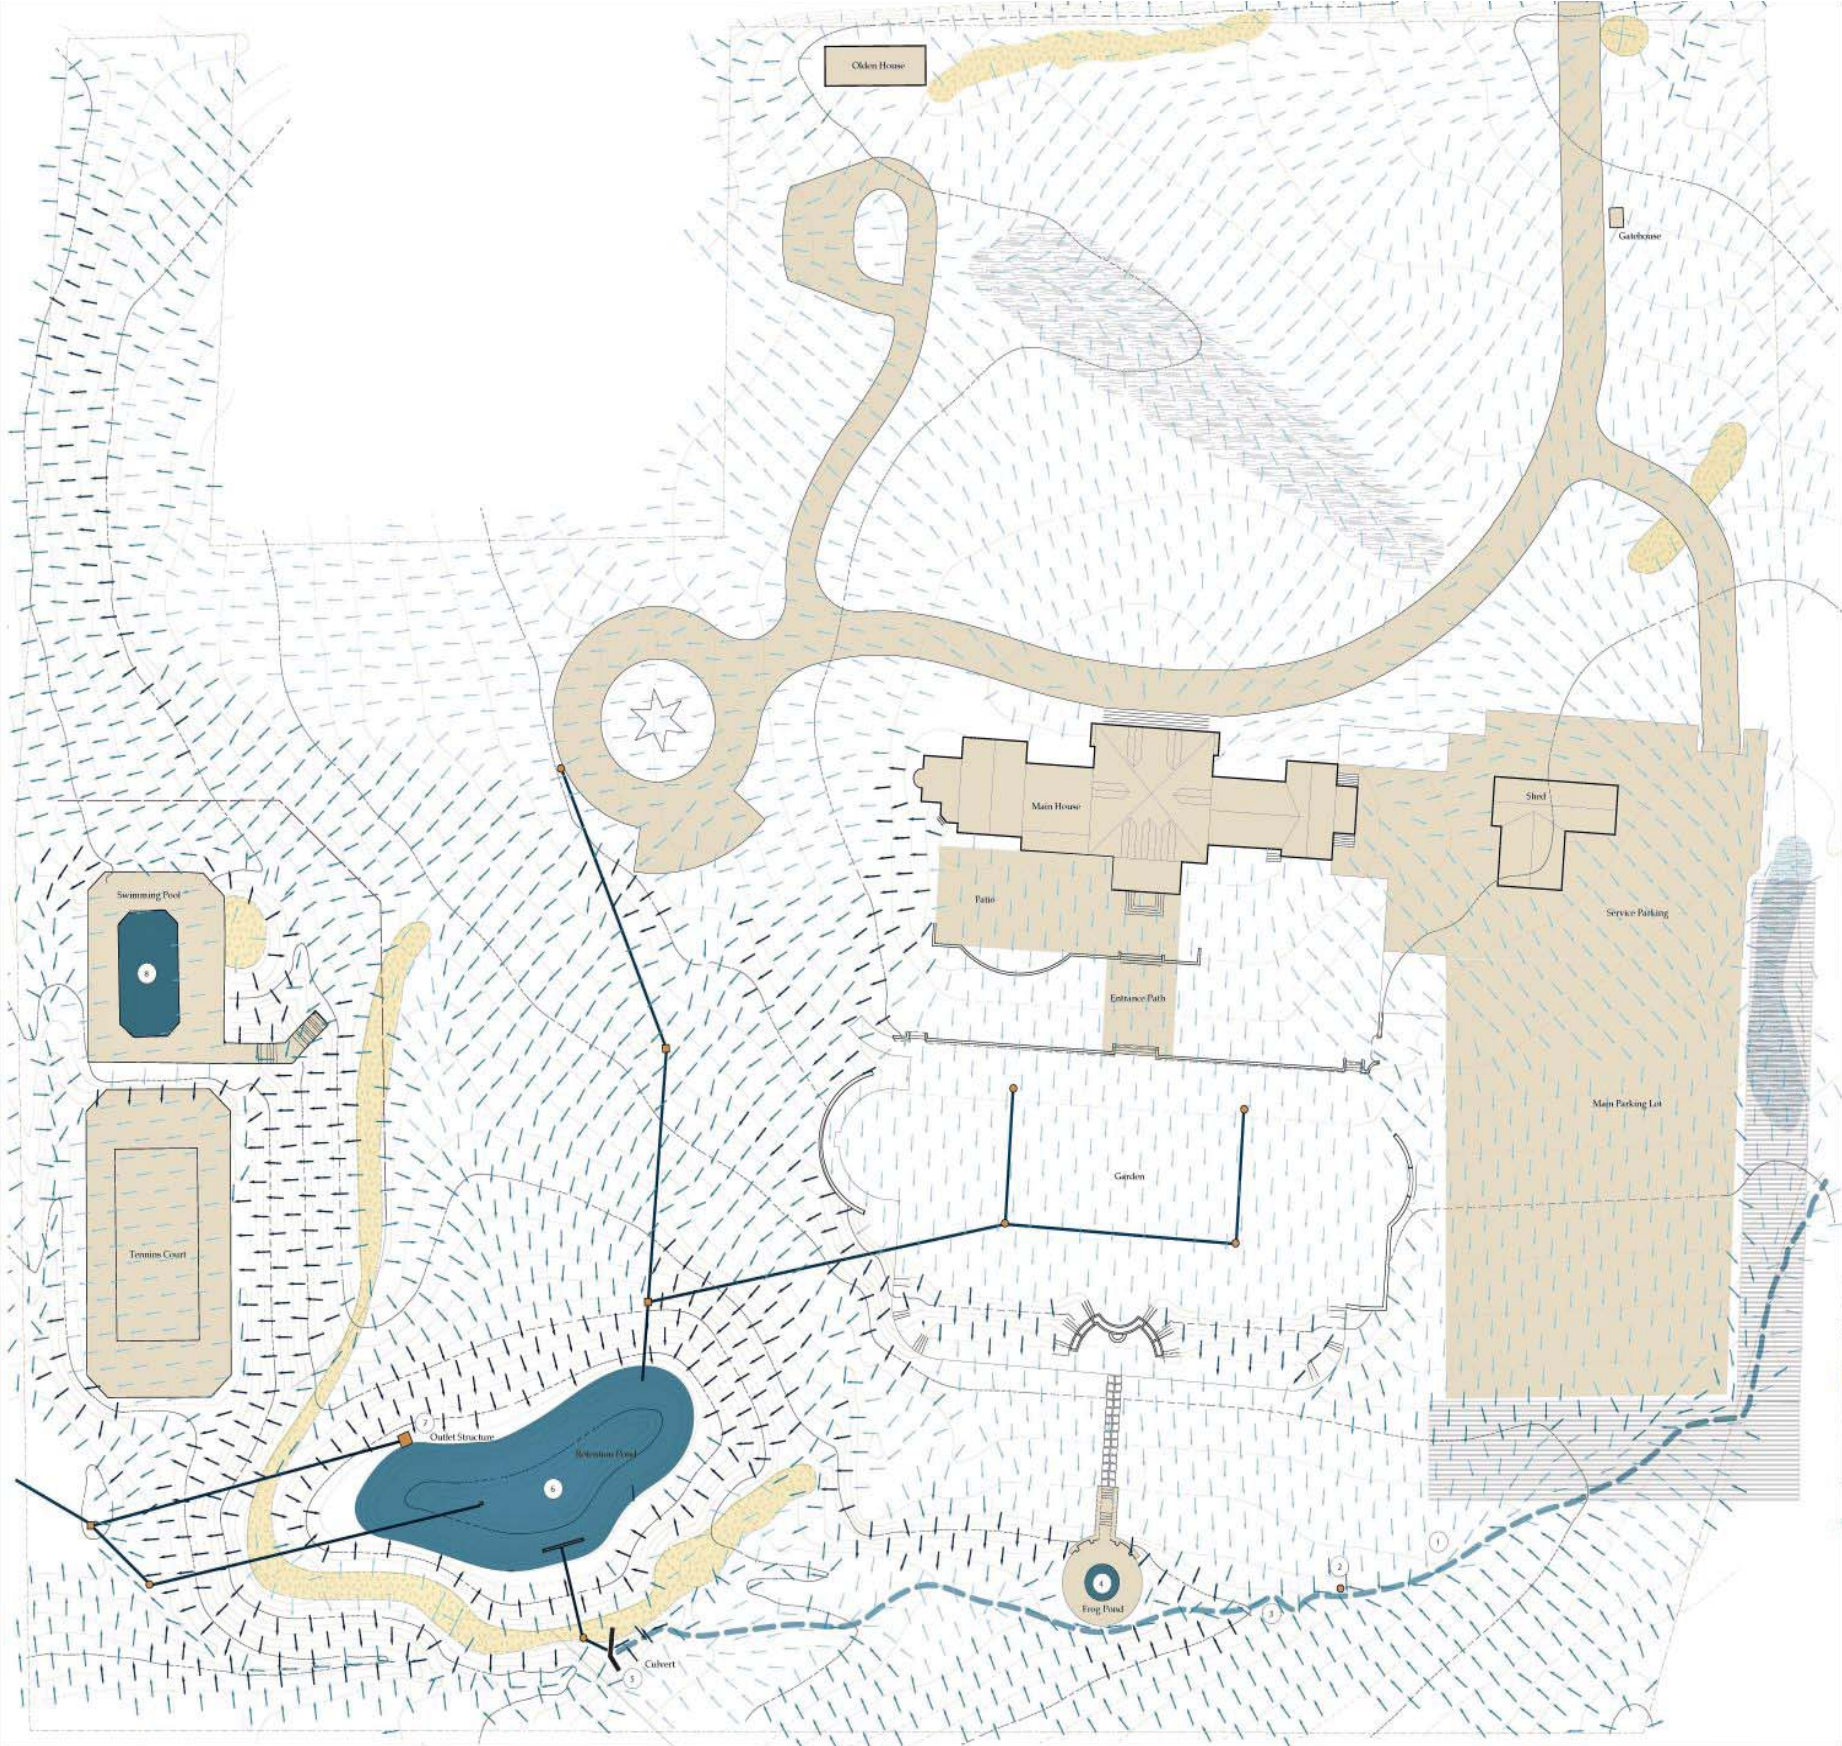
WATER AND DRAINAGE

Specific topography of Drumthwacket estate along with the impervious surface coverage are two important factors to consider for the stormwater management planning. The topography was last surveyed by HMR Architects in 1992 when drainage pipes and drains were added in the garden area and retention pond was regraded. At that time, the drainage system was designed to capture and channel water off the property via the shortest and quickest route possible, as used to be a standard practice. Evidence of stream channelization is found in the stream bed at the south end of the property where textile lining is covering the bottom of the creek, and further down the stream there are asphalt chunks found in the stream bed (3). Older, possibly historic drain pipe in this area requires more research to determine its exact age and capture area (2).

Steepness of slopes determines the potential for soil erosion, the steeper the slope, the higher the risk for erosion is. Areas with darkest arrows are the areas where water runs the fastest over the land. Lightest arrows designate the areas where slopes are minimal, they appear to be flat. This is where water has the most chance of percolating back into the ground recharging the water table. Within these areas are low-lying wet areas where water tends to pool after rain events. These areas tend to stay moist for longer periods. Ridges are higher and drier than their surroundings.

There is some recent evidence of erosion around the new parking lot addition. Our recommendation is regrading and planting the area directly adjacent to the lot. At this size, the lot generates over 9,000 gallons of runoff for every inch of the rainfall. Runoff is often hot and polluted coming of the parking lot's black-top surface and it needs to be mitigated before it runs back to the swale in forested area.

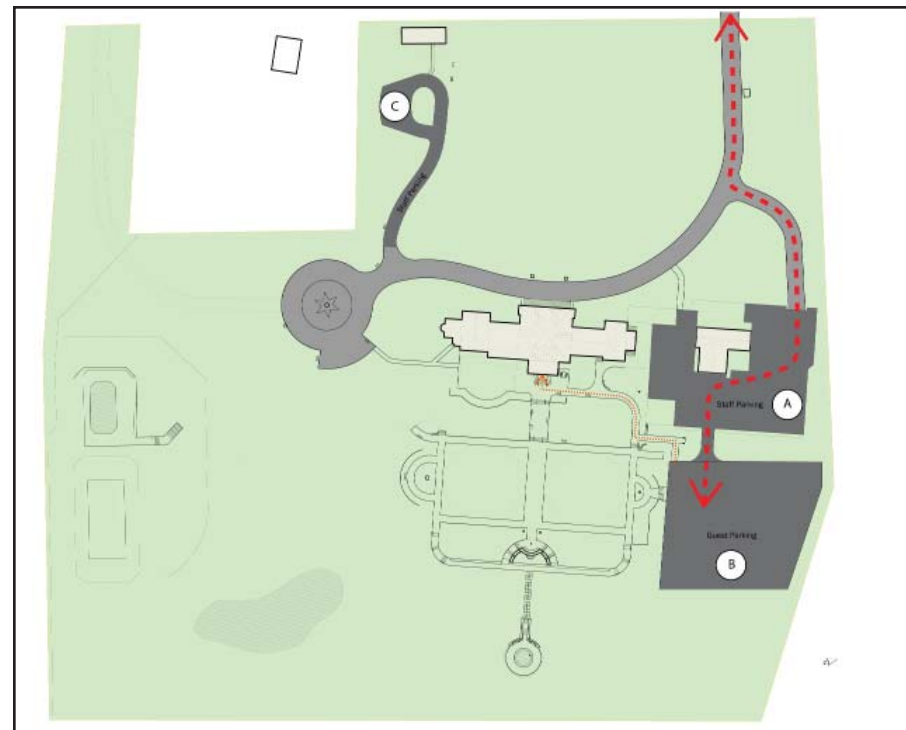
Small Event Vehicle Circulation Plan

A small event at Drumthwacket will consist of less than 25 vehicles. For this size event, parking in Zone B will be reserved for event attendees. There will be no need for valet parking, and attendees can park themselves in Zone B to be received by the garden entrance.

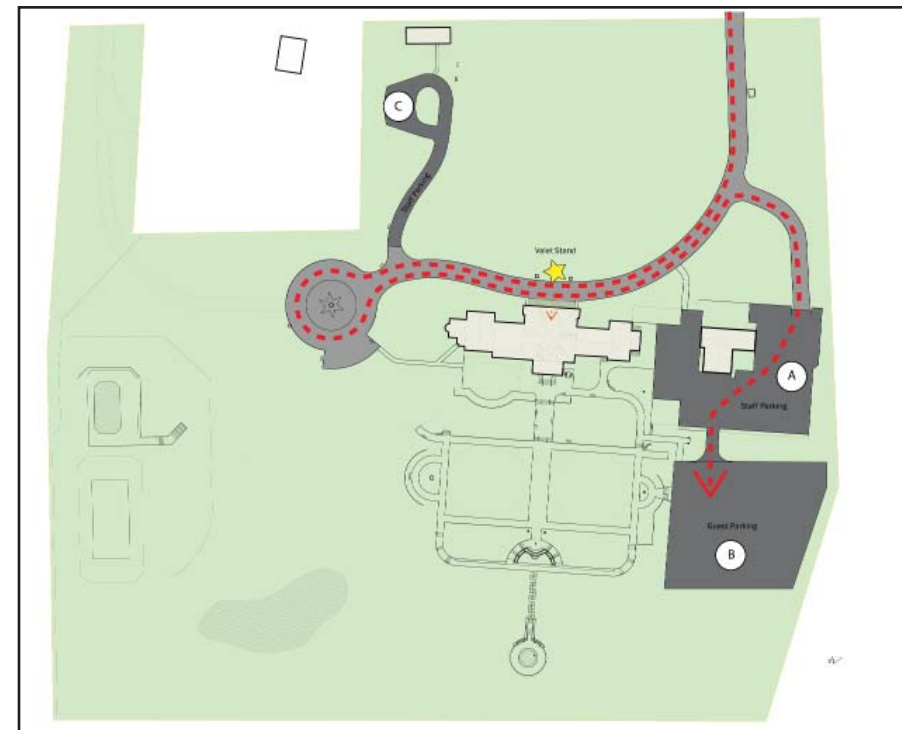
Medium Event Vehicle Circulation Plan

In order to adequately accommodate a 25-75 vehicle event, a professional valet service will be needed to fit the appropriate number of vehicles in the parking available. Event attendees will arrive and be greeted by the host/hostess on the front stairs and the valet will park the vehicle in one of the on-site parking zones. All vehicles will be parked on Drumthwacket property.

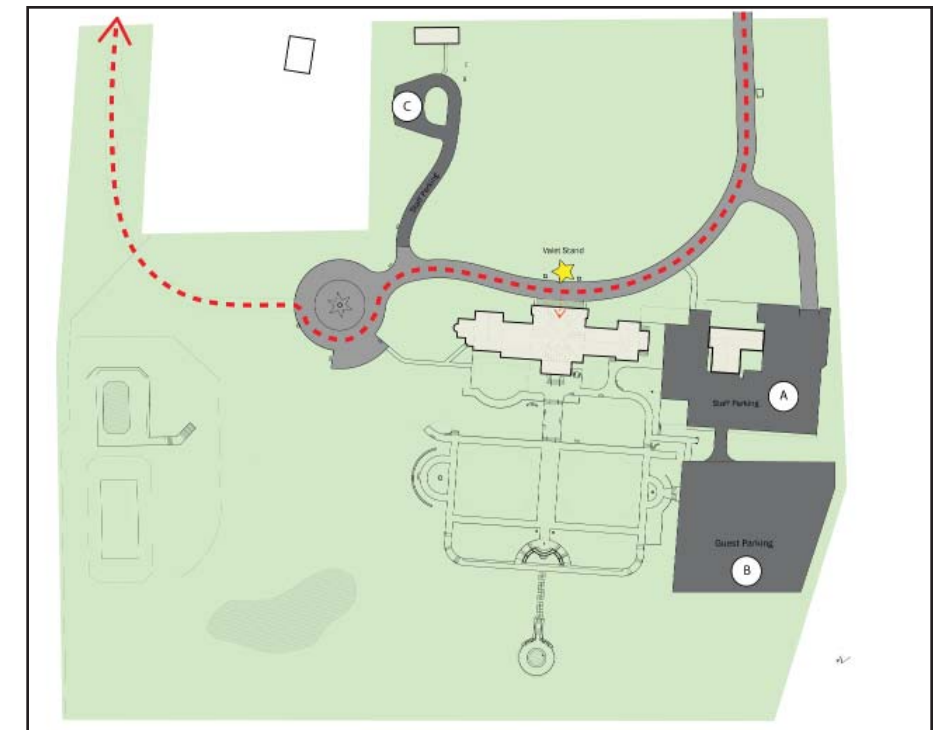
Large Event Vehicle Circulation Plan

To accommodate large events of more than 75 vehicles, off-site parking is required. A valet service will be required. Event attendees will arrive and be greeted by the host/hostess on the front stairs and the valet will park the vehicle either in one of the on-site parking zones, or a designated nearby parking location (Table 3). If possible, it's recommended that the southern entrance to the property is opened so the traffic flows in one direction to ensure smooth and efficient arrivals and departures. If the southern entrance is unavailable, the departing cars can be turned around at the roundabout.

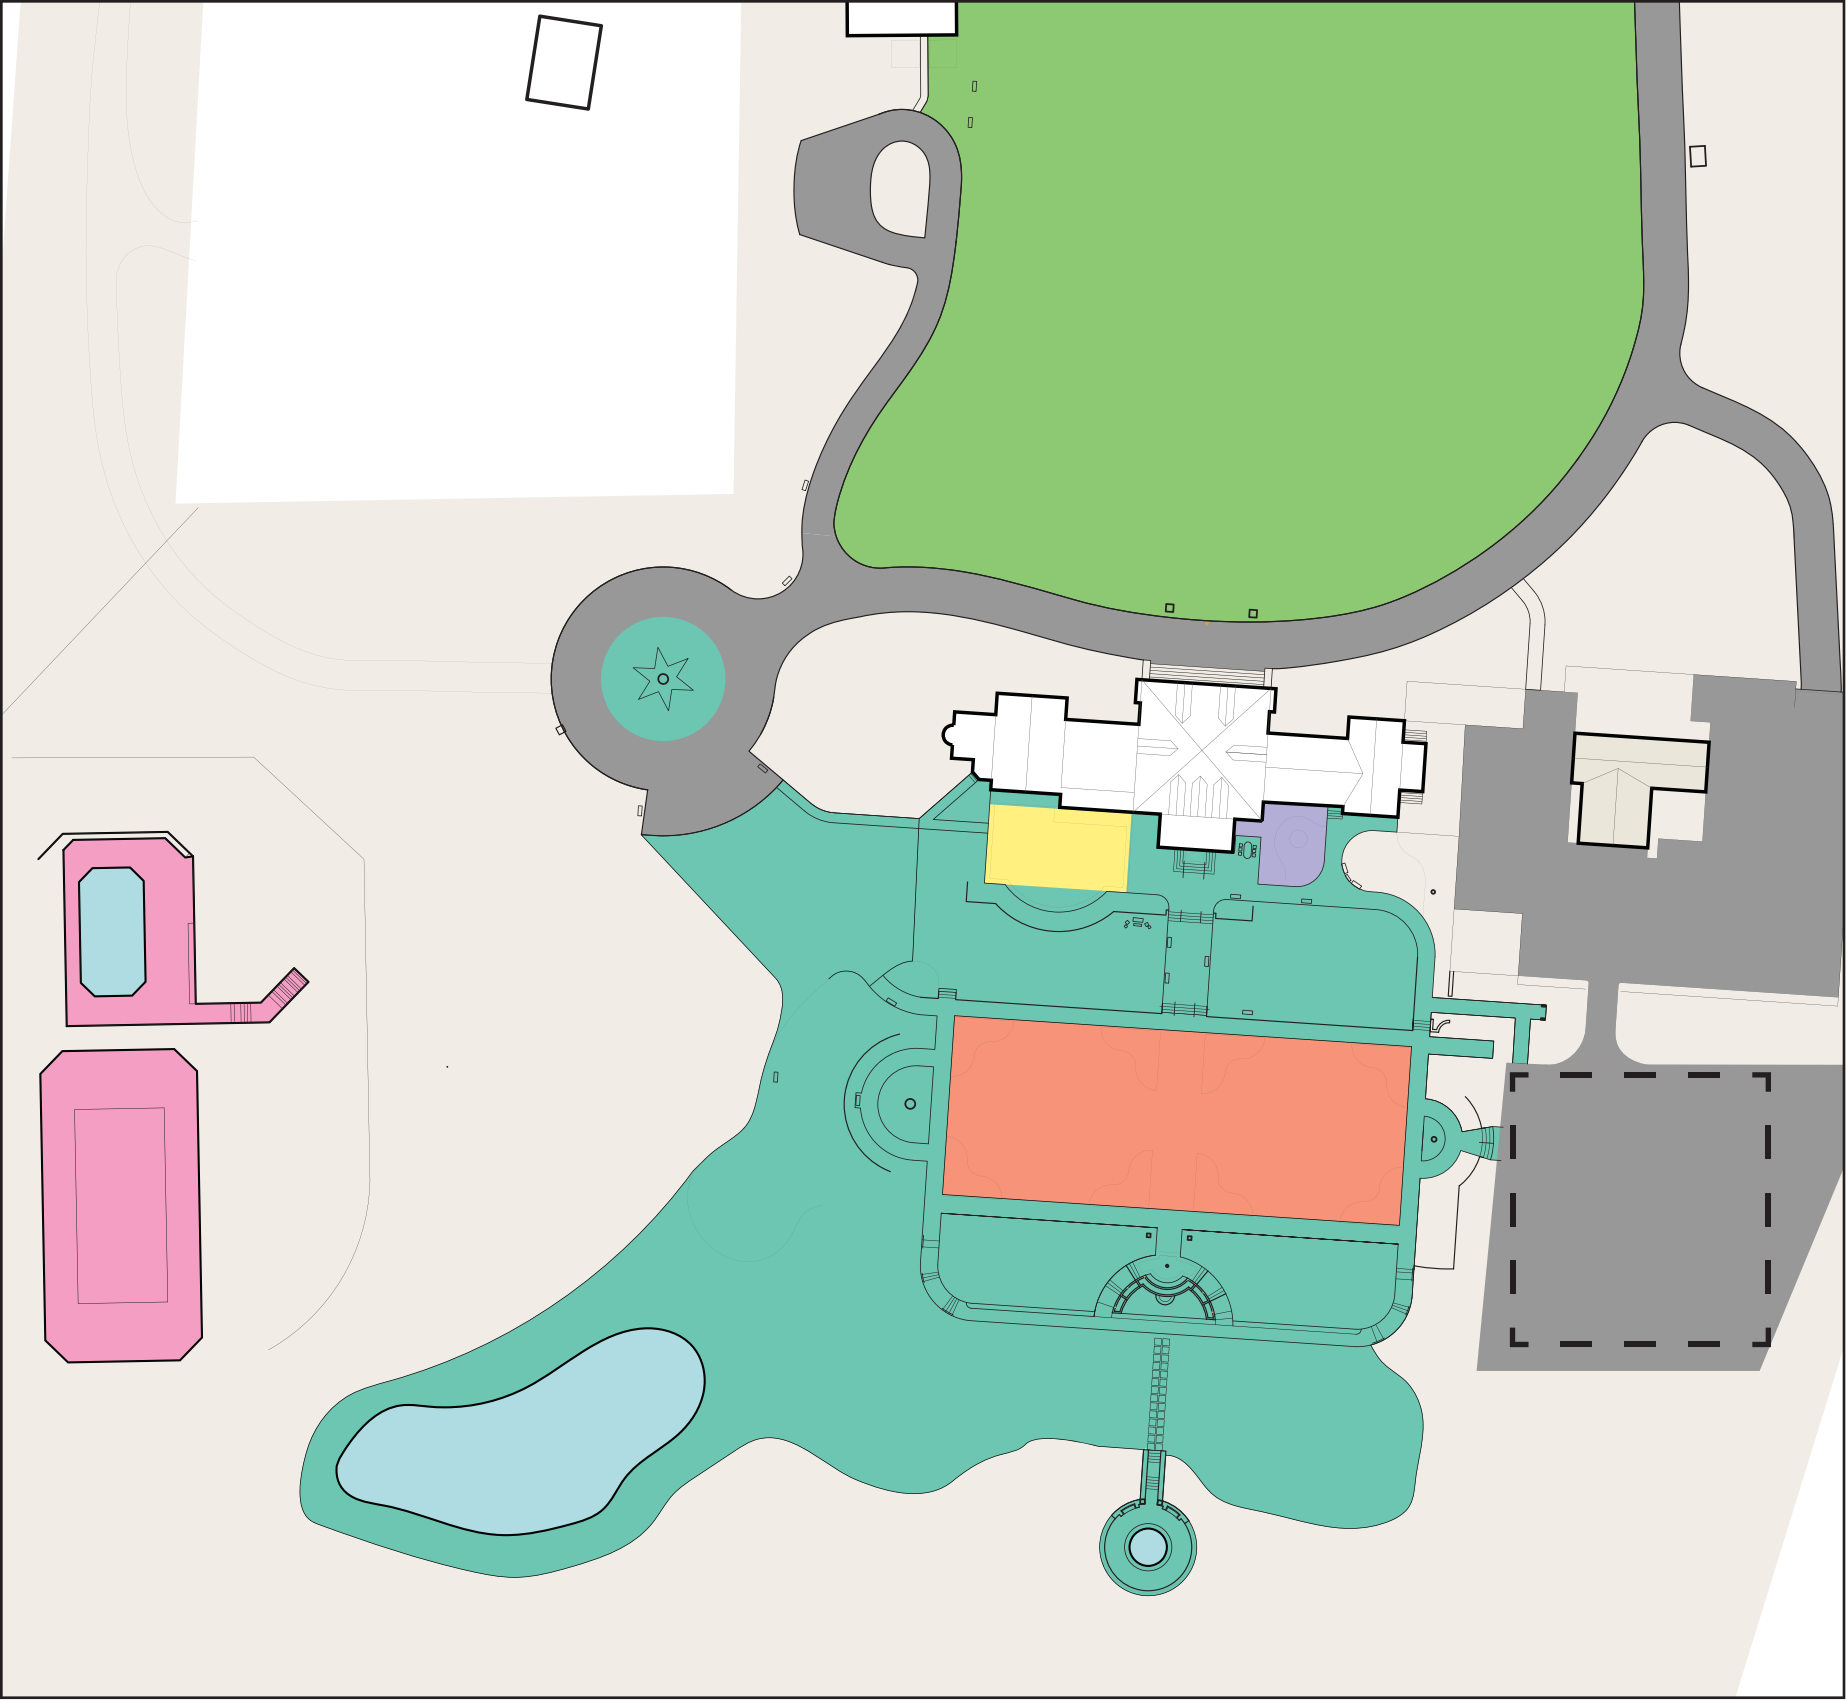
SITE ZONES

In order to properly manage the estate and accommodate its dual purpose as residence of the Governor and a location for state functions, it is important to identify the different spaces that can be used in specific ways. The figure to the left divides the estate property into zones for use.

- Family Breakfast Terrace
- Governor's Family Space
- Small Event Tent Space
- Large Event Tent Space
- Visitor Park Experience
- Great Flat Lawn
- Potential Large Event Tent Space

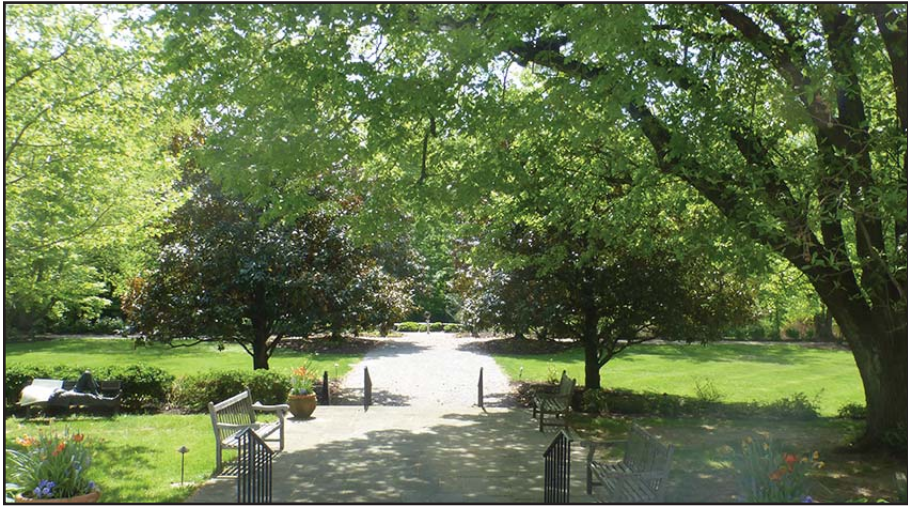
Small Event Tent Space

Small events can be held with enough space for a tent. It is close to the back entrance to the house and is shaded by the sycamores to provide a comfortable and convenient environment.

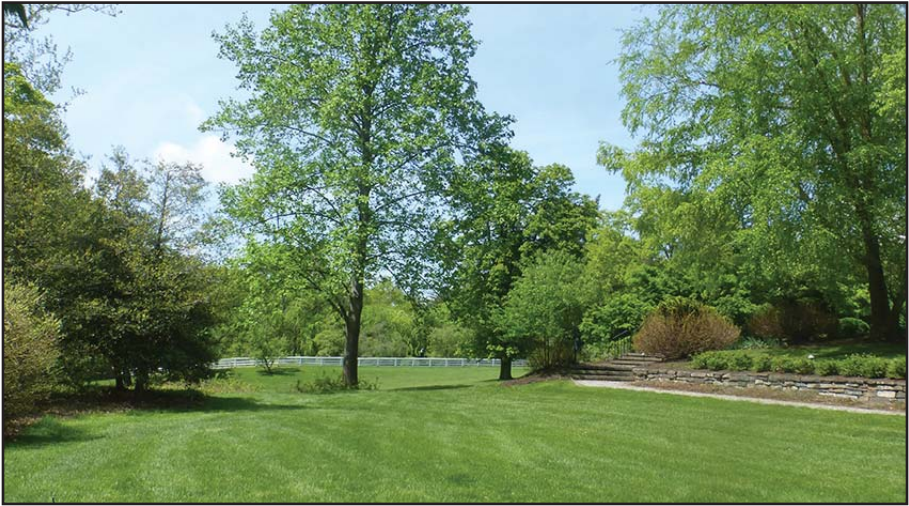
Current Large Event Tent Space

The required tent for large events is currently placed in the center of the Italianate garden. Utilizing off-site valet parking will make it possible to place a large tent on the large parking lot. This would free up the space for the enjoyment of the guests.

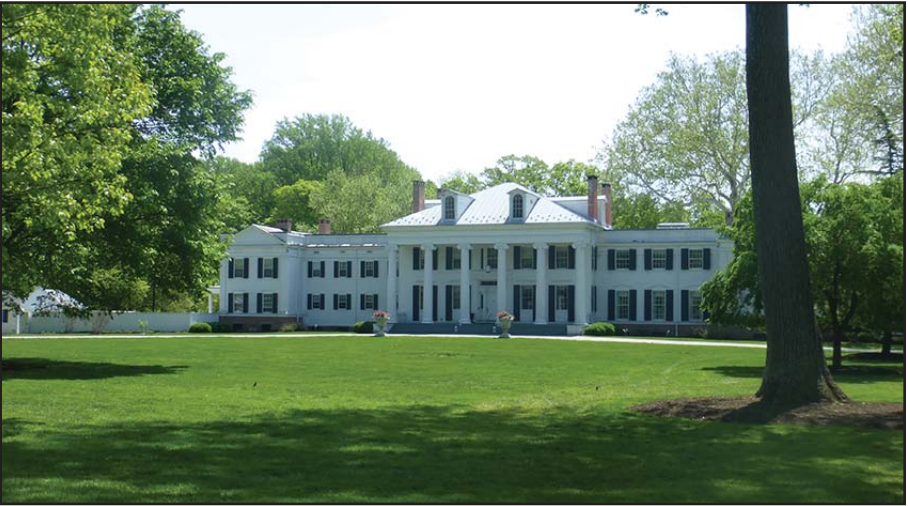
Visitor Park Experience

This outlines the space where visitors to Drumthwacket will be experiencing the property. The space includes historic locations such as the frog pond and the Italianate garden.
