# Van Buskirk Island Cultural Landscape Report

**Van Buskirk Island County Park  
New Milford Plant of the Hackensack Water Company County Historic Site  
New Milford Avenue, Elm Street and Madison Avenue**

**Boroughs of Oradell and New Milford  
County of Bergen, New Jersey**

**Department of Landscape Architecture  
Center for Urban Environmental Sustainability  
School of Environmental and Biological Sciences  
Rutgers, The State University of New Jersey**

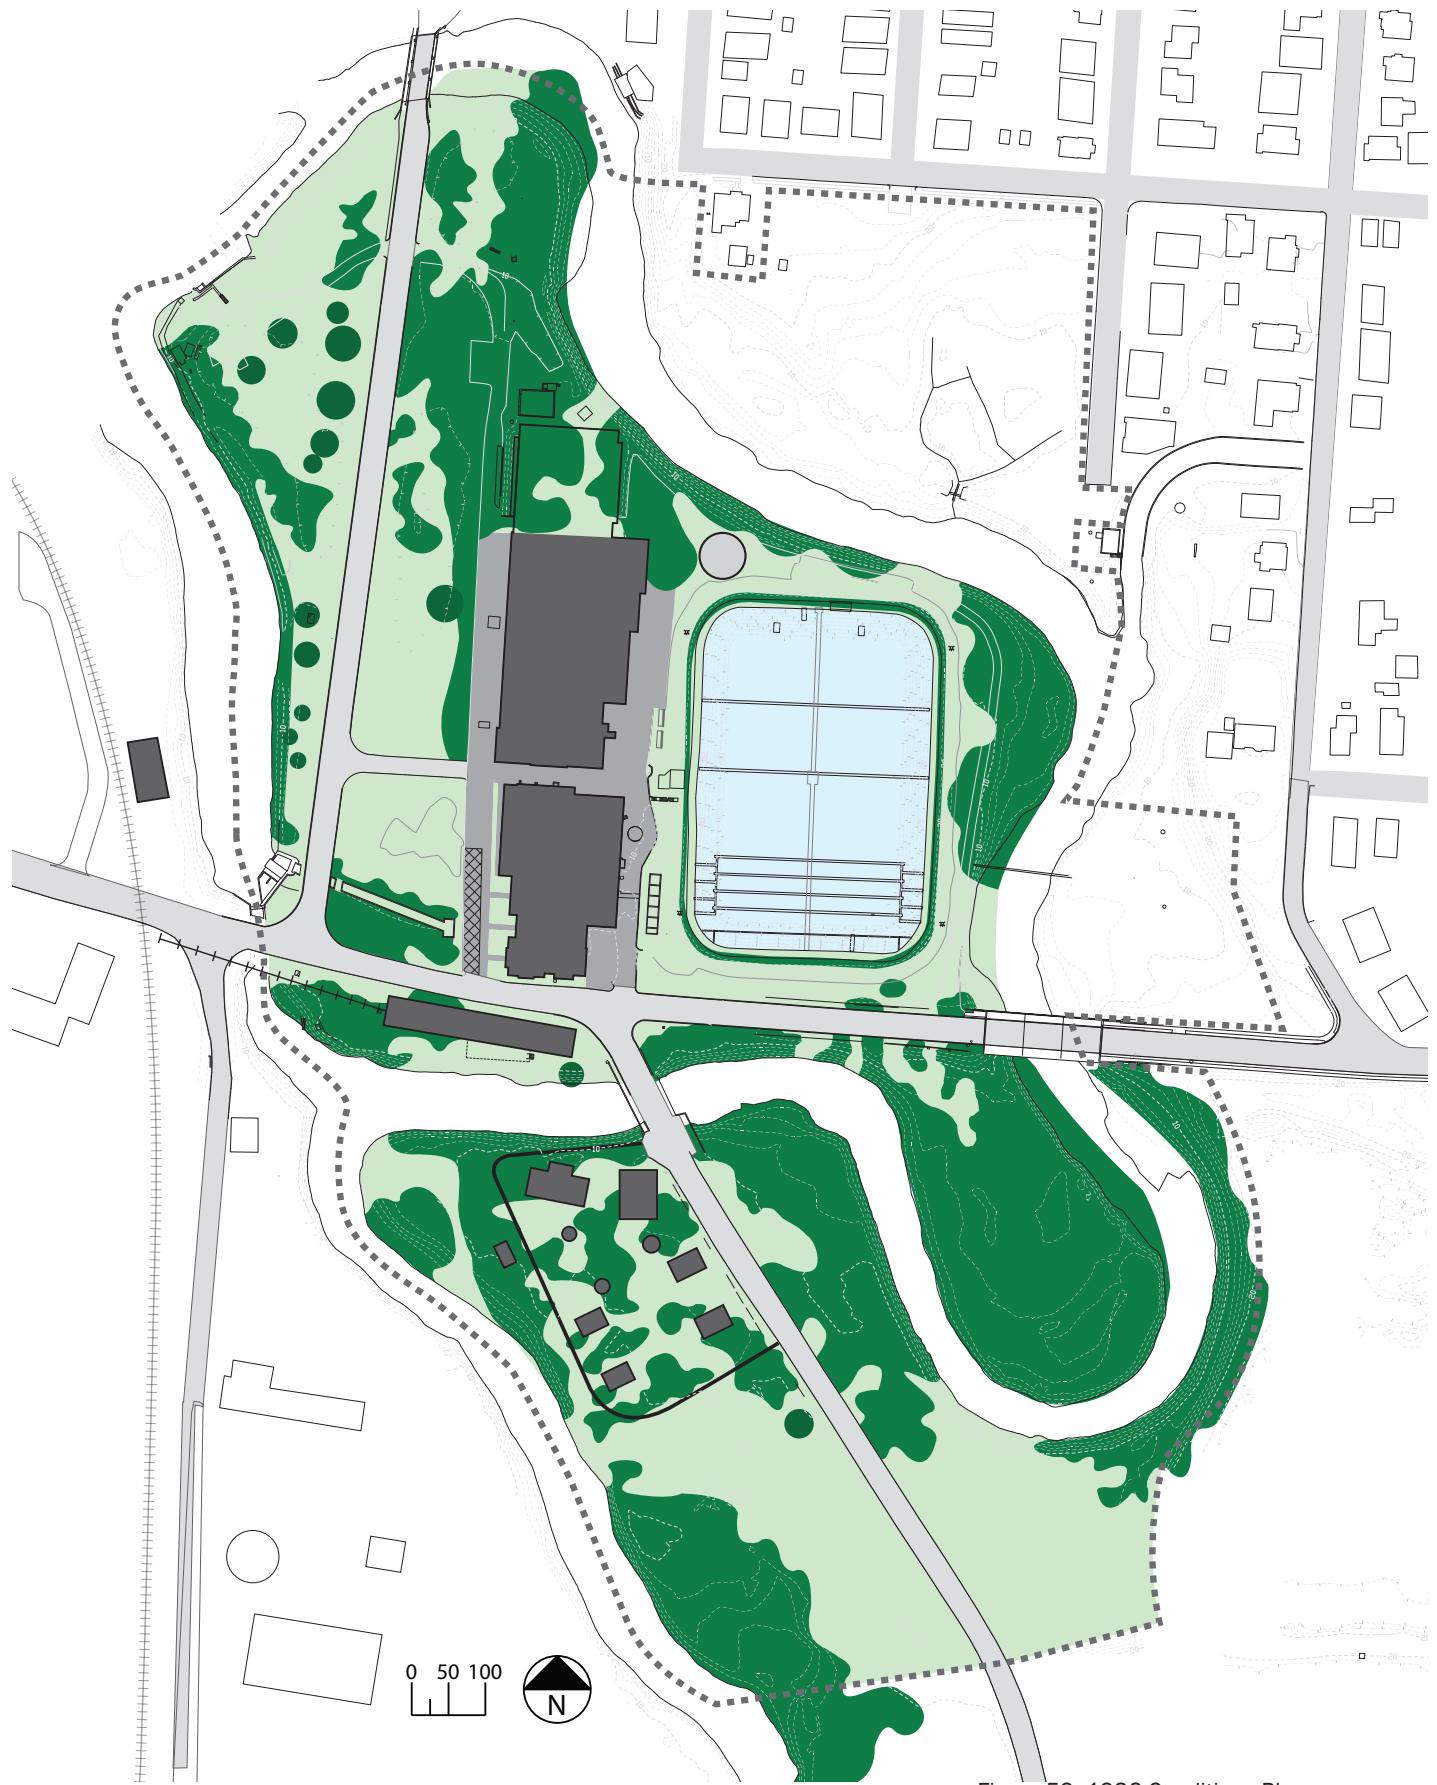
Figure 59: 1936 Conditions Plan.

To determine the character and levels of change across the Hackensack Water Works facility, the method used is to compare the existing conditions of the property (figure 38) and the 1936 conditions of the property (figure 59). While considering the change since the 1936 conditions, it will also be pertinent to examine the conditions that existed within the property prior to 1936.

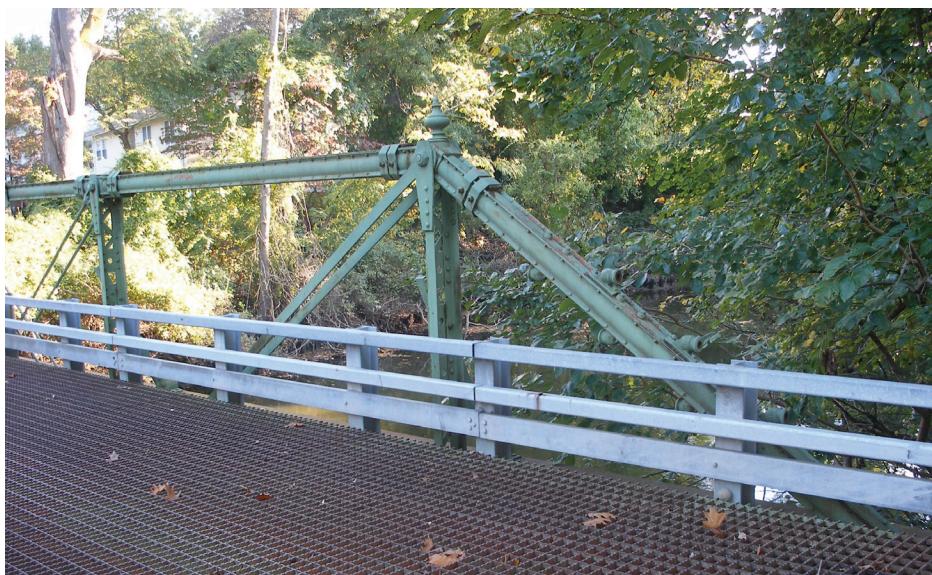
Figure 63: Elmstreet Bridge (c. 1892),  
Phoenix column truss

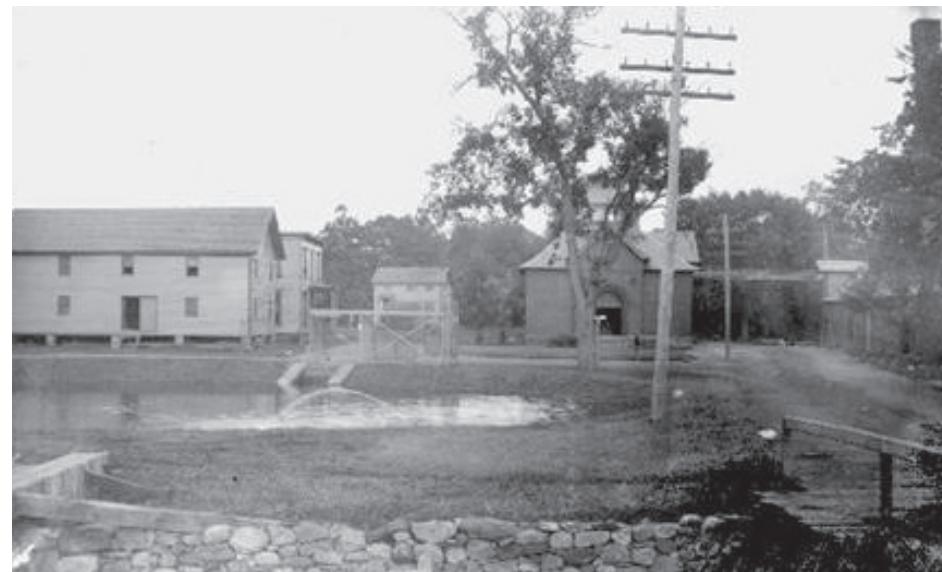
Figure 69: A 1911 plan showing the approximate location and scale of first settling basin marked by the circular dotted line.

through the intake grating from the “equalizing basin” to the pump house. Since the decommissioning of the Hackensack Water Works in 1990, the intake canal has been filled with soil, although iron elements still remain exposed above the surface. The portion closest to Elm Street is now the location of a main water line. This water main protrudes above the ground surface and is surrounded by chain link fence (figure 79). A guardrail between the chain link fence and Elm Street has been added to the landscape along with 18 different signs along Elm Street and New Milford Avenue.

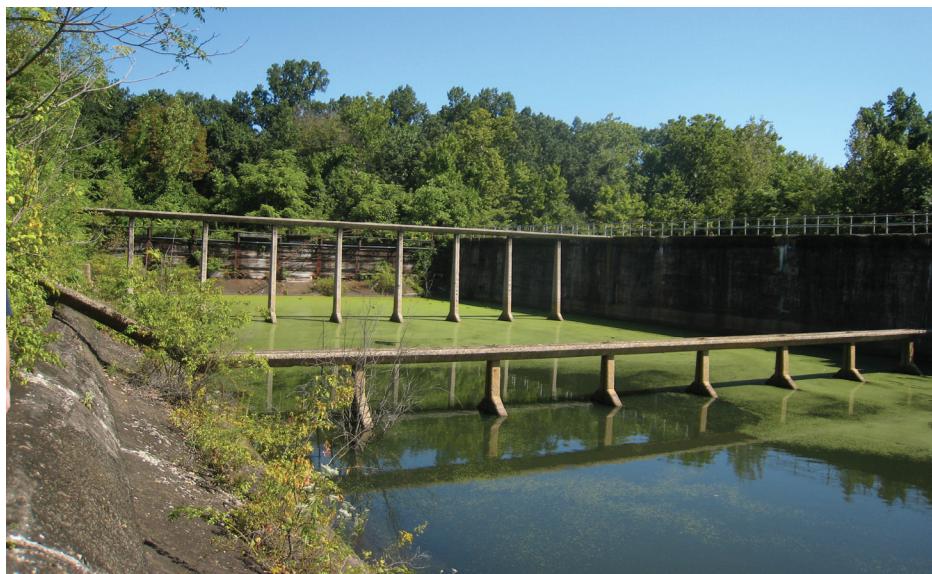
Figure 81: The presence of the coagulation basin contributes to the high level of design integrity.

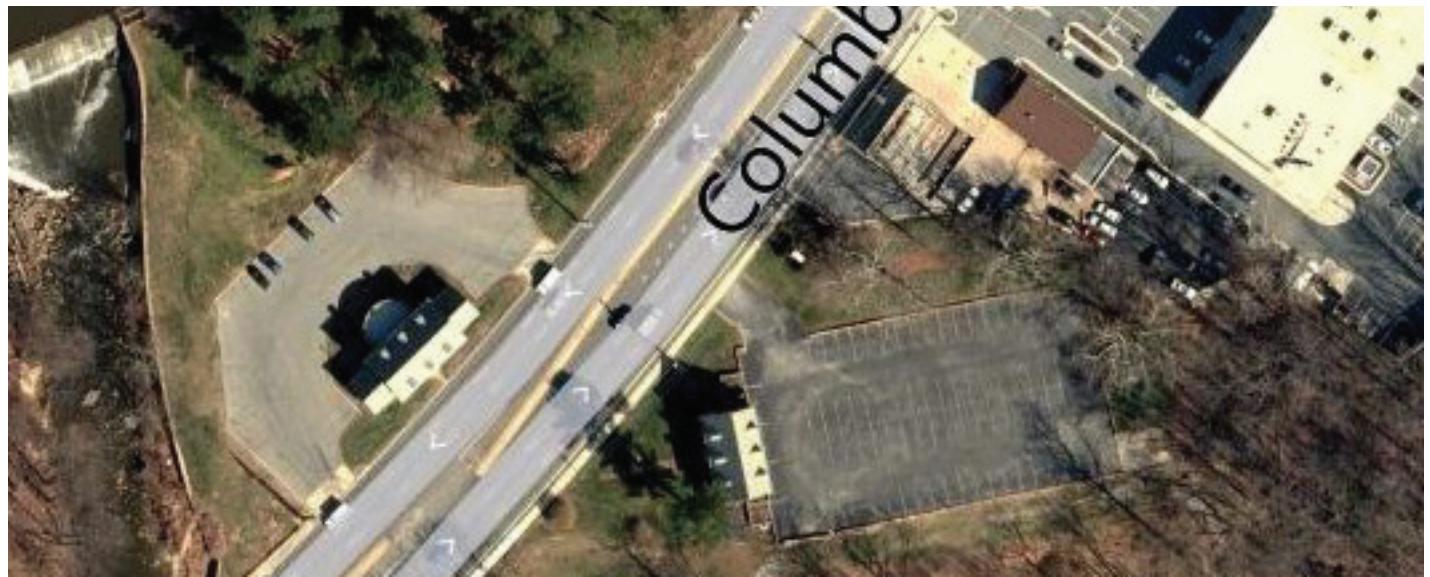
Figure 97: HAER as-built birdseye drawing
