# ENVIRONMENTAL REVIEWS AND CASE STUDIES

## Unique Landfill Restoration Designs Increase Opportunities to Create Urban Open Space

**Environmental Practice 18: 106–115 (2016)**

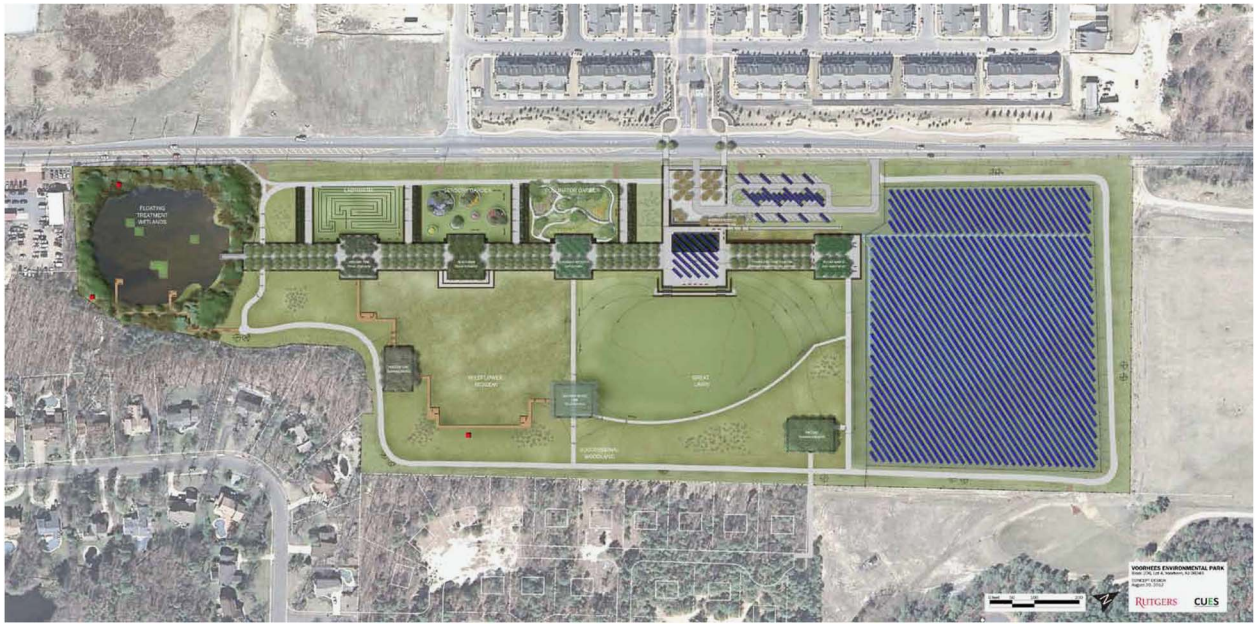
**Figure 2.** Voorhees Environmental Park Conceptual Restoration Plan.

The proposed restoration plans for both sites (Figures 2, 3) reintroduced woody species and tree canopies to increase species assemblage, create a more natural forested riparian

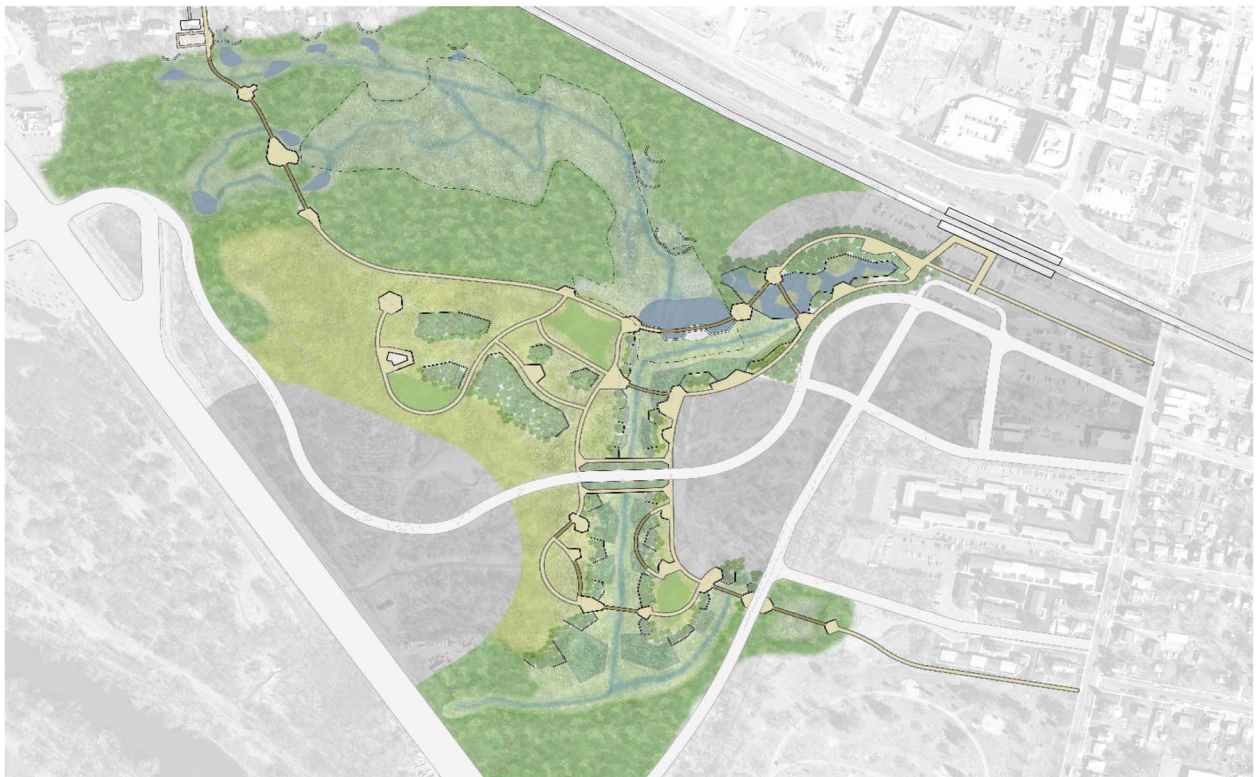
**Figure 3.** Somerville Green Seam and Transit Station Redevelopment Conceptual Restoration Plan.

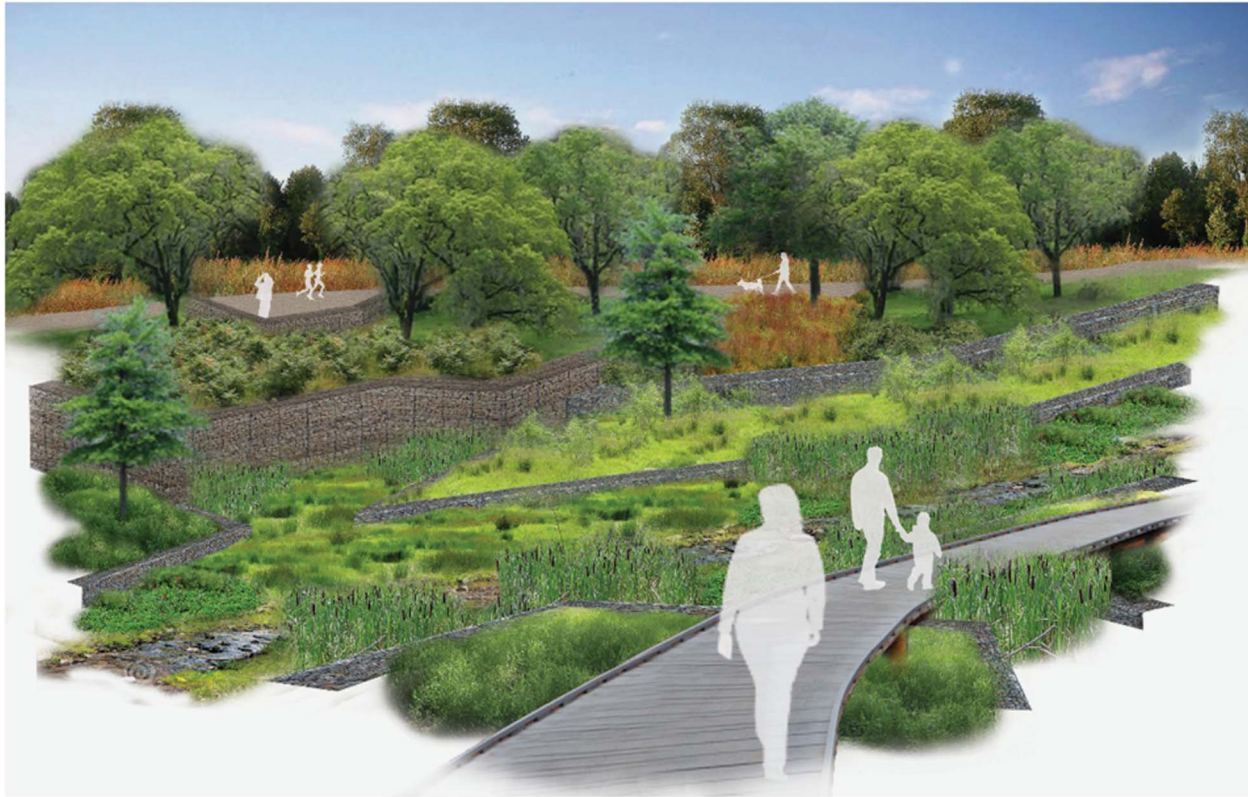
**Figure 7.** Rendering of the transition area between the proposed capped Somerville Landfill and the existing wetland. The proposed enhanced wetlands increase stormwater retention while serving as points of public access.

hydrologic system has become increasingly “flashy,” exhibiting a significant loss of water retention within the watershed and particularly on the landfill site itself. Therefore several design interventions are proposed to enhance onsite water retention. Wetland improvements (Figure 7) include the deepening of wetland areas to enhance water storage and to create standing water habitat. These enhanced wetlands also include forbay areas to capture sediment, thereby facilitating maintenance.

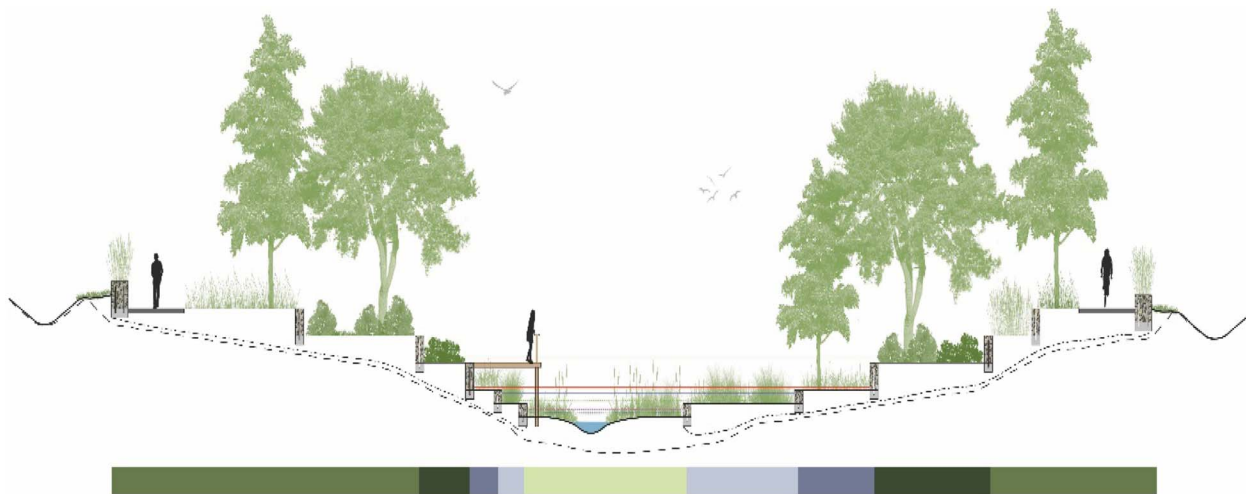
**Figure 8.** Typical cross-section indicating elevations needed to capture various storm events, creating both facultative and obligate hydric planting zones. In addition, the approximate depth of fill required to develop shrub and forest guild assemblages is indicated.

for proposed conditions under different storm scenarios provided information for the team’s landscape architects to design “creek terraces” and select hydrologically compatible vegetation (Table 1). The terraces were placed on top of the soil/geosynthetic liner capping system; soil depths inside the terrace structures increase as the terraces are placed farther away from the creek bank edges (Figure 8).
