# **Hackensack Meadowlands Tide Gates Inspection Report**

**The National Flood Insurance Program  
Community Rating System**

**The New Jersey Meadowlands Commission  
One DeKorte Park Plaza  
Lyndhurst, New Jersey**

**March 27, 2006**

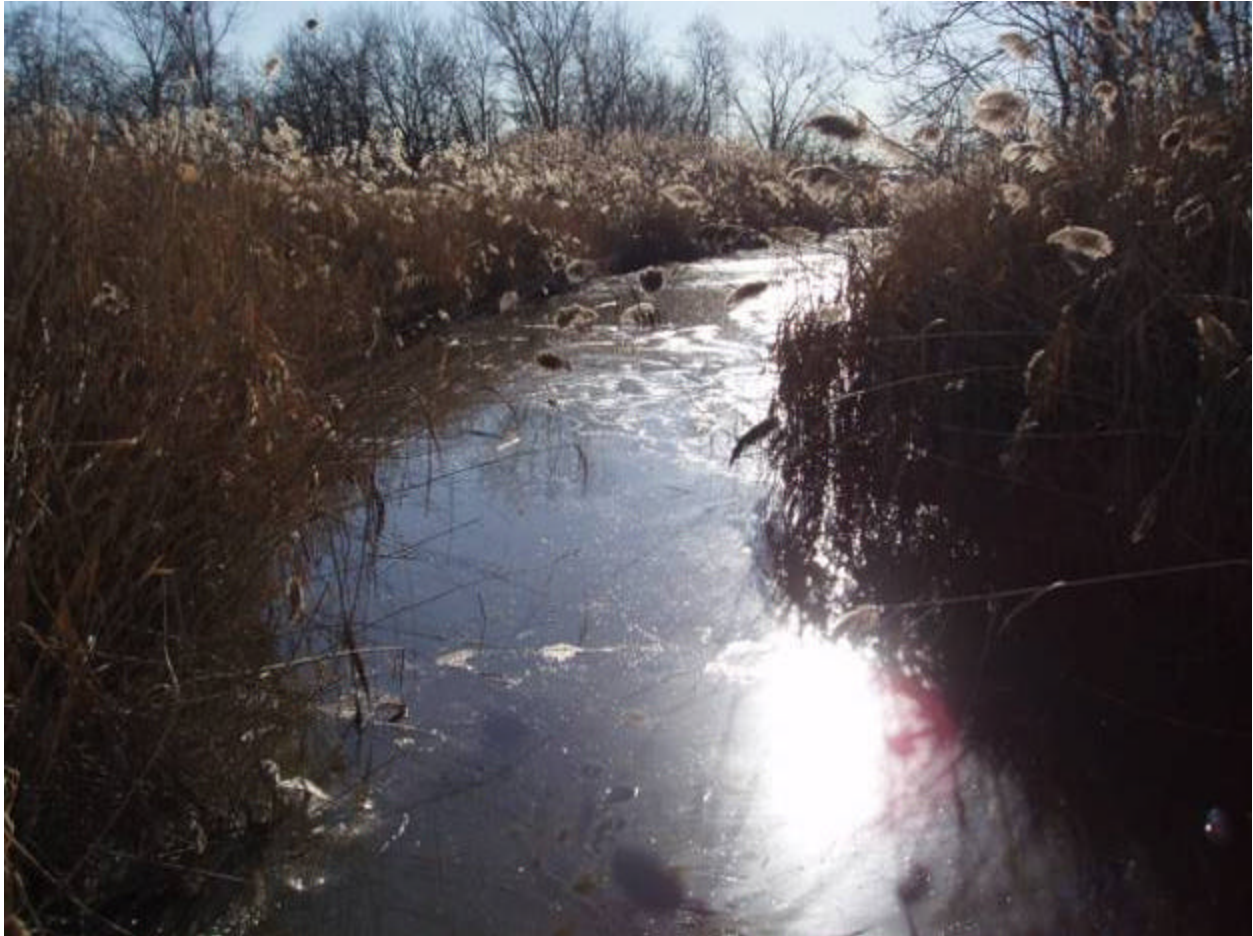
The gate appears to be working during high tide conditions. The storm sewer in the area need to be maintained regularly due to the build up of sedimentation.

**Photo 2 Description:** Downstream view from tide gate

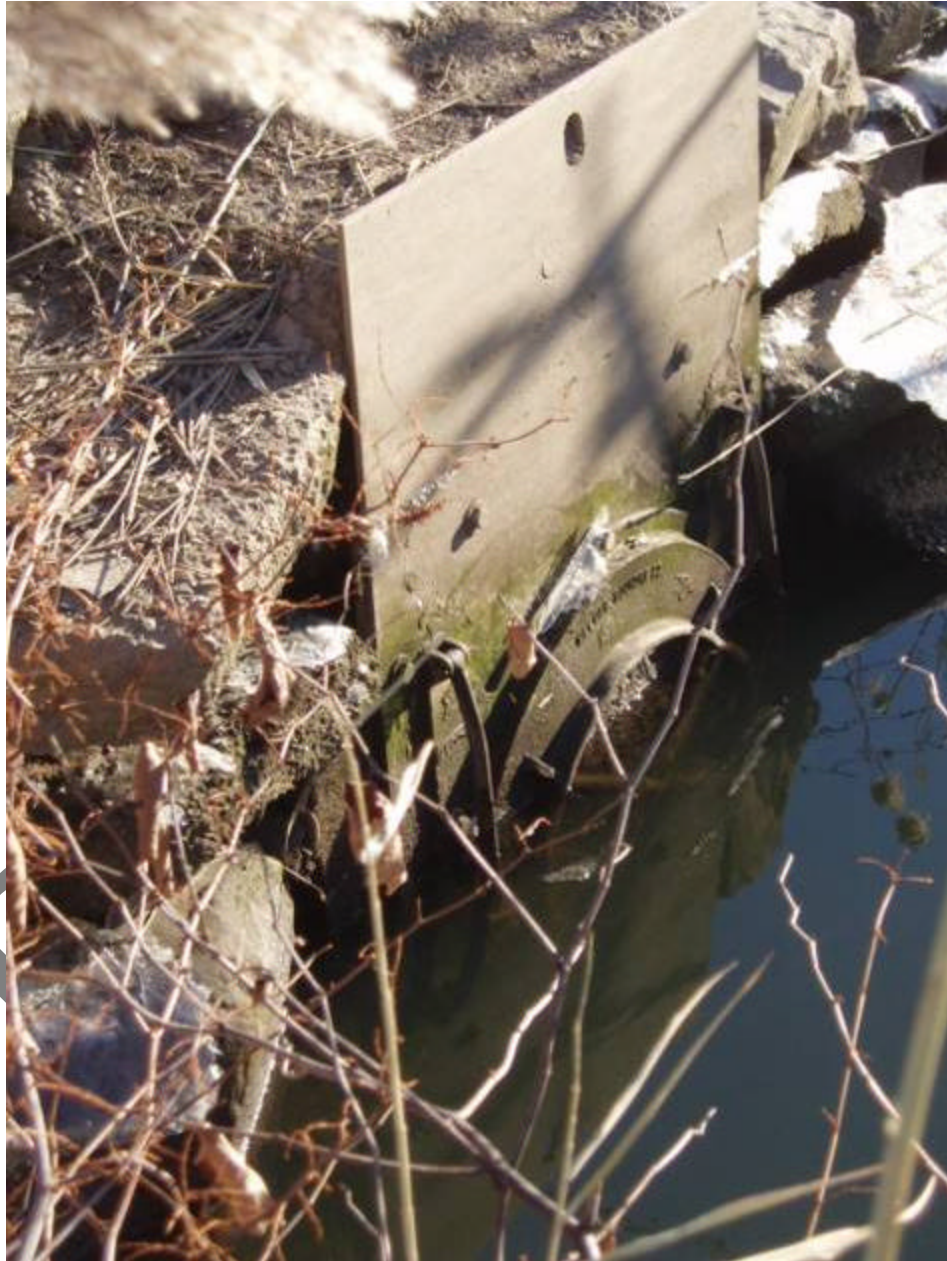
**Photo 1 Description: Metal flap gate**

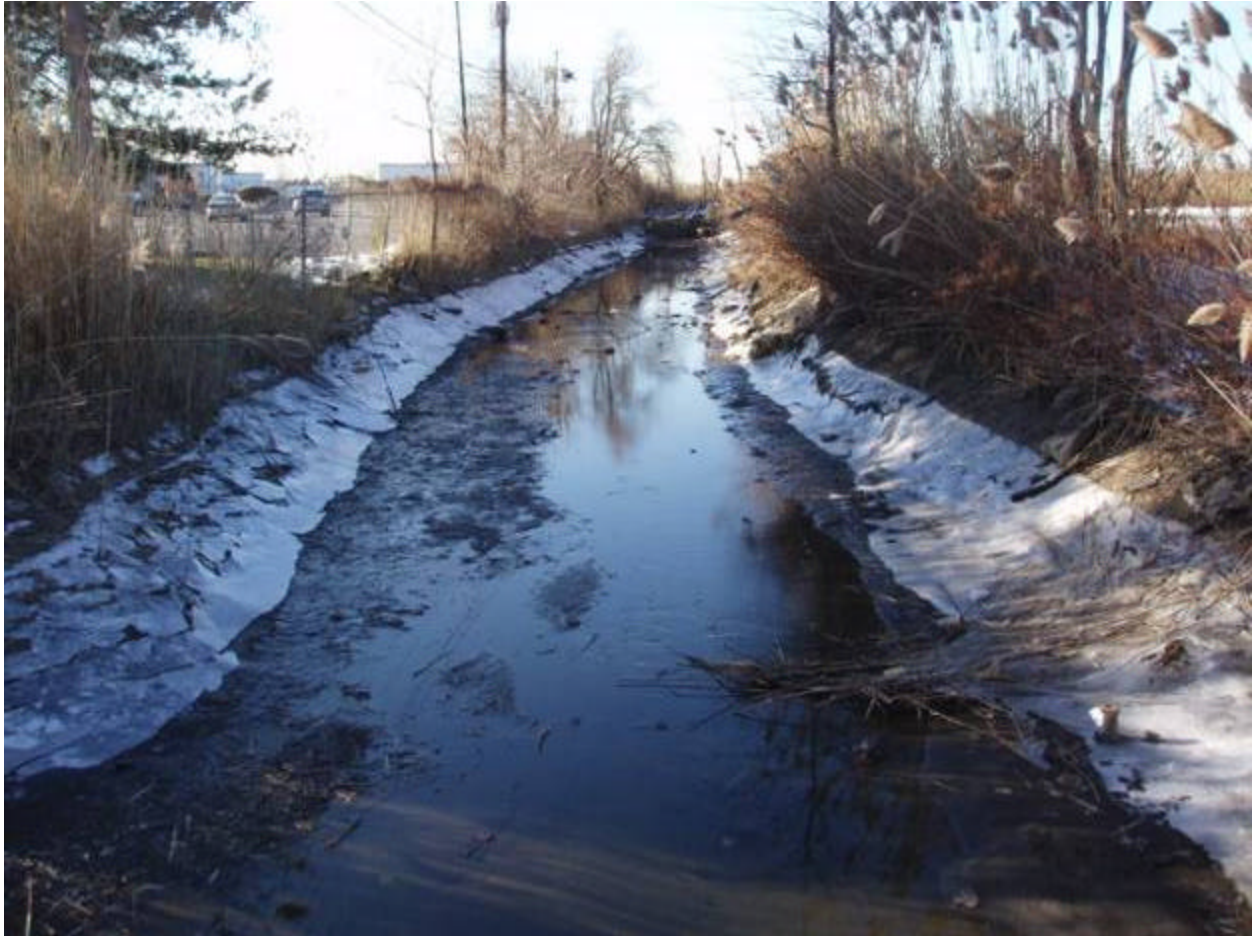
**Photo 2 Description:** Downstream view from tide gate

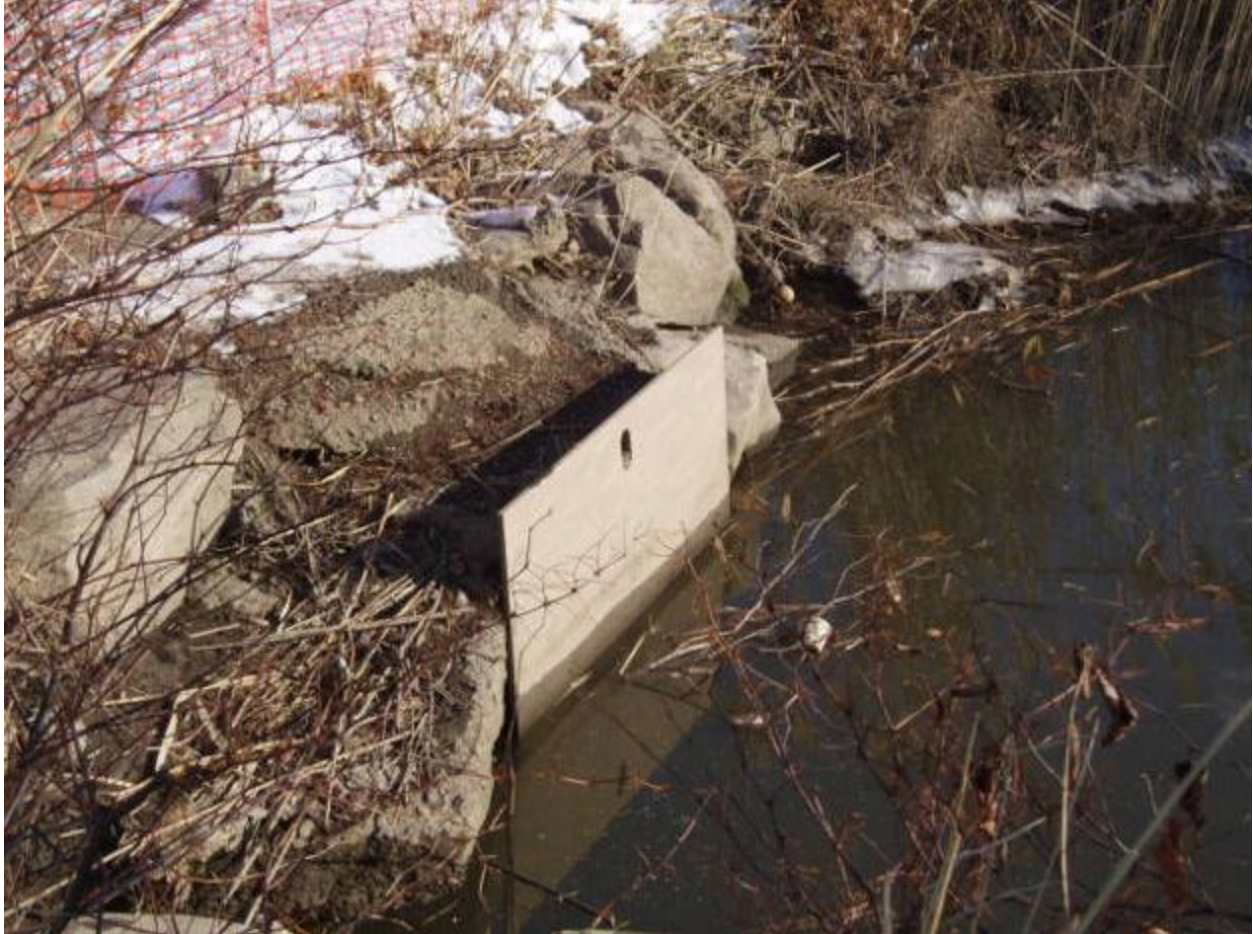
The tide gate appears to be working properly during high tide conditions.

**Photo 1 Description: Metal flap gate**

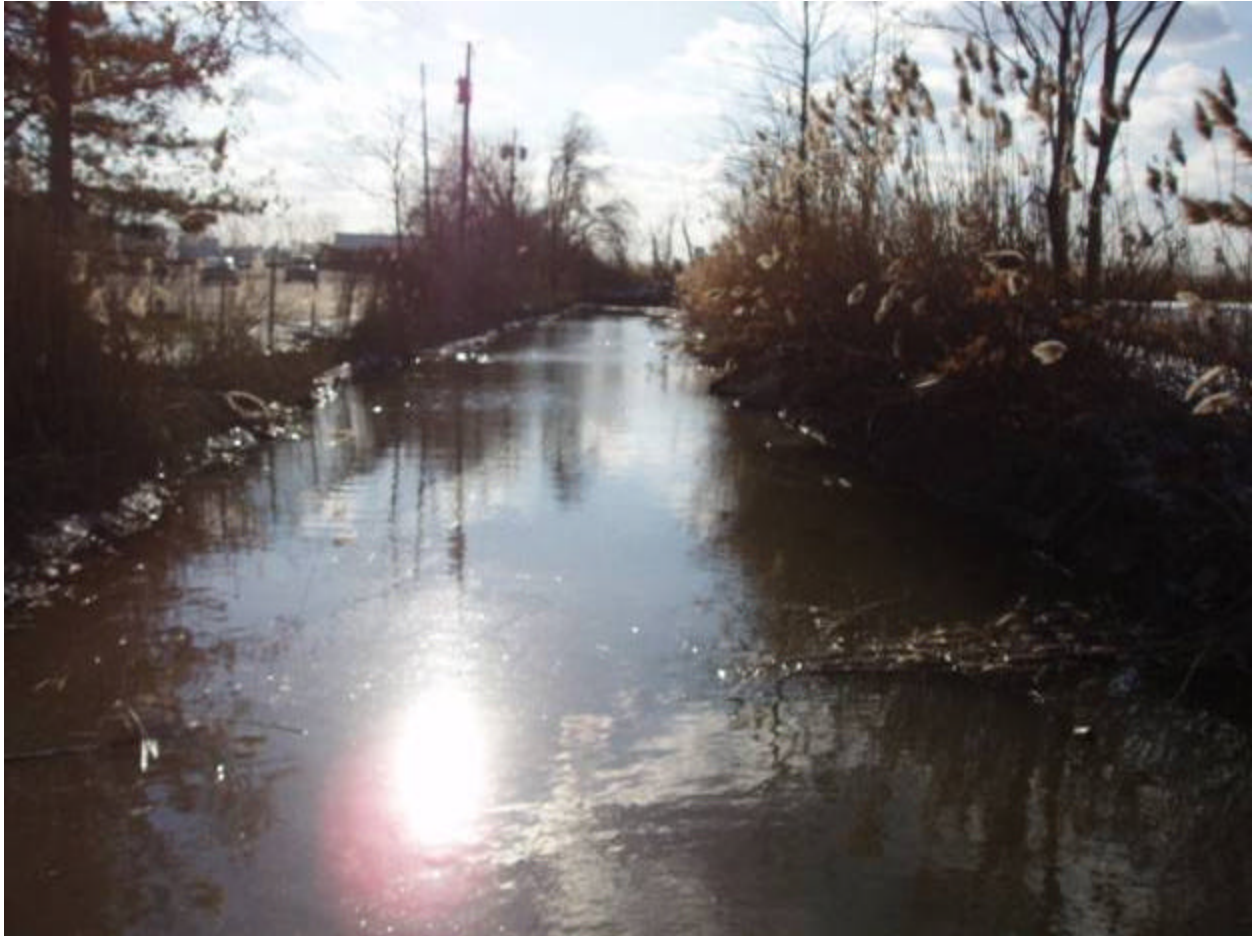
**Photo 2 Description:** Upstream view from tide gate

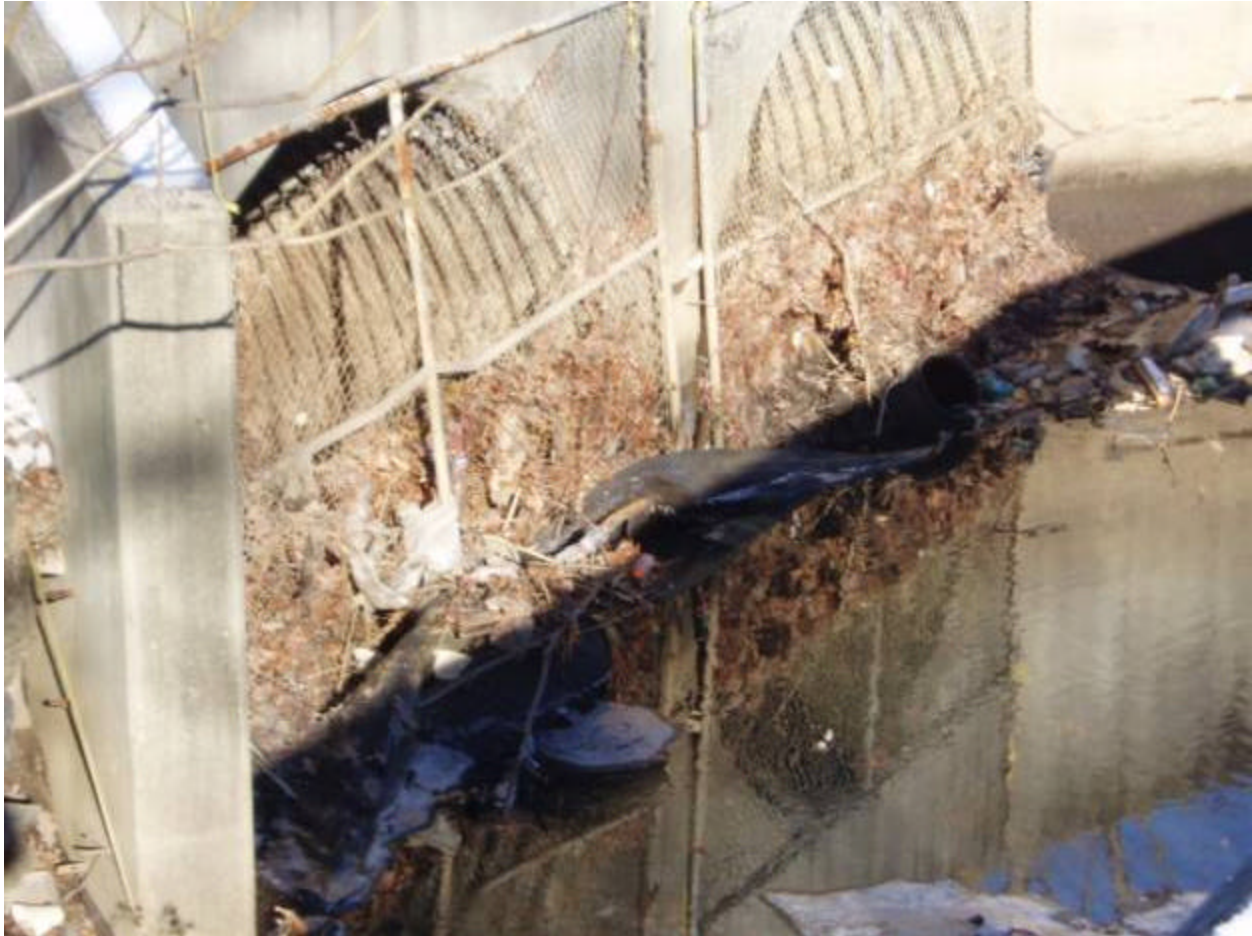
The trash rack needs immediate repair and cleaning. Debris has collected and blocks the flow of water through the gates. The roadway is also in need of repair due to settling above the tide gates.

**Photo 2 Description:** Upstream end of the tide gates

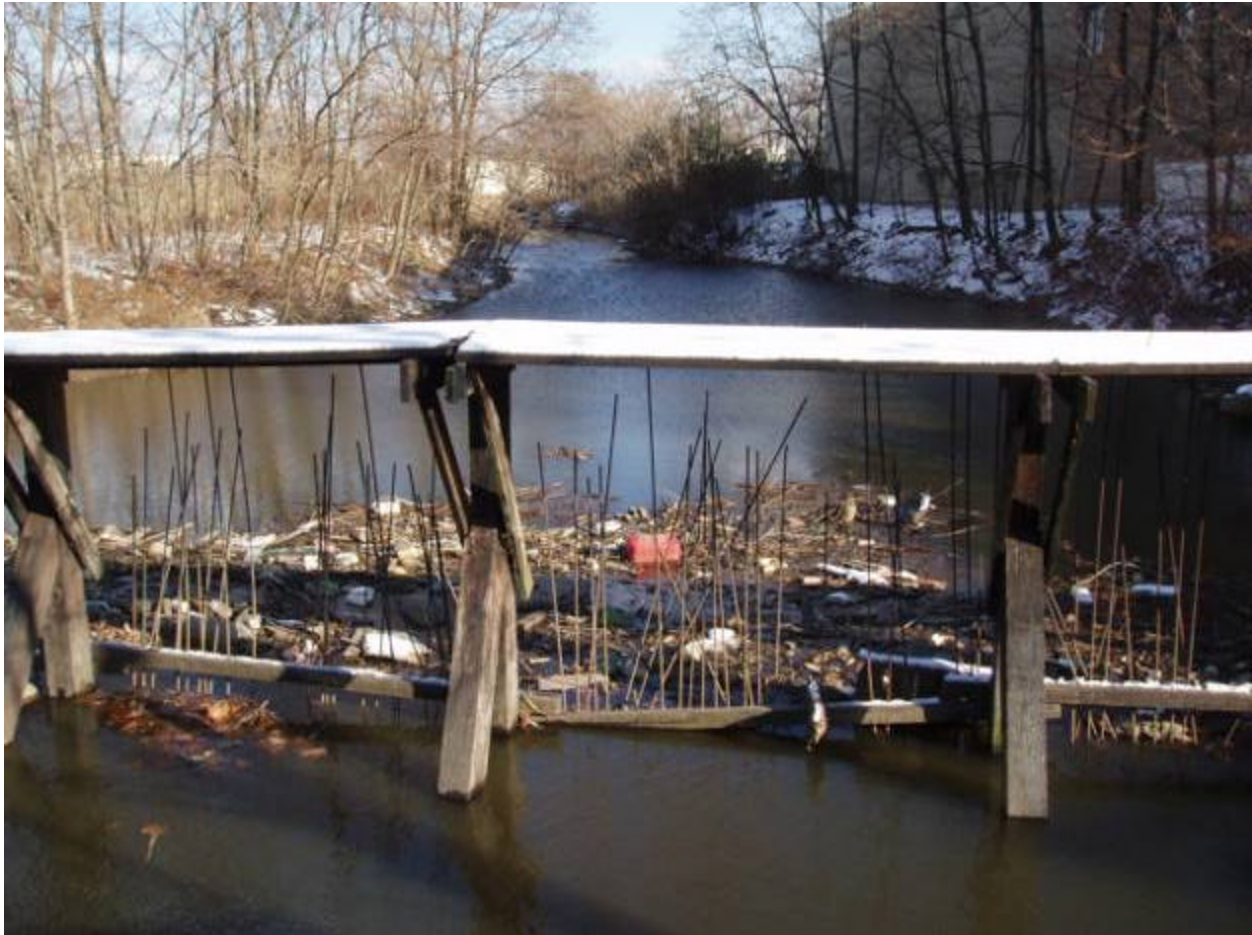
The tide gates are malfunctioning and not seating properly, specifically tide gates two and four. The water is entering through the gates and entering the upstream system during high tide conditions.

**Photo 2 Description:** Upstream view from tide gates and view of the trash rack system

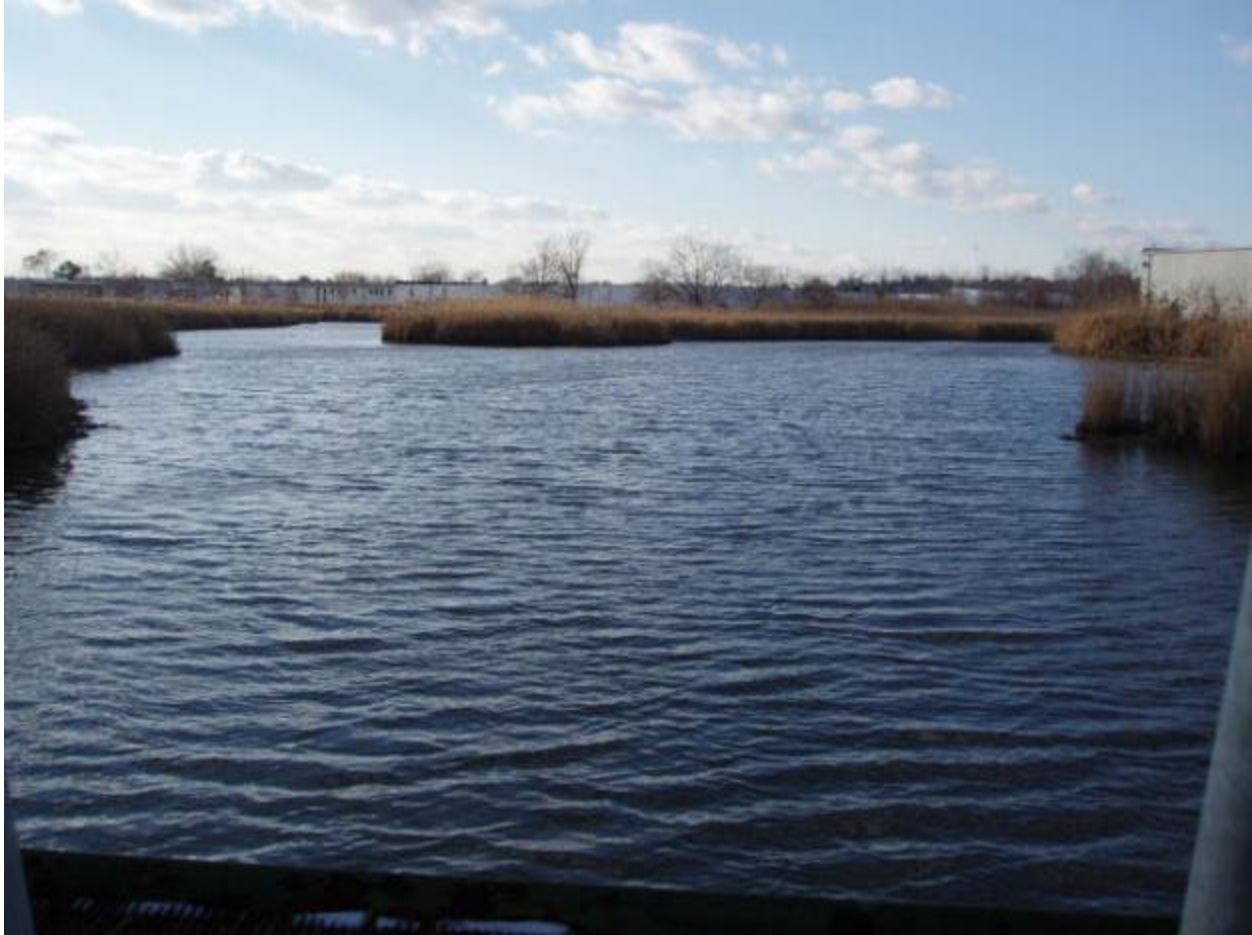
**Photo 3 Description: Downstream view from the tide gates**

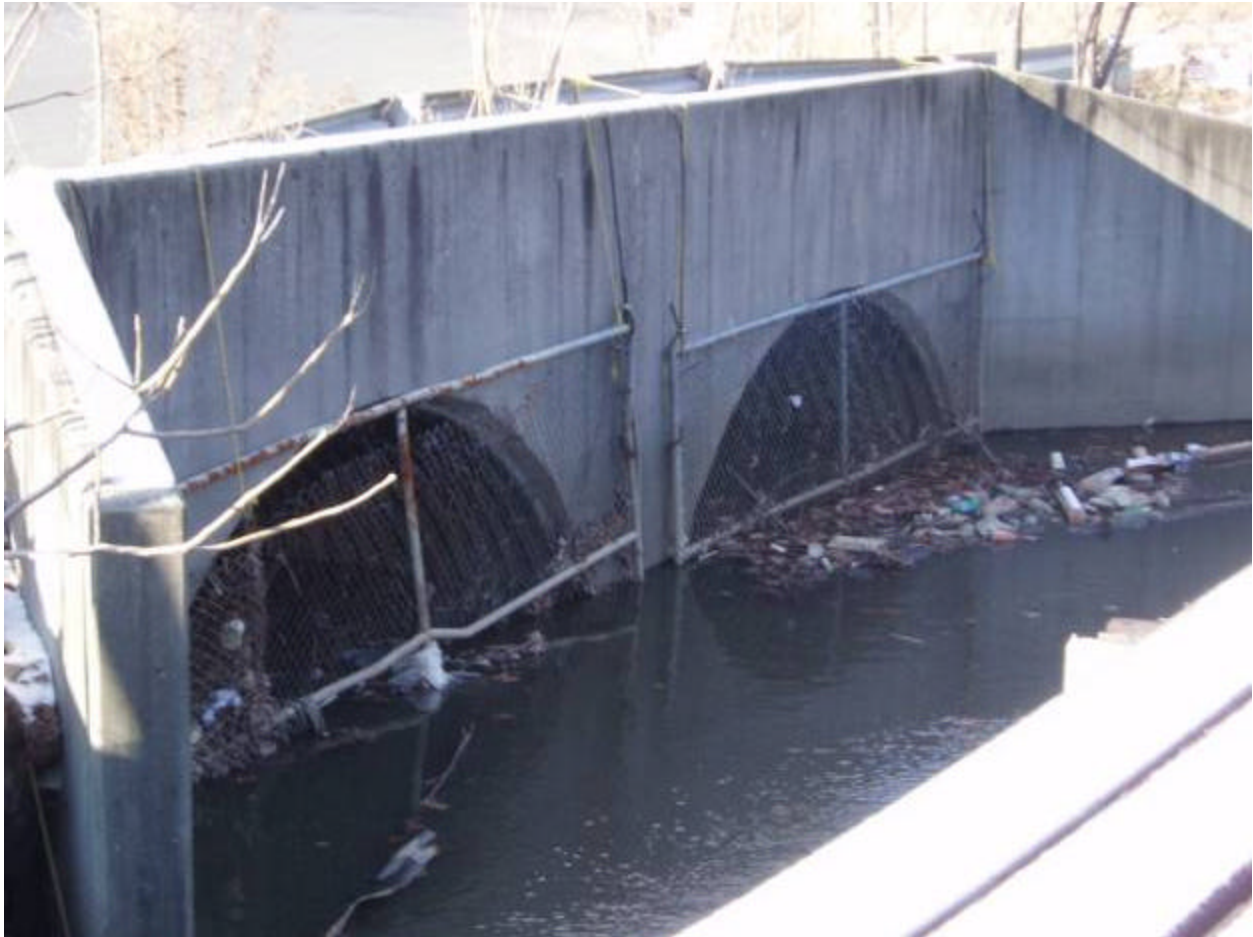
**Photo 4 Description:** Upstream end of the tide gates

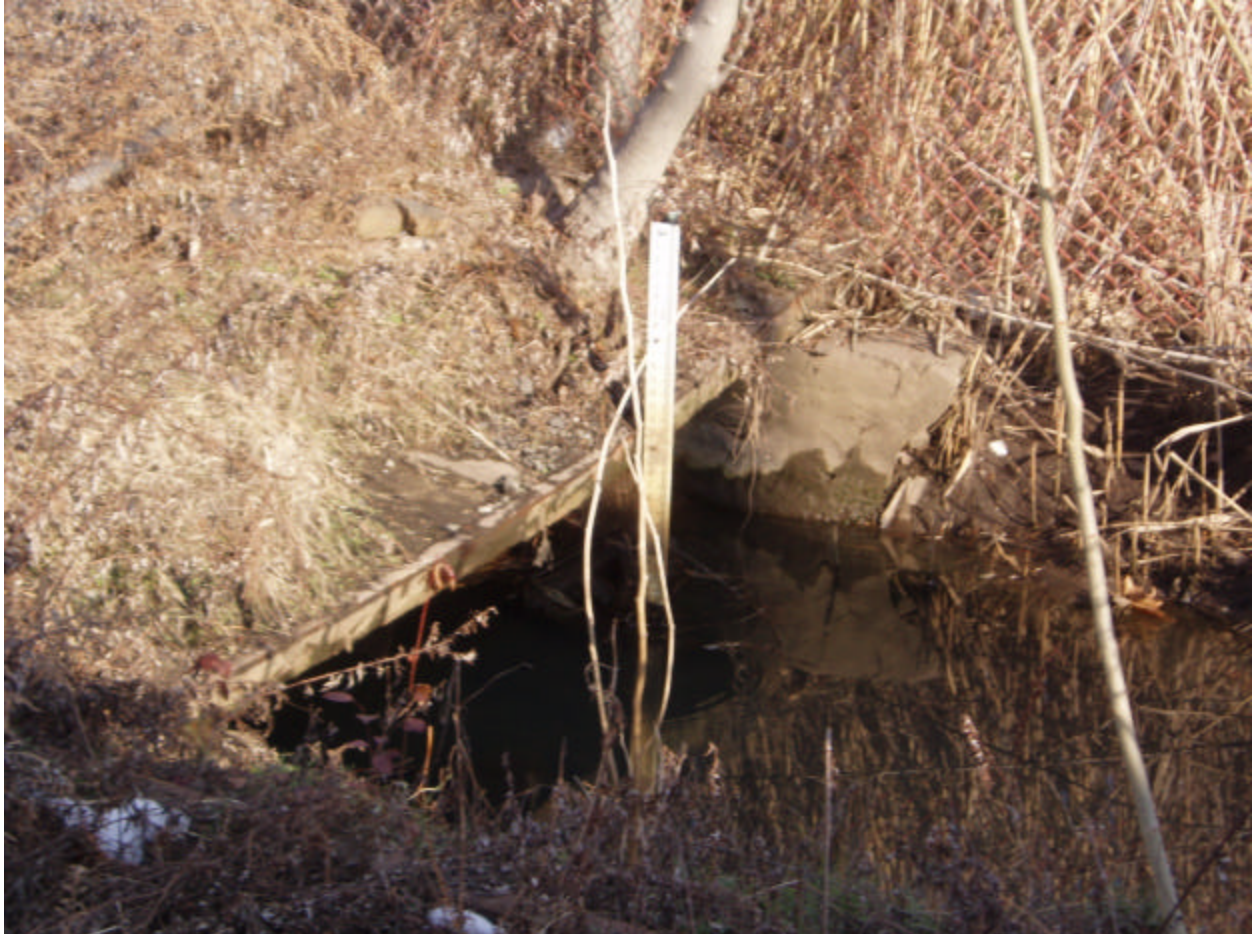
The tide gate located in the intersection of 13<sup>th</sup> Street and Division Street in Carlstadt was inspected on December 19, 2005 during low and high tide conditions. The water elevation in the vicinity of the tide gate did not change regardless of the tidal conditions. The tide gate is constantly submerged and cannot be inspected. After a detailed analysis of the topographic data and aerial mapping, NJMC has determined tidal water cannot reach the tide gate, and therefore, it is recommended that the J.P. Smith Tide Gate no longer be inspected.

**Photo 1 Description:** Existing tide gate structure shown

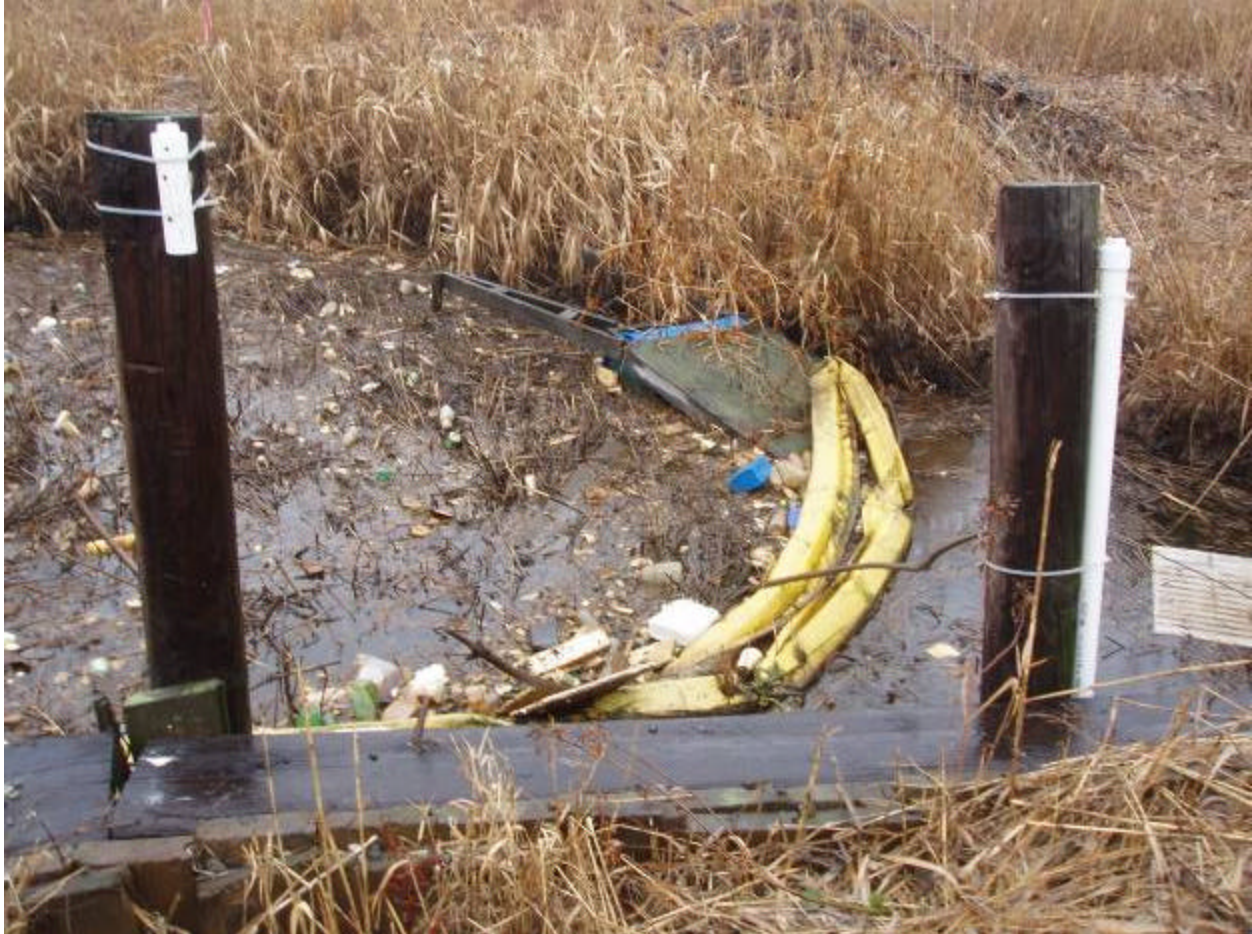
**Photo 2 Description:** View of trash rack on upstream side of the tide gate

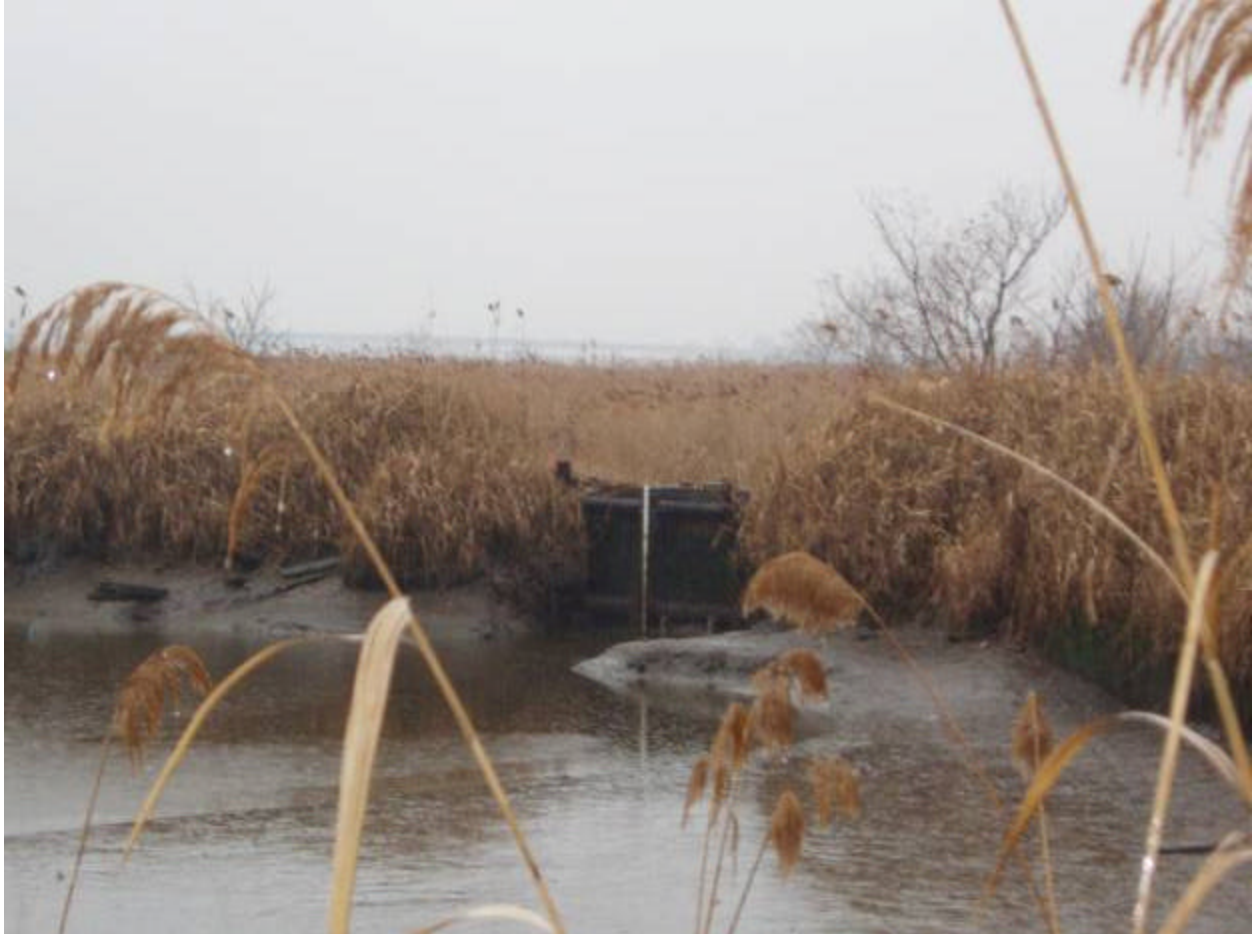
**Photo 3 Description: View of tide gate structure**

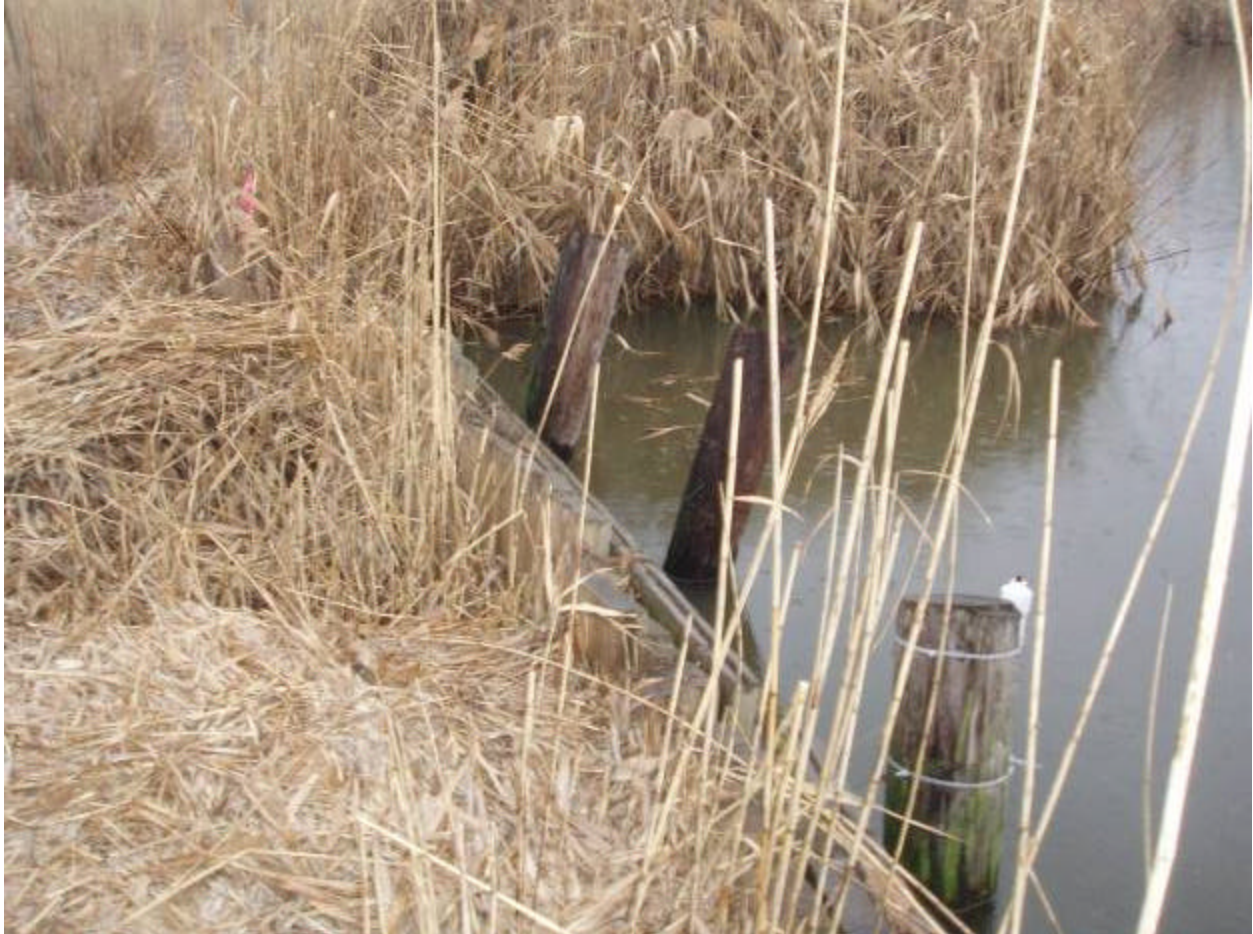
The tide gate appears to be working properly during high tide conditions.

**Photo 2 Description: Tide gate headwall**

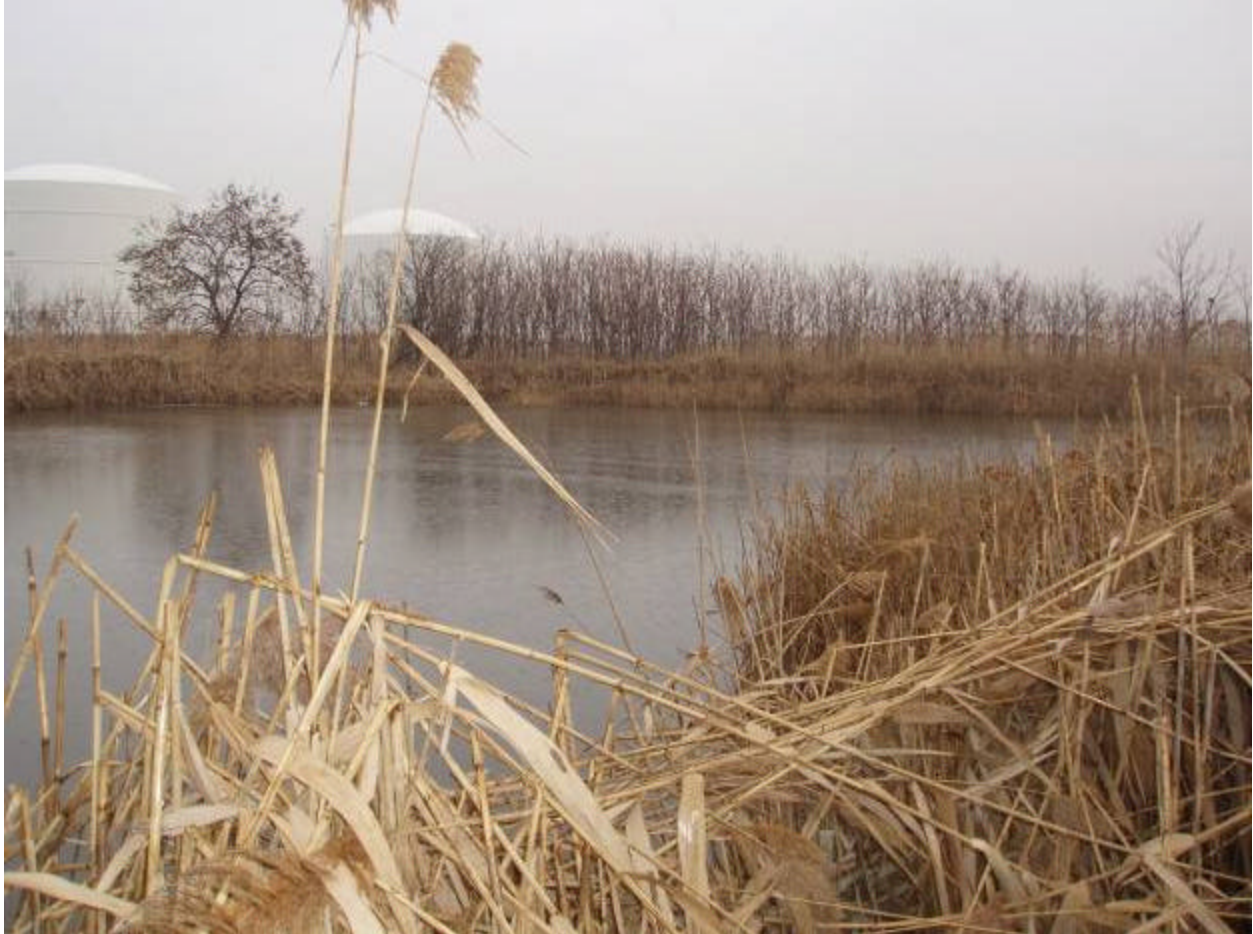
**Photo 3 Description: Downstream of the tide gate**

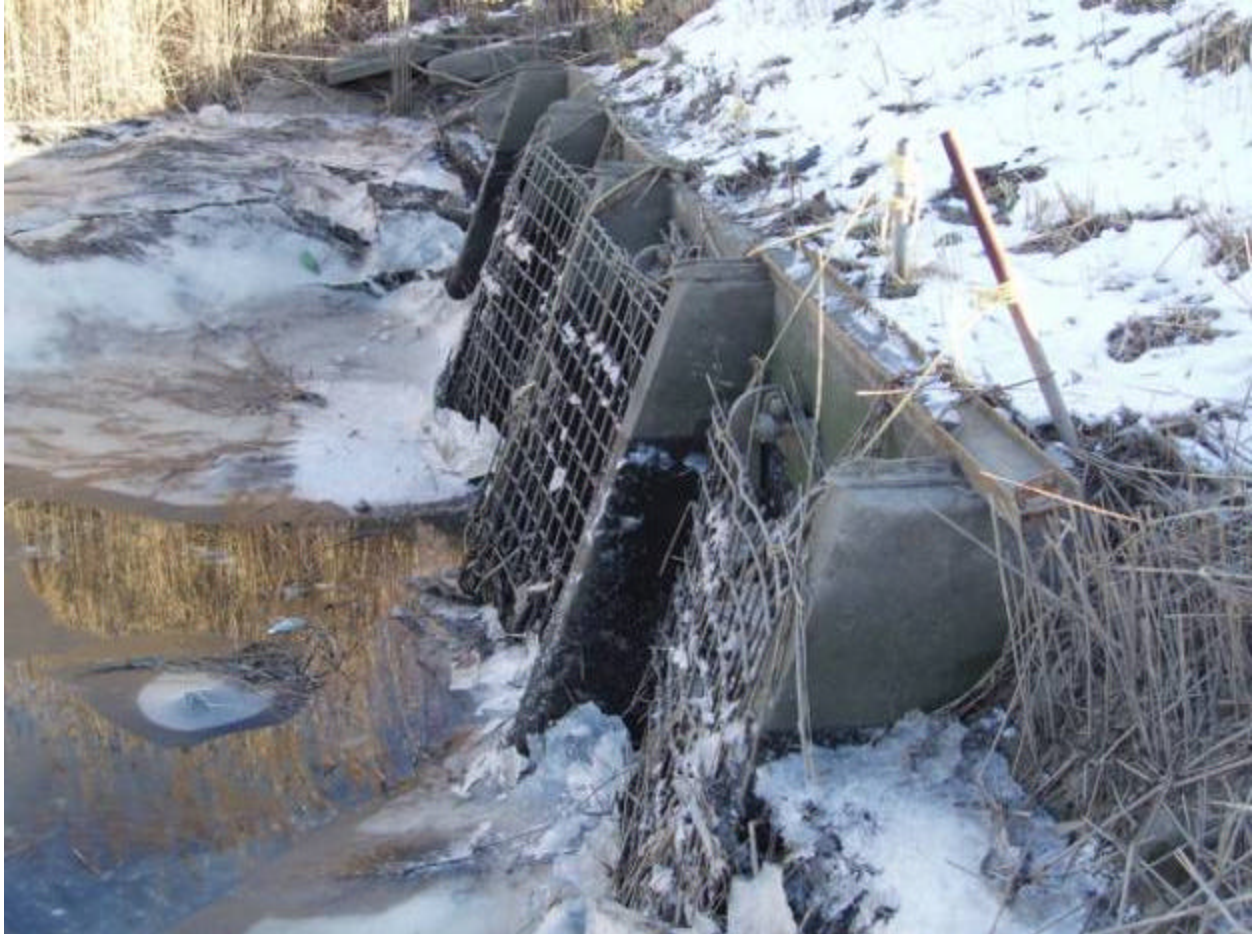
**Photo 1 Description: 4 metal flap gates**

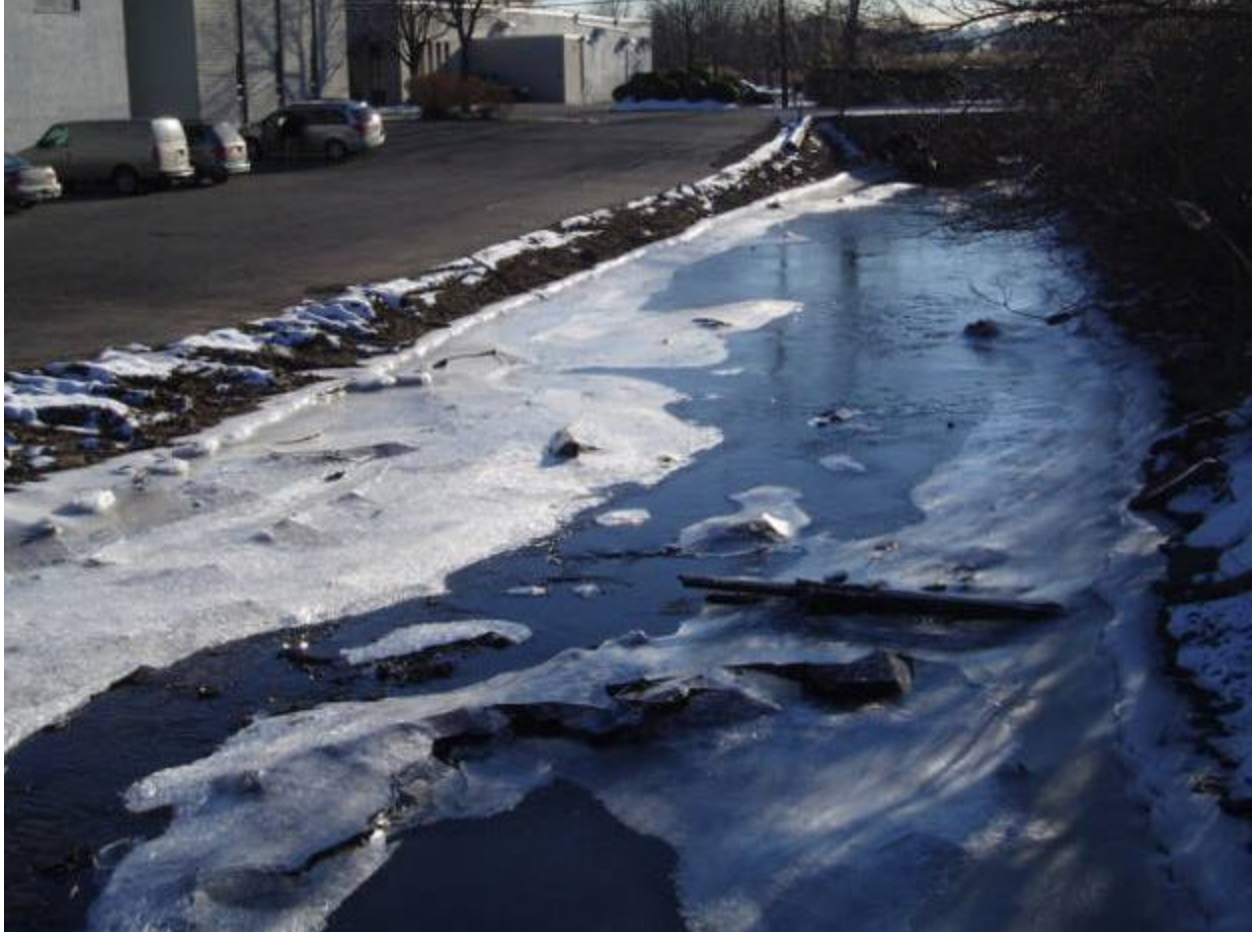
**Photo 2 Description: Upstream view from gates**

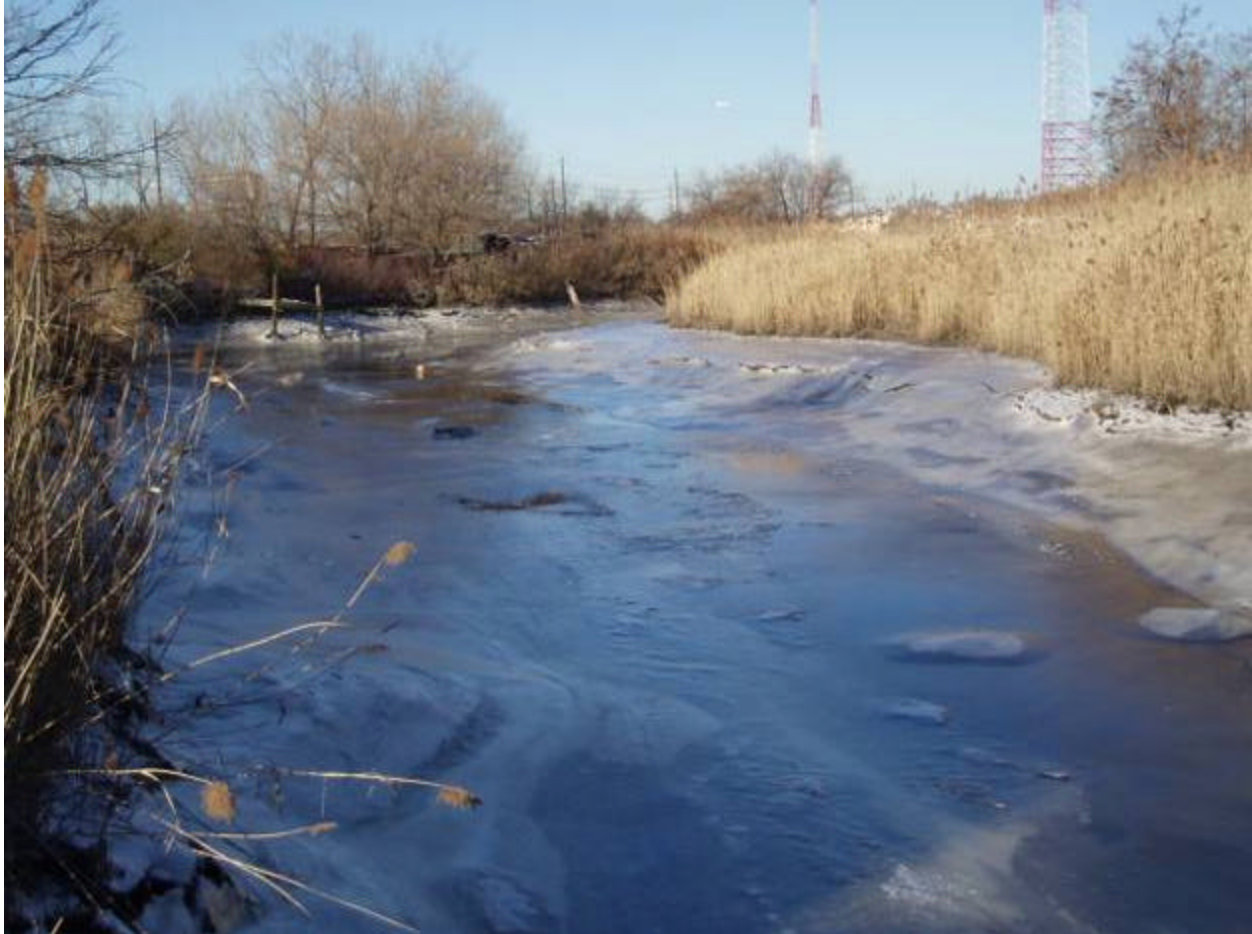
**Photo 3 Description: Downstream view from gates**

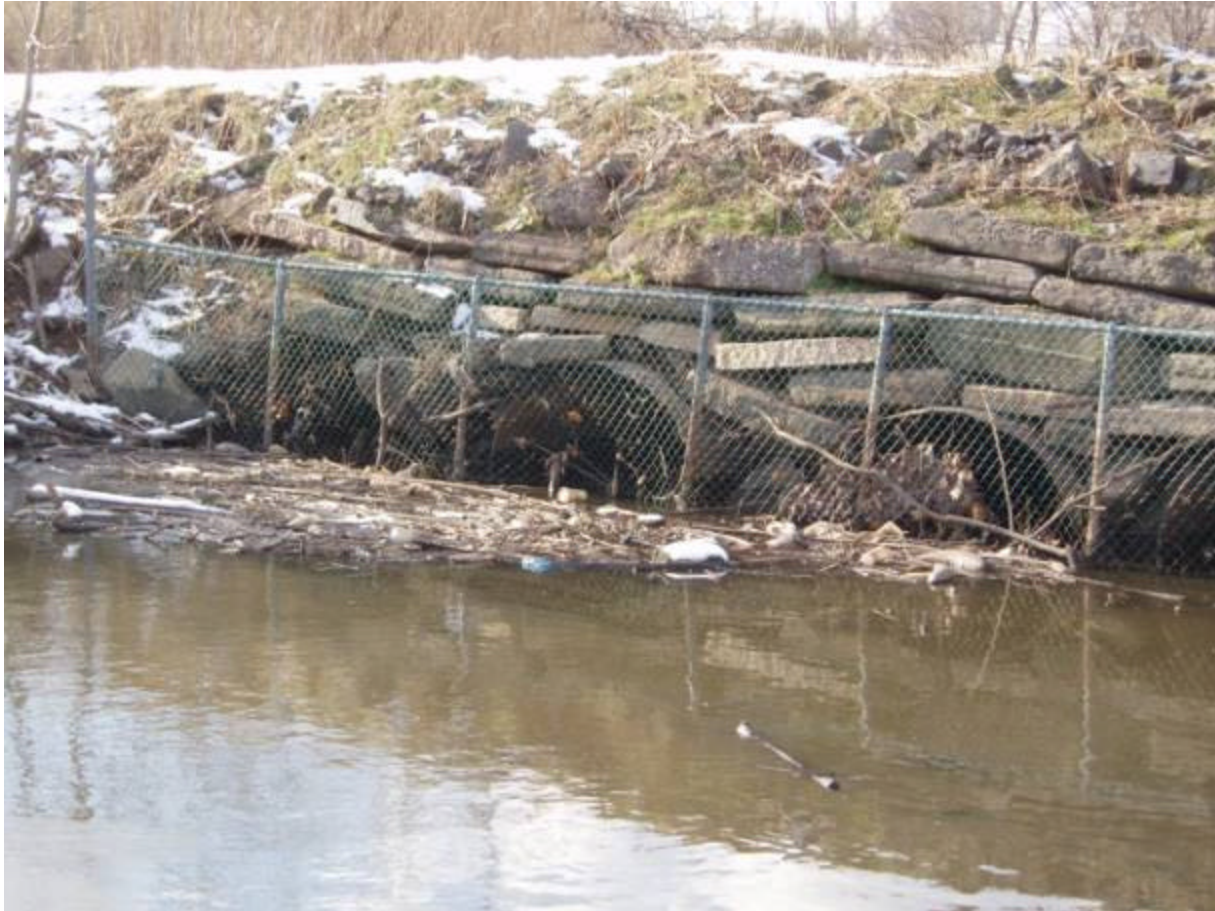
The tide gates do not seat properly during high tide conditions and a small amount of water continues to seep through and into the upstream system.

**Photo 1 Description:** Trash rack on upstream side of the tide gates

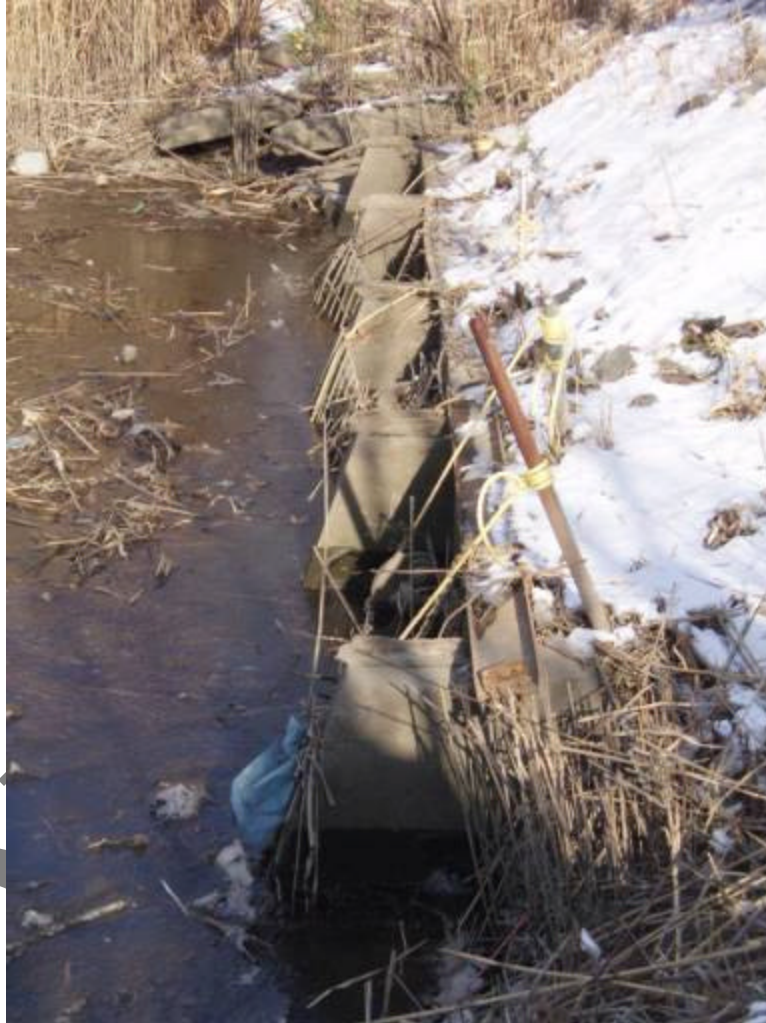
**Photo 2 Description: 4 metal flap gates**
