# **Hackensack Meadowlands Tide Gates Inspection Report**

**The National Flood Insurance Program  
Community Rating System**

**The New Jersey Meadowlands Commission  
One DeKorte Park Plaza  
Lyndhurst, New Jersey**

**March 27, 2006**

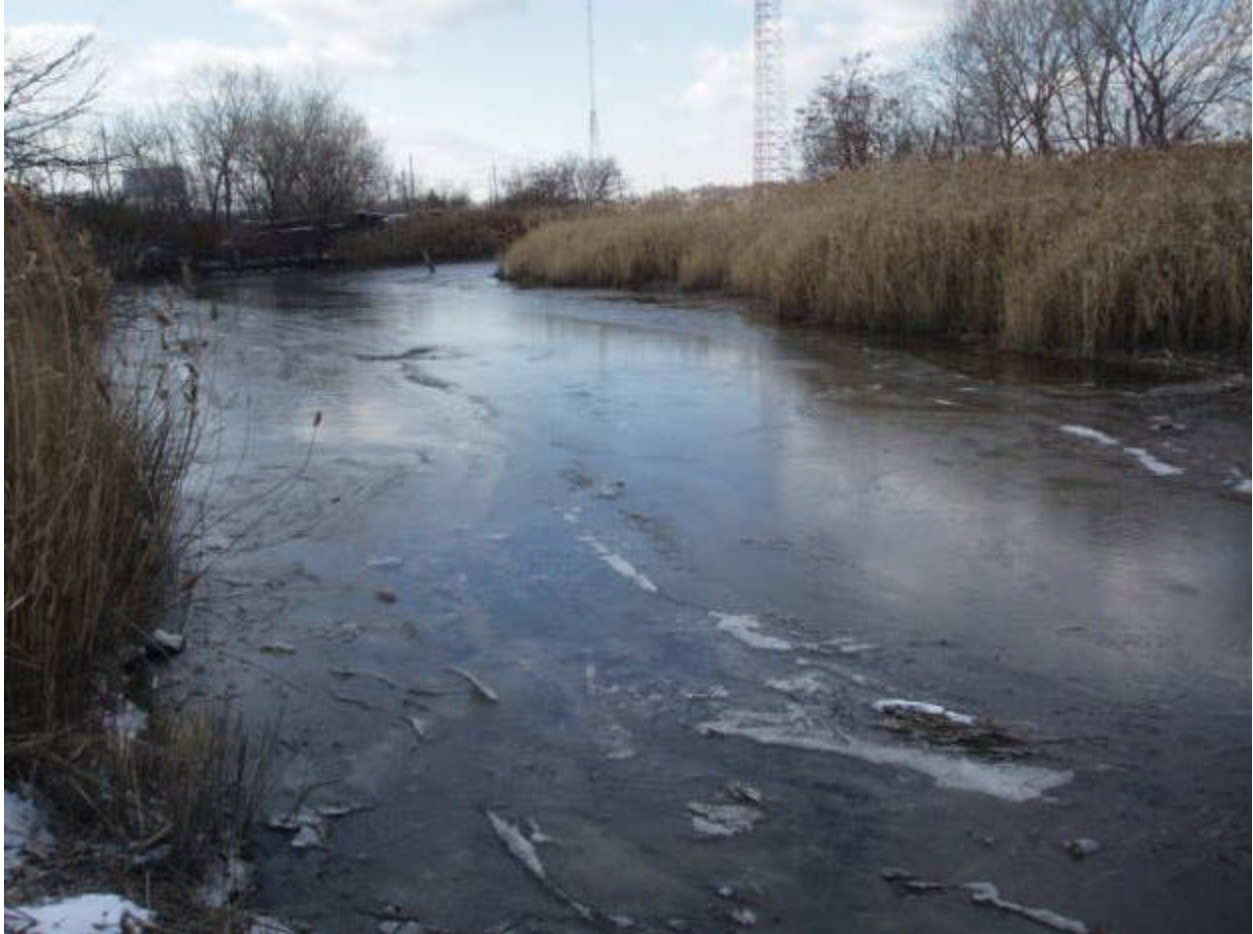
**Photo 3 Description:** Downstream view from the tide gates

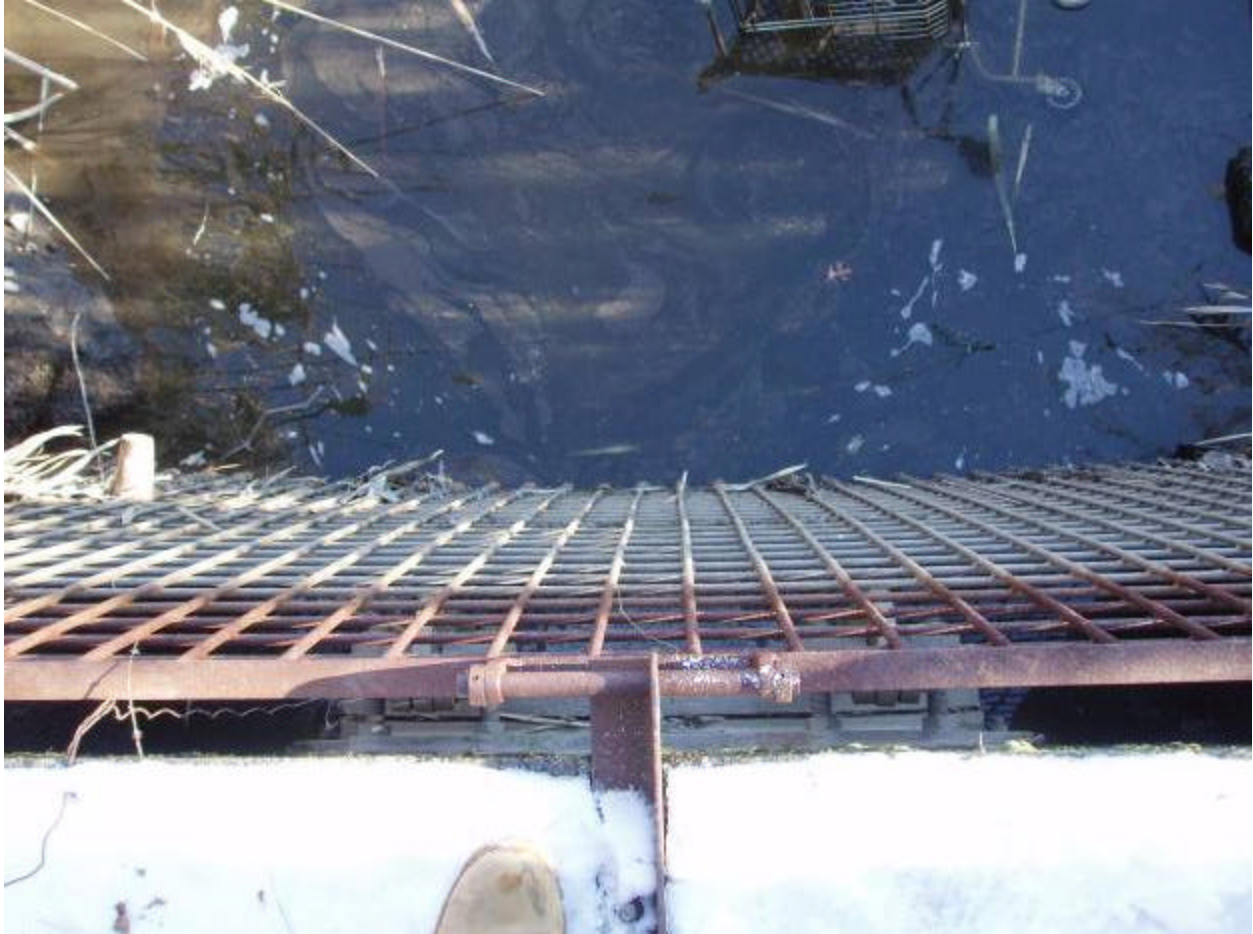
**Photo 1 Description:** Metal flap gate with a trash rack

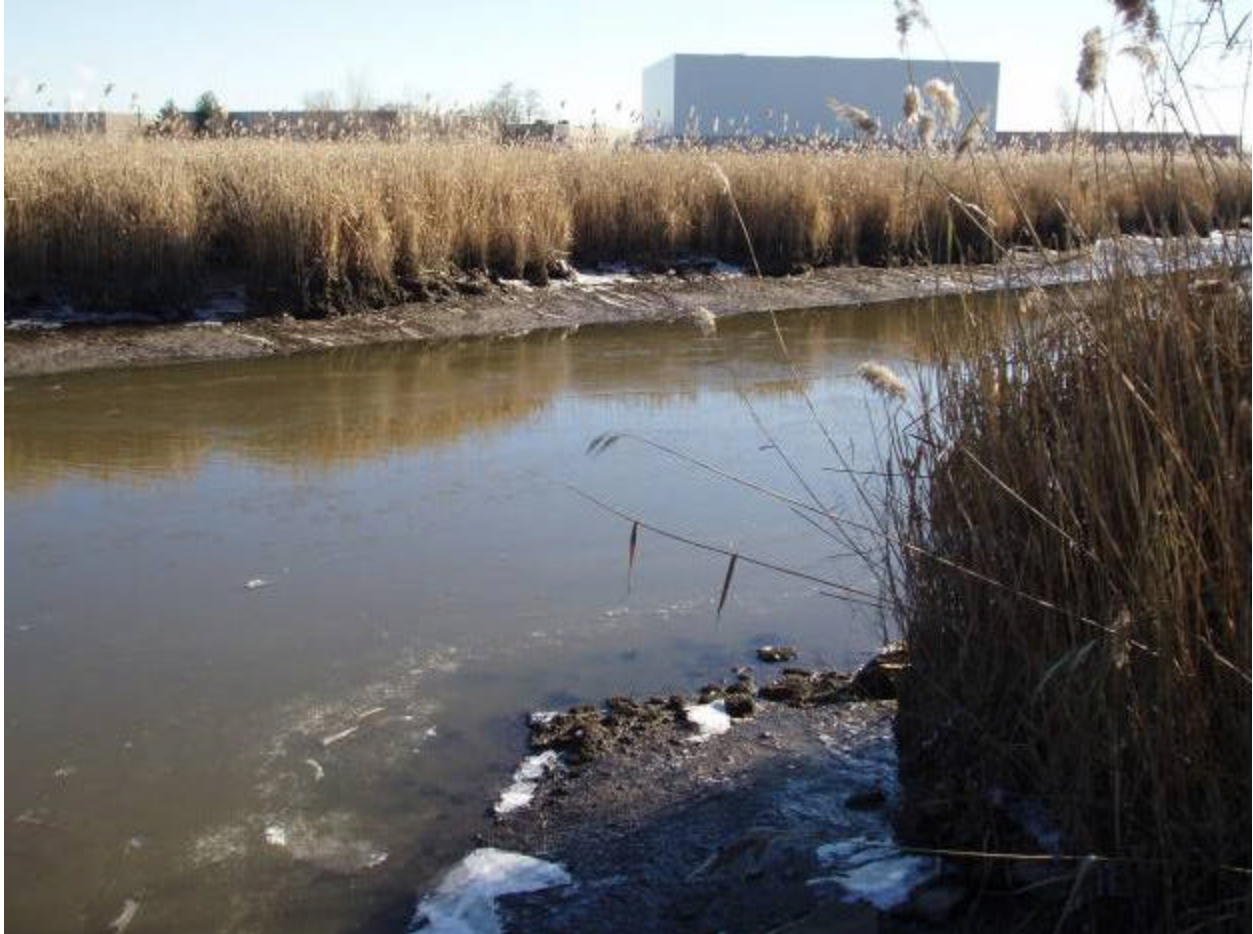
**Photo 2 Description:** Downstream view from the tide gate

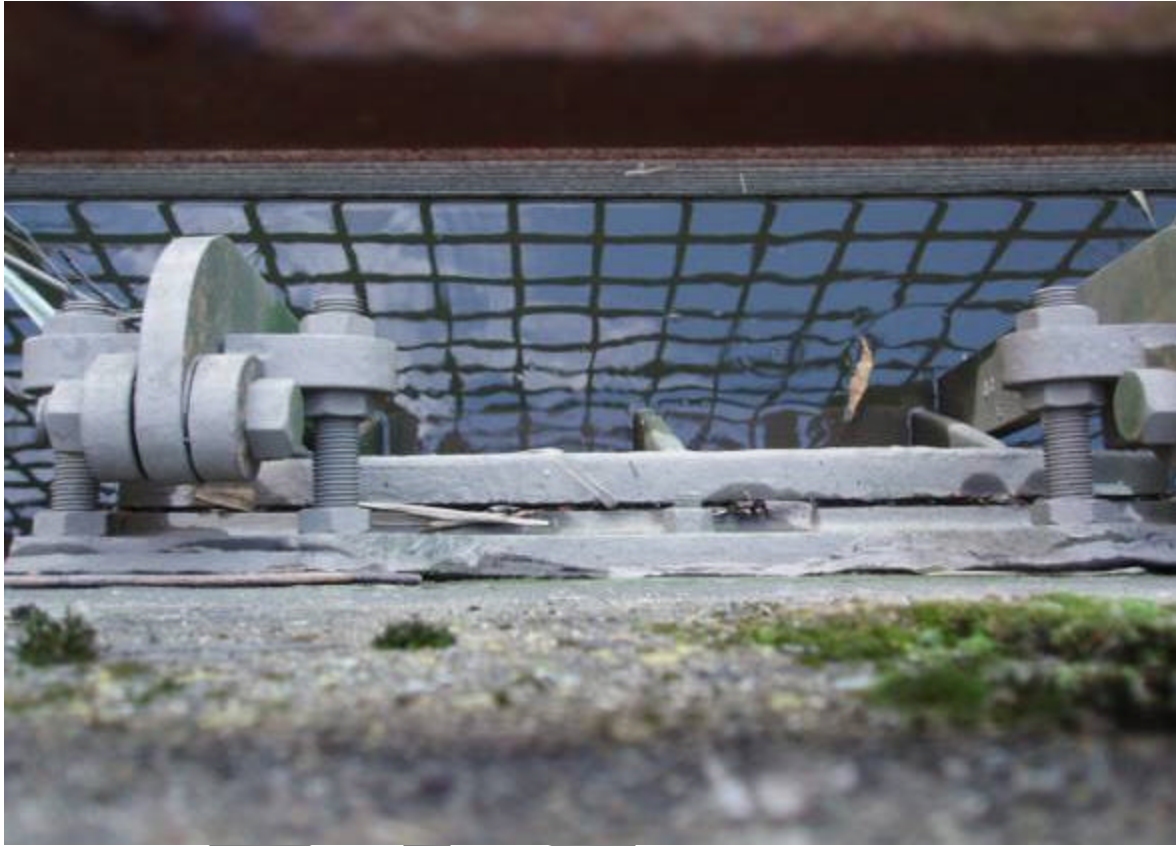
**Photo 1 Description: Metal flap gate**

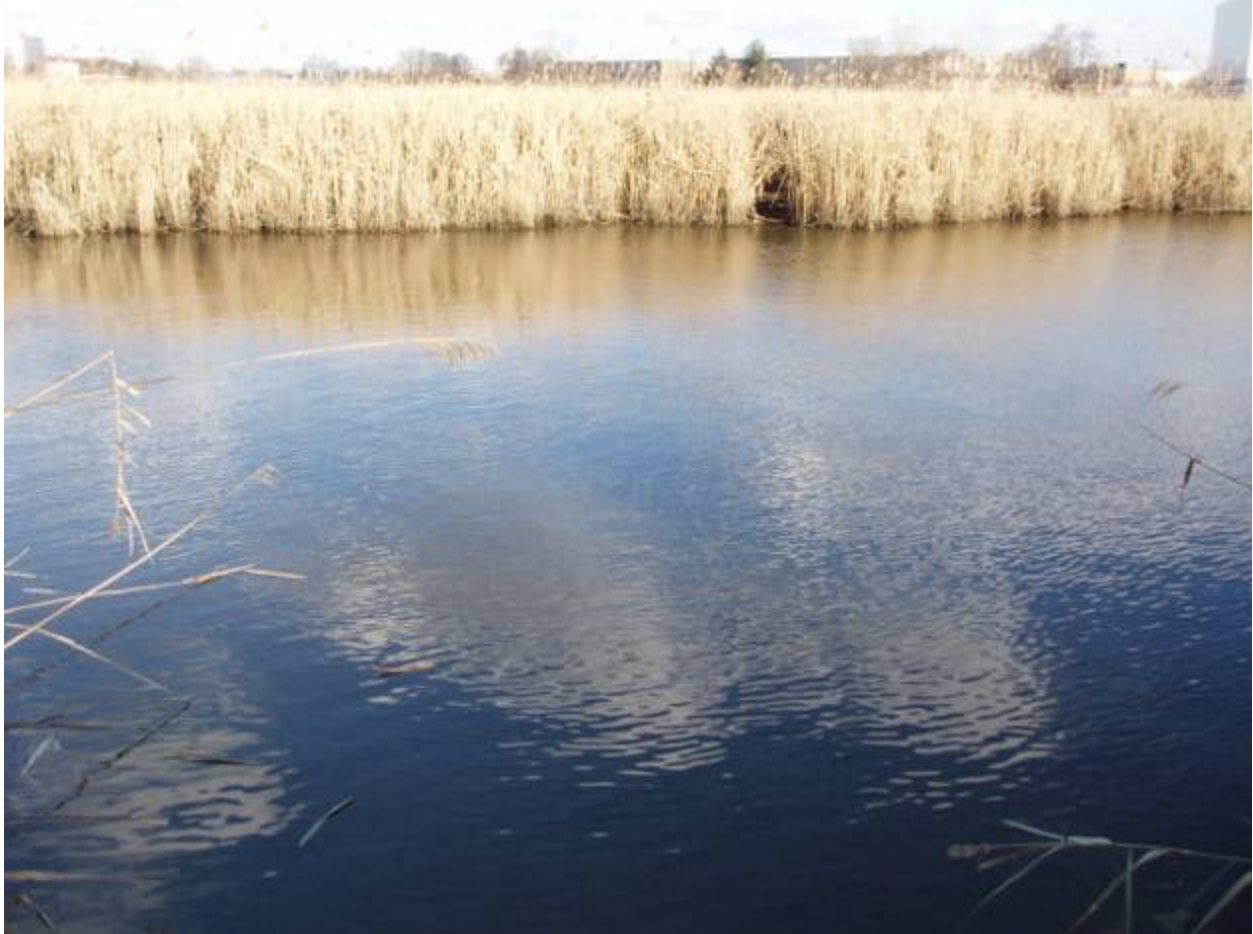
**Photo 2 Description:** Downstream view from the tide gate

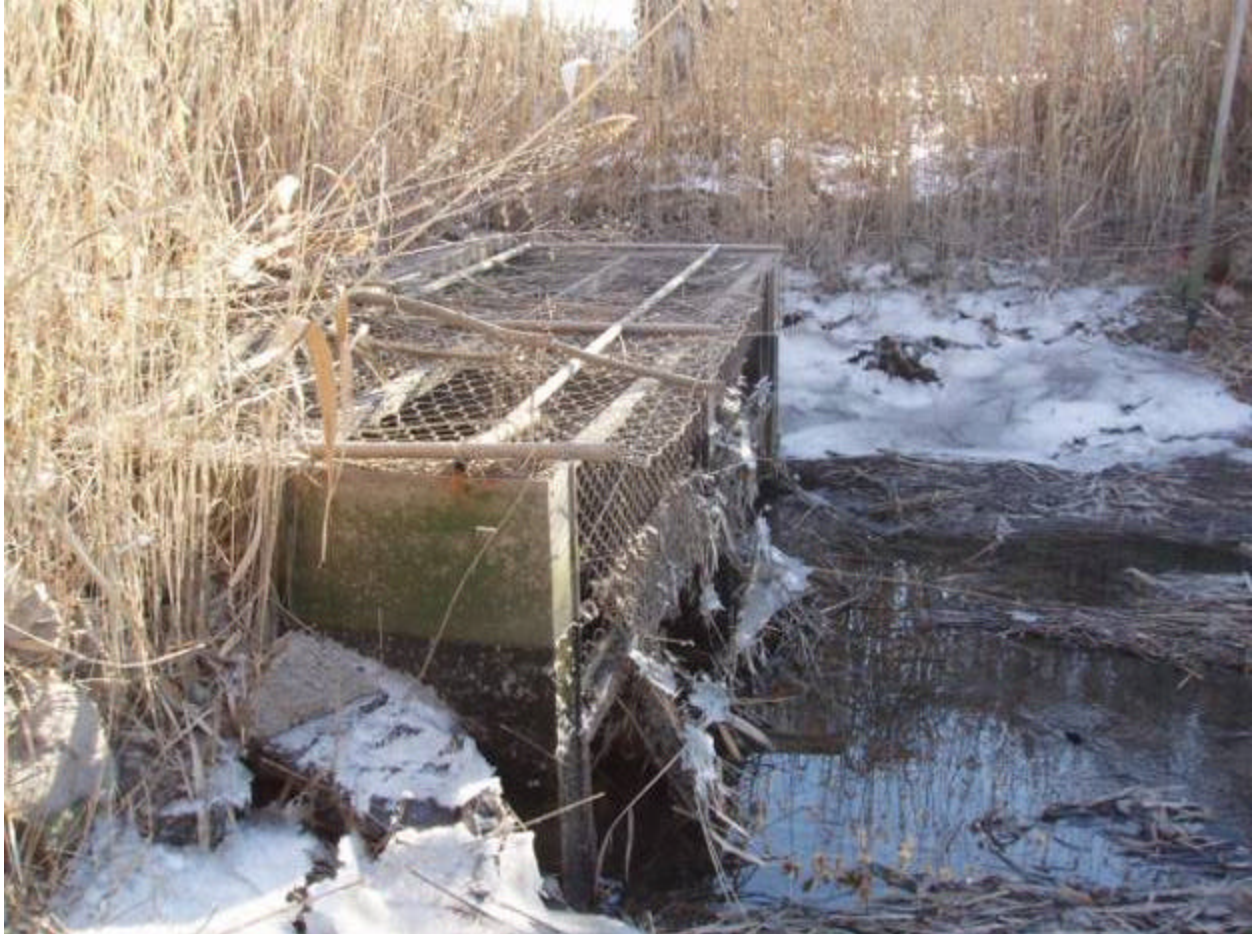
**Photo 1 Description: Tide gate structure**

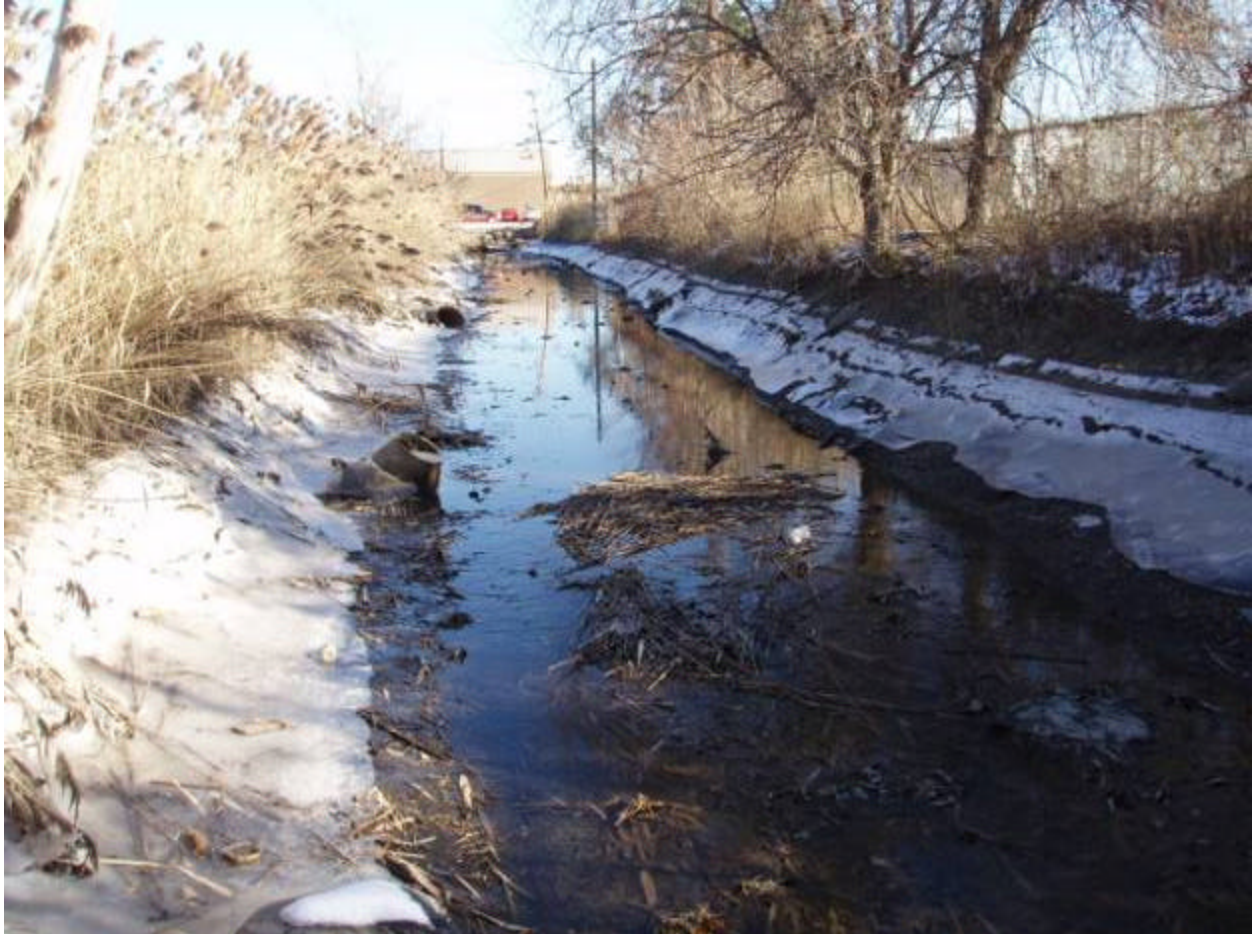
**Photo 2 Description:** Upstream view from tide gates

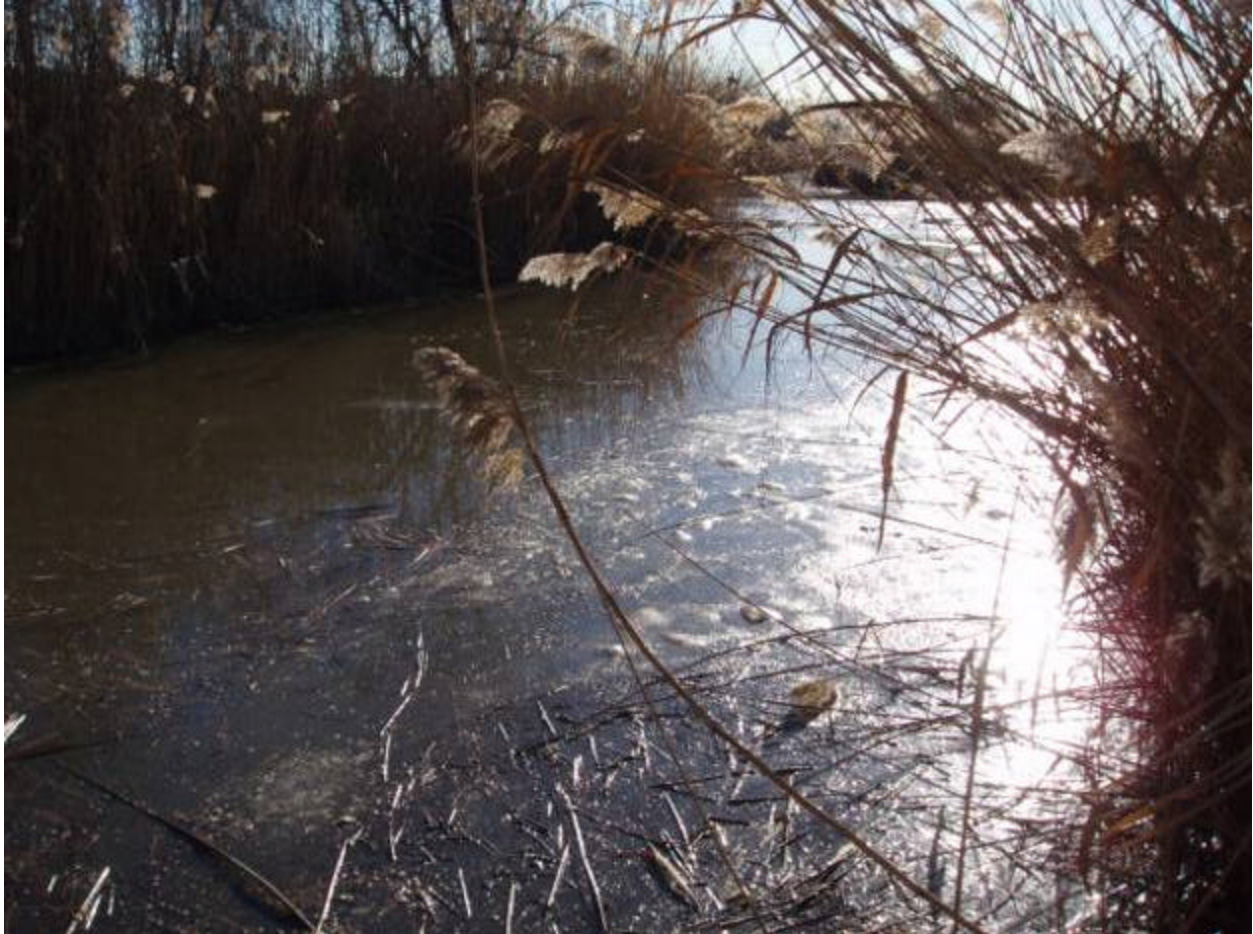
**Photo 2 Description: Downstream view from the tide gates**

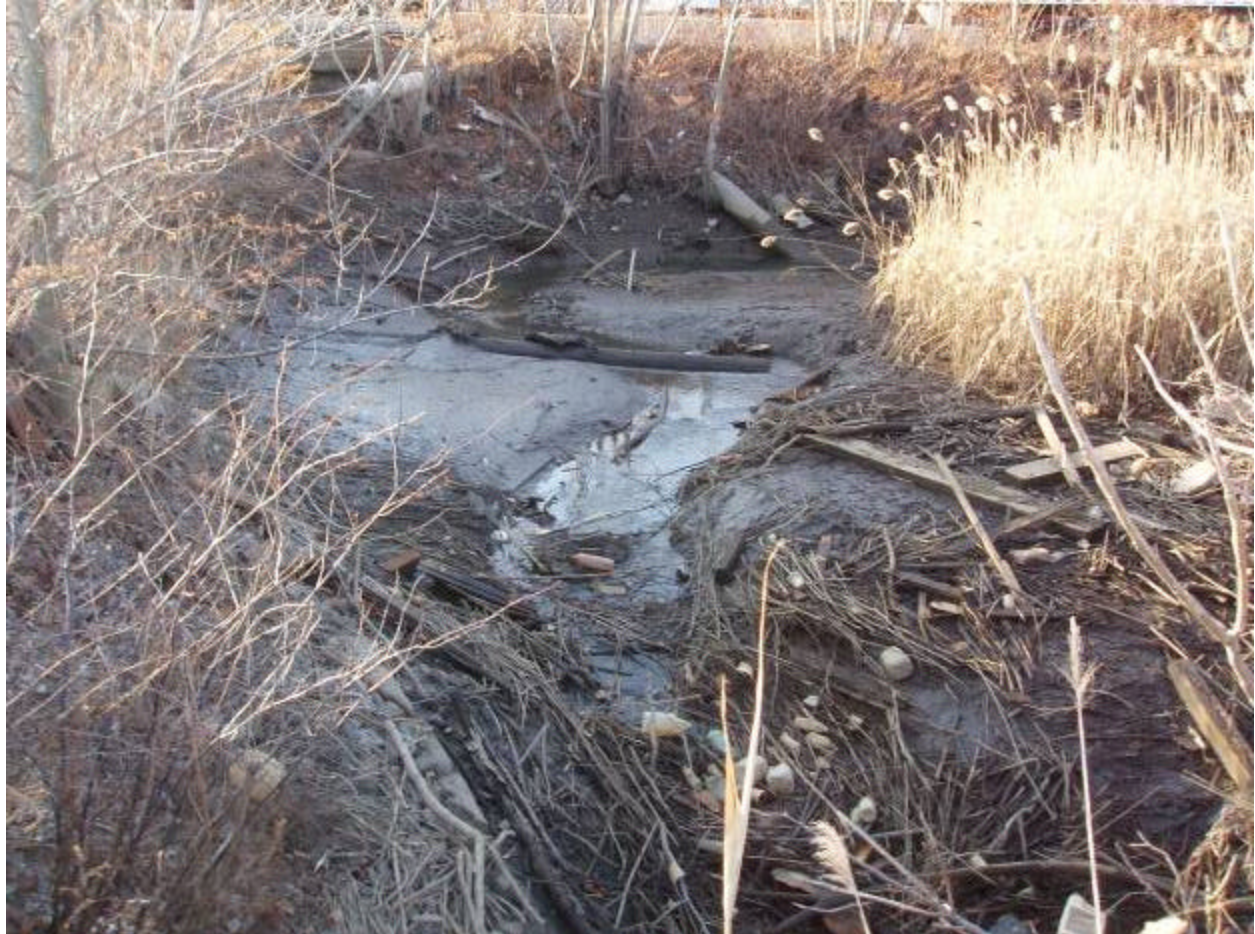
**Photo 2 Description:** Upstream view from the tide gate

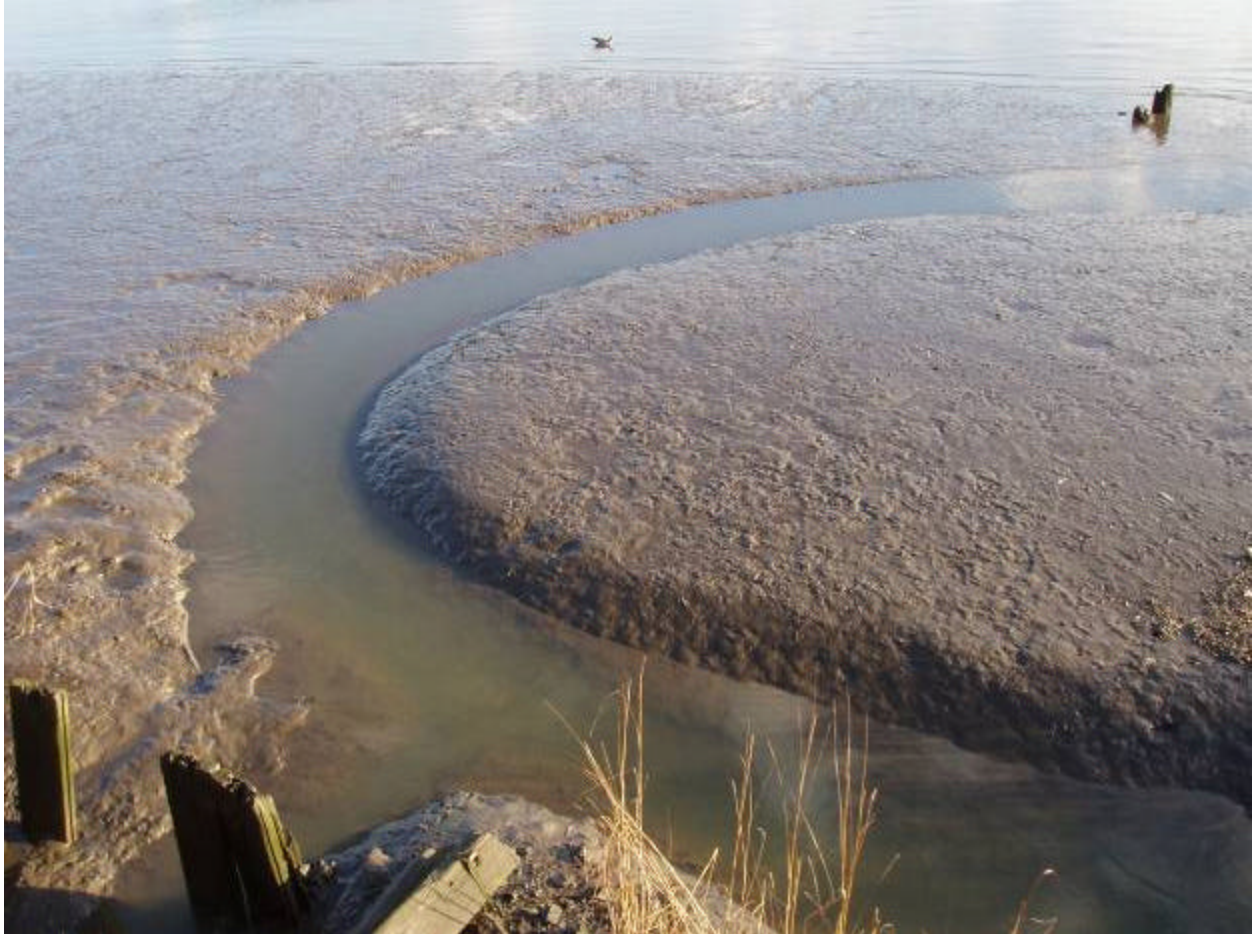
**Photo 3 Description:** Downstream view from the tide gate

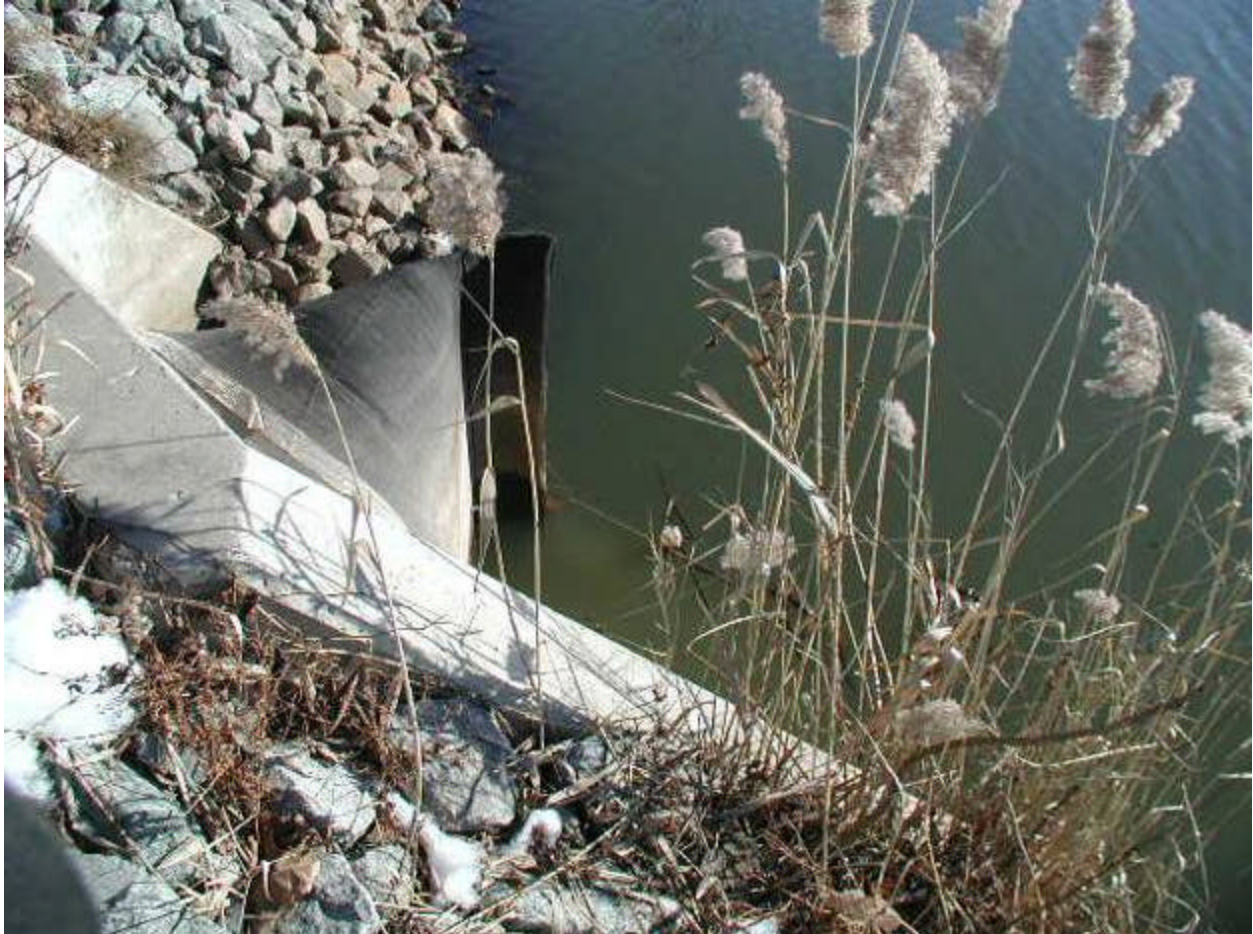
**Photo 1 Description:** Tideflex<sup>TM</sup> check valve structure

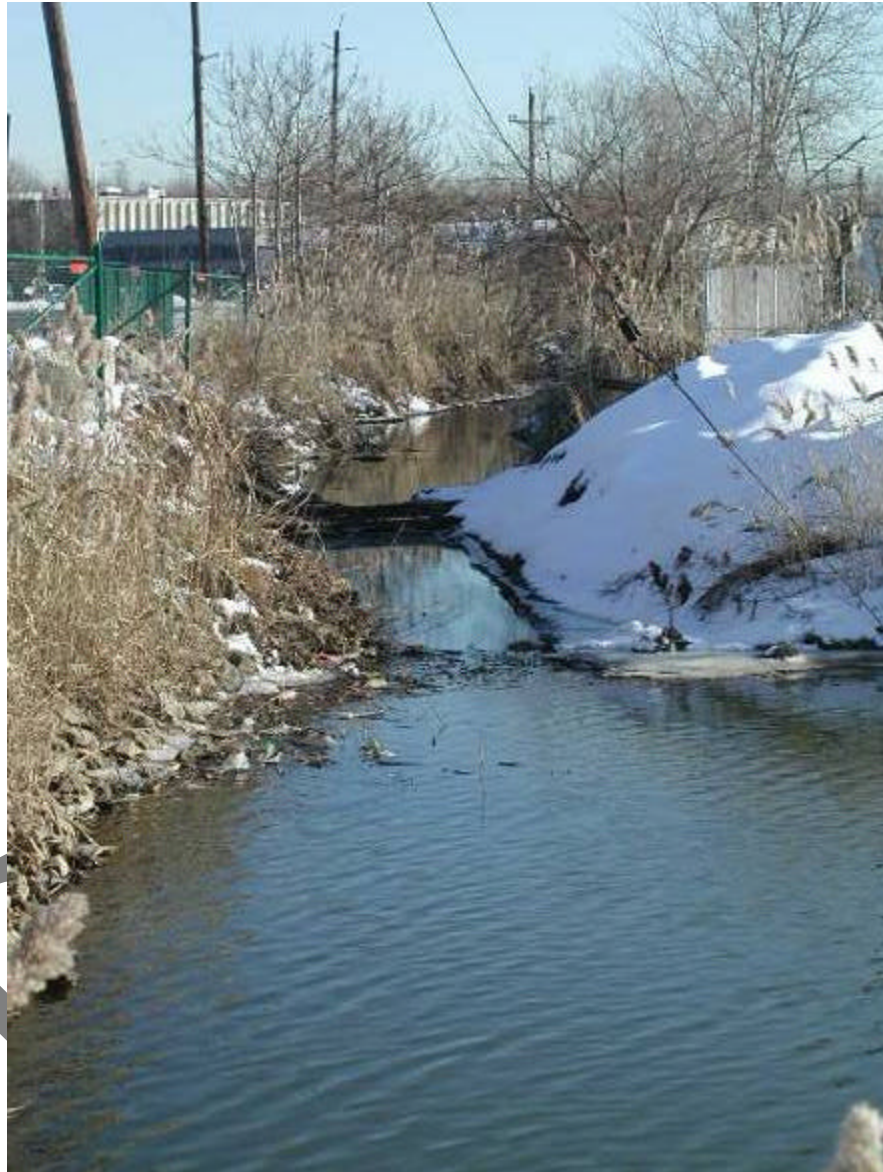
**Photo 2 Description: Downstream view from tide gate**

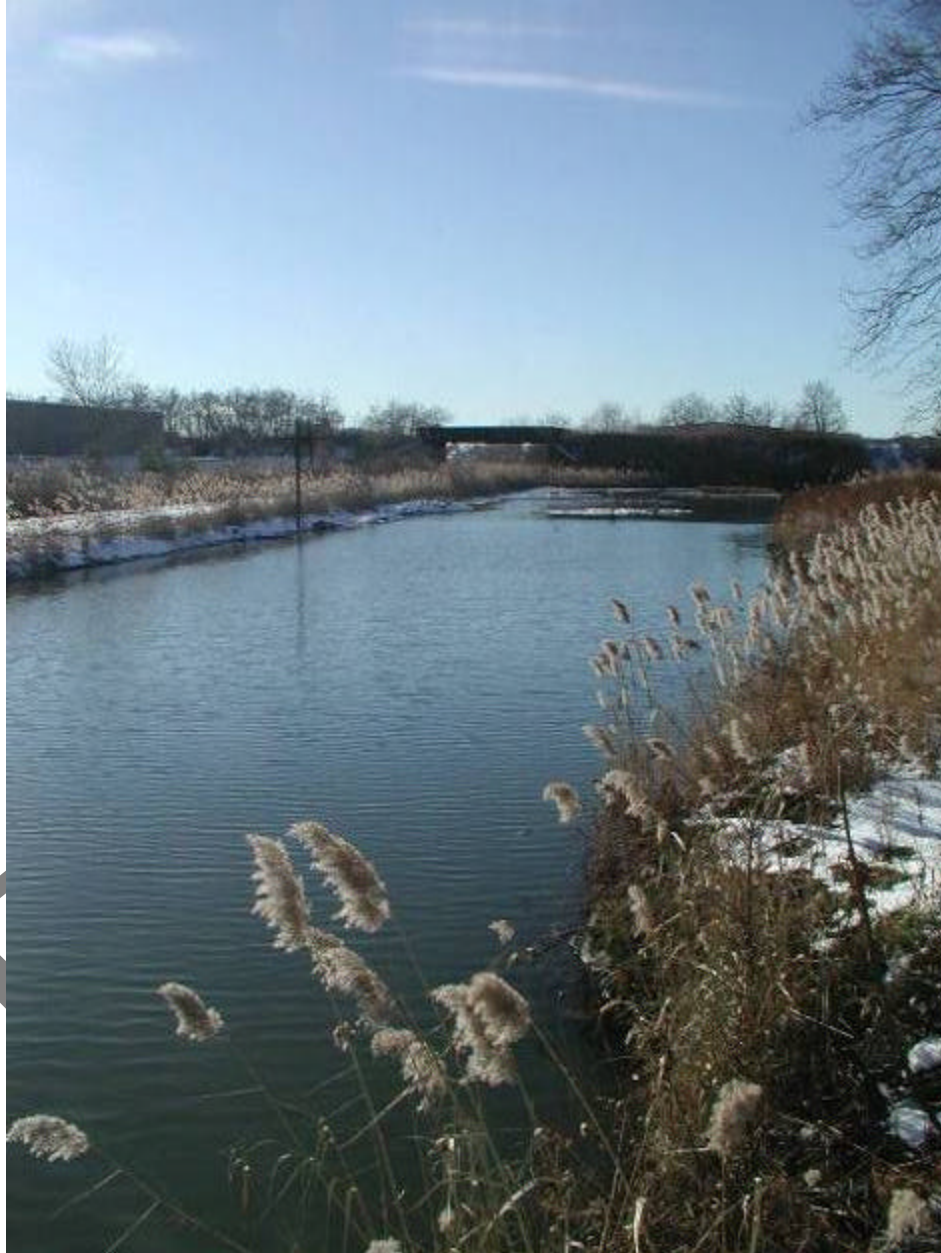
**Photo 3 Description:** Downstream detention basin located at the tide gate outfall

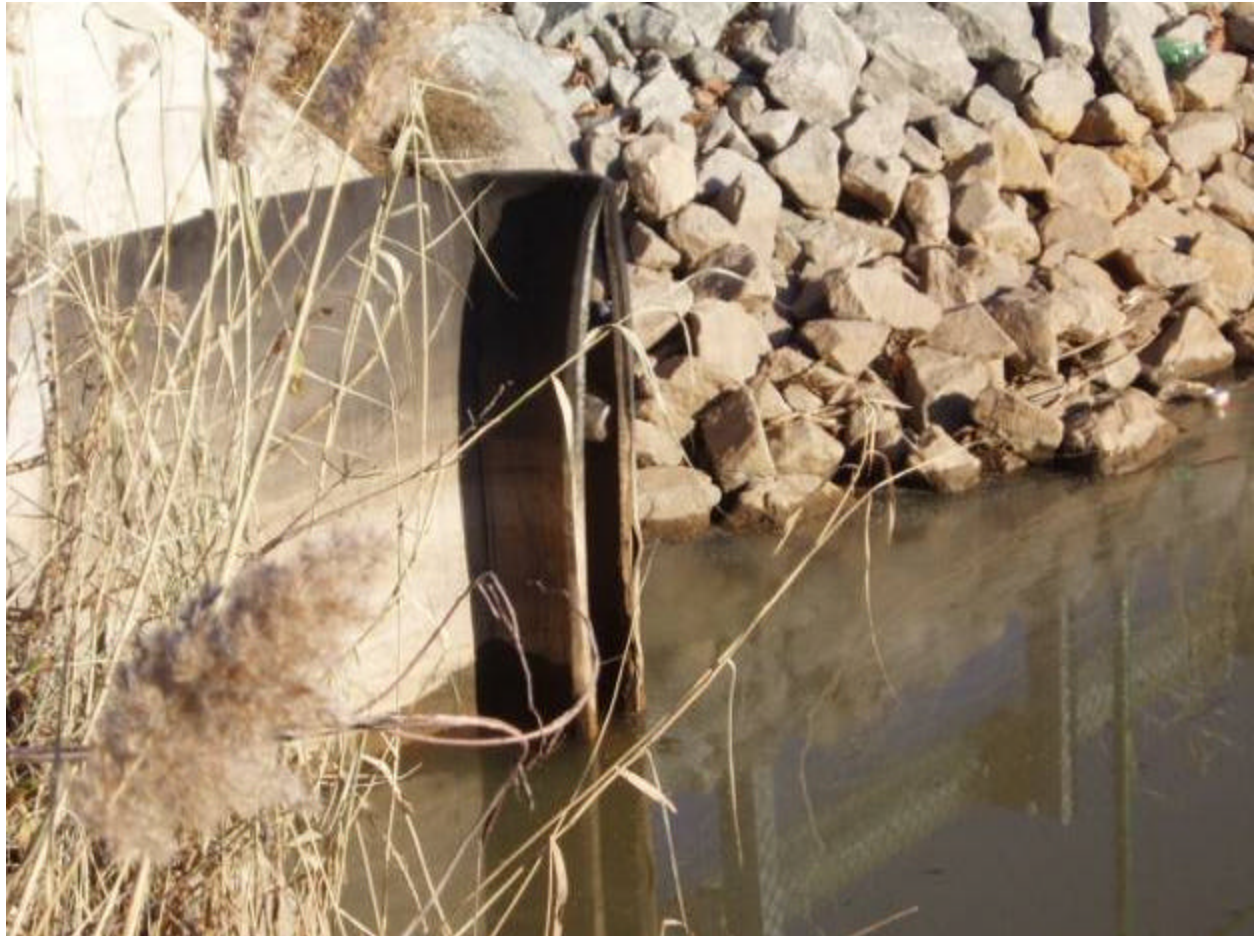
**Photo 1 Description:** Tideflex<sup>TM</sup> check valve structure

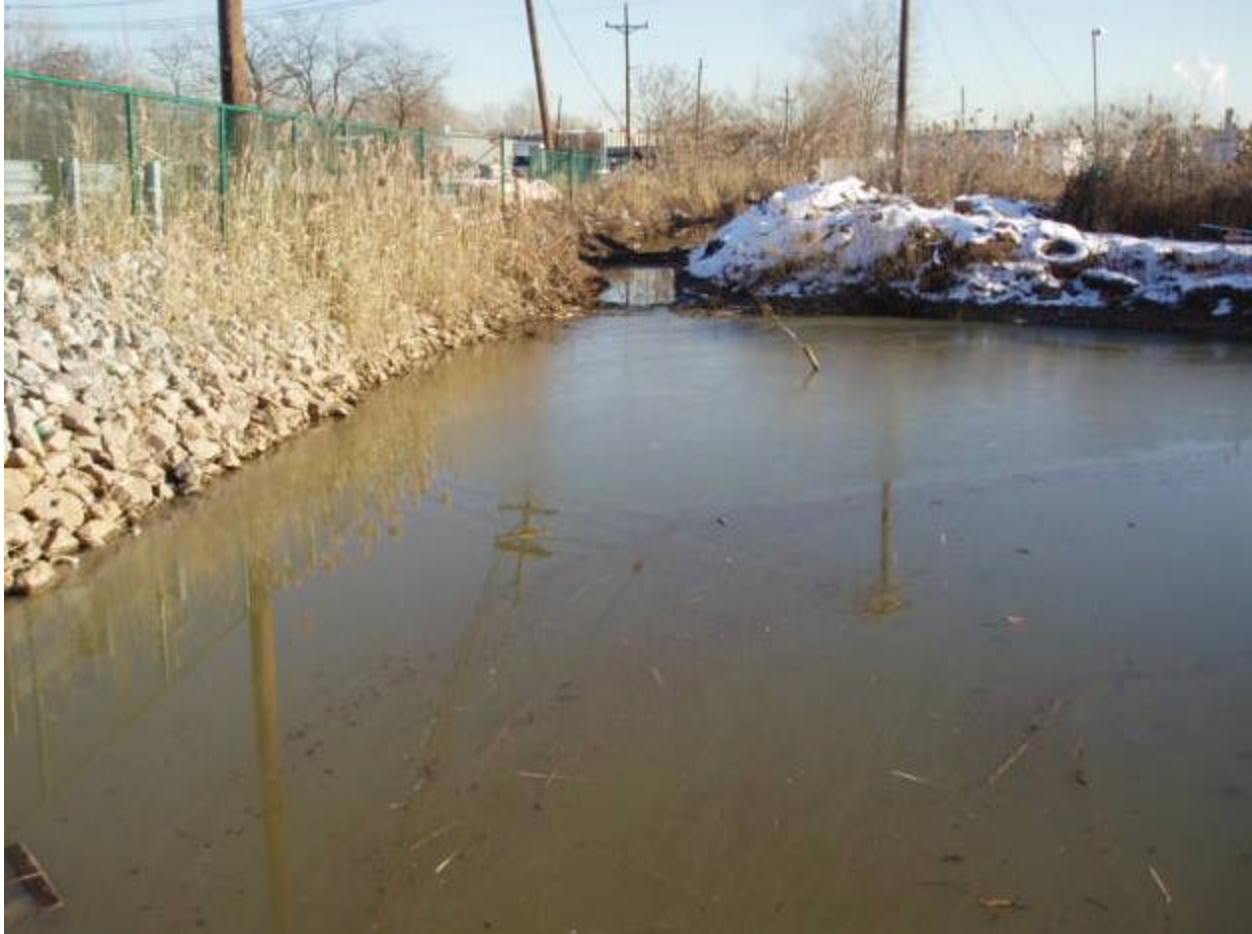
**Photo 2 Description: Downstream view from tide gate**

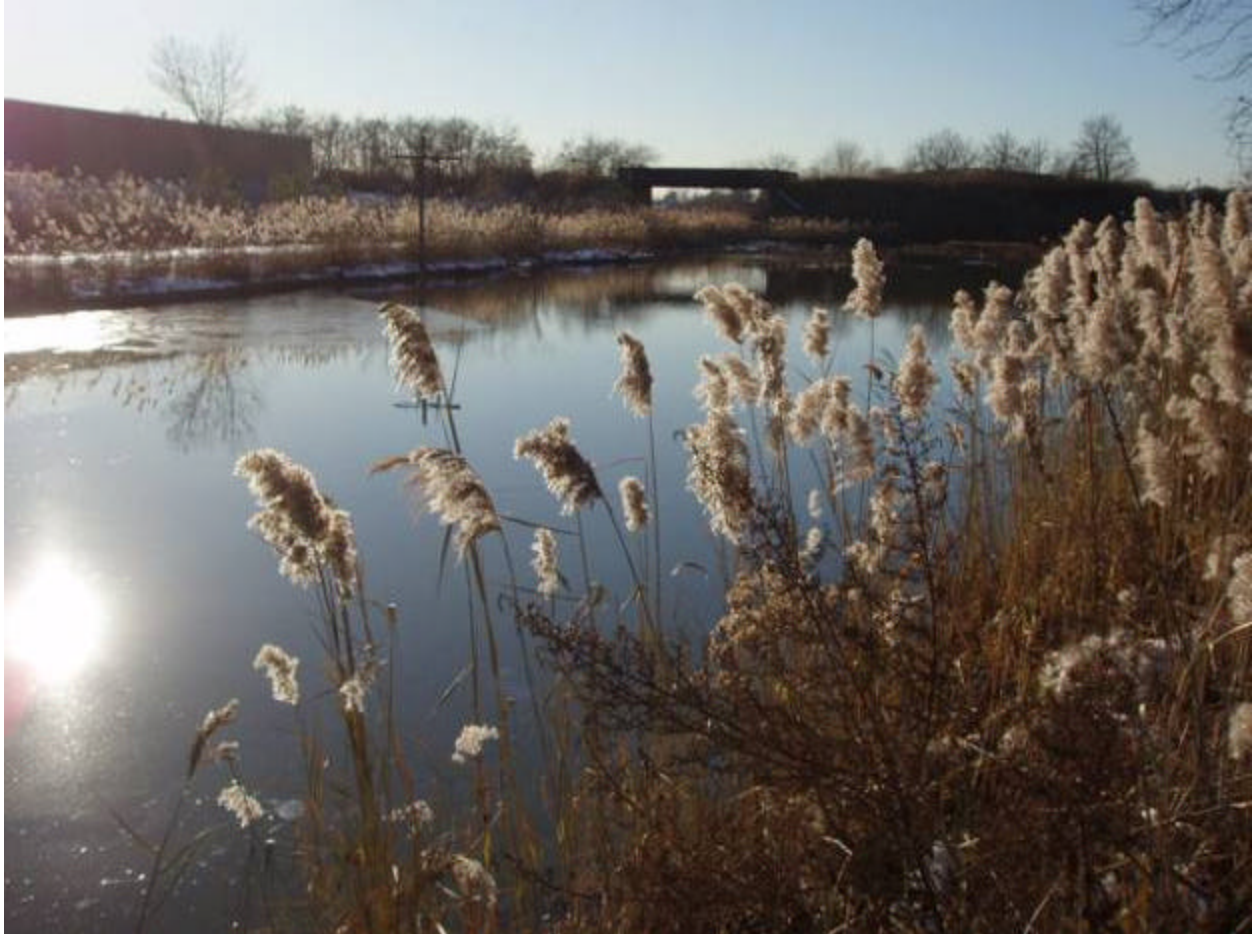
**Photo 3 Description:** Downstream detention basin located at the outfall of the tide gate

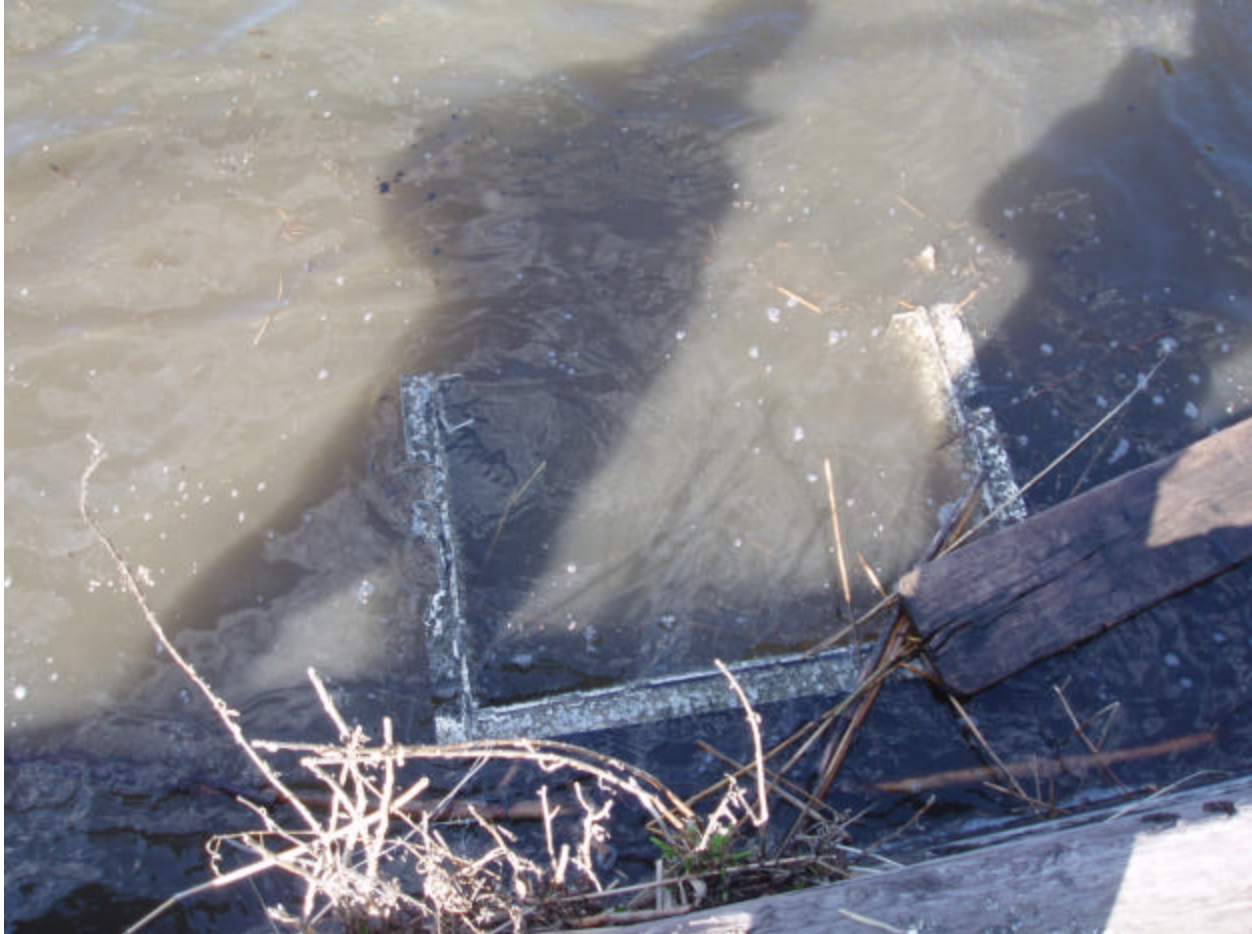
Three existing tide gates were found but the tide gate structures did not appear to be functional. The pump station is abandoned and without electrical service. Flow of water between the Hackensack River and the marsh across the dike might be seeping through the old tide gate structures. No signs or indications were found to prove the dike has been breached in the past.

**Photo 1 Description:** View of old tide gate structure

No interim maintenance is required because the Cayuga Dike system has deteriorated into a dilapidated state. An analysis of the Cayuga Dike system will be required to determine if the system is needed for flood control mitigation and should be repaired.

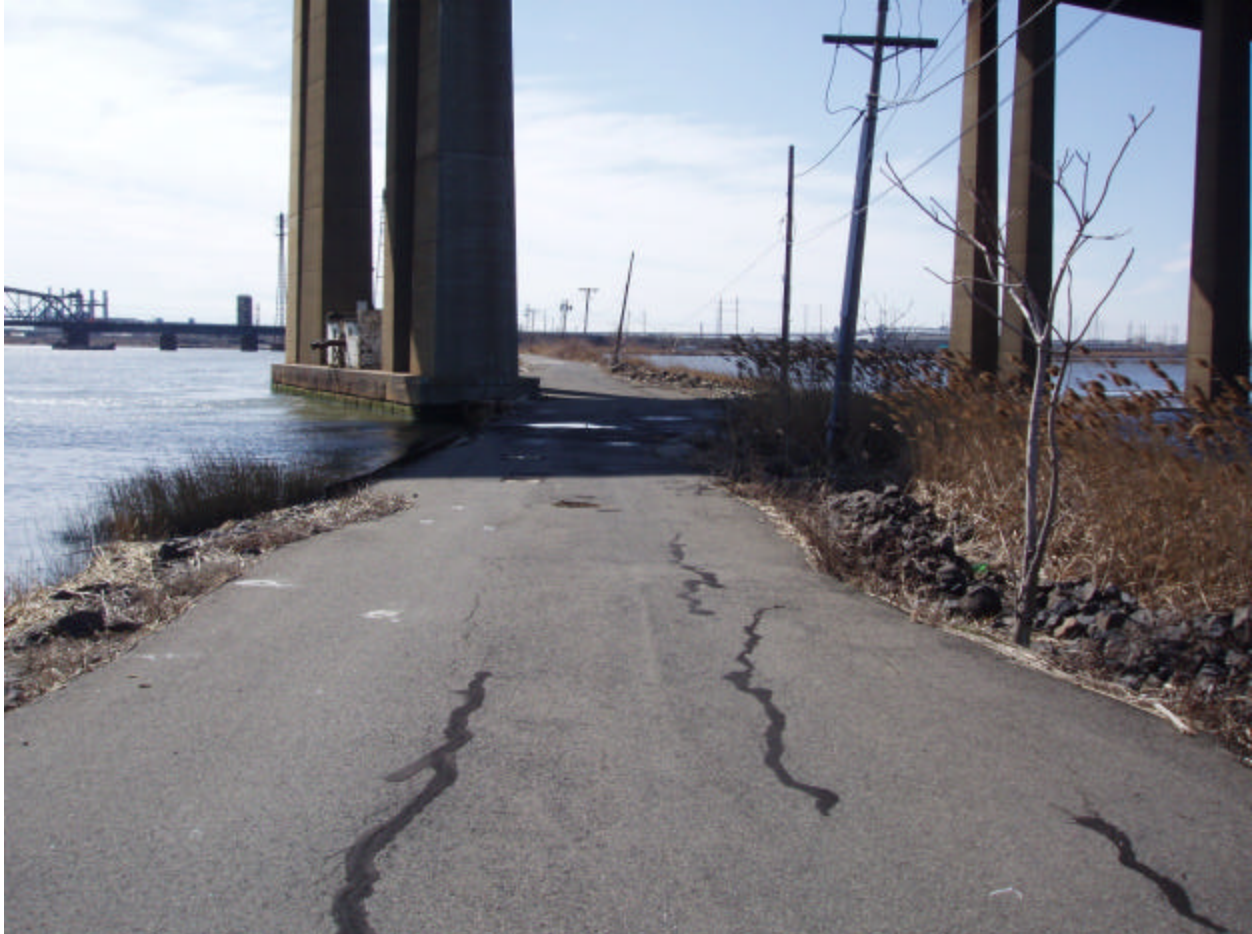
**Photo 2 Description:** View of pump station underneath the NJ Turnpike

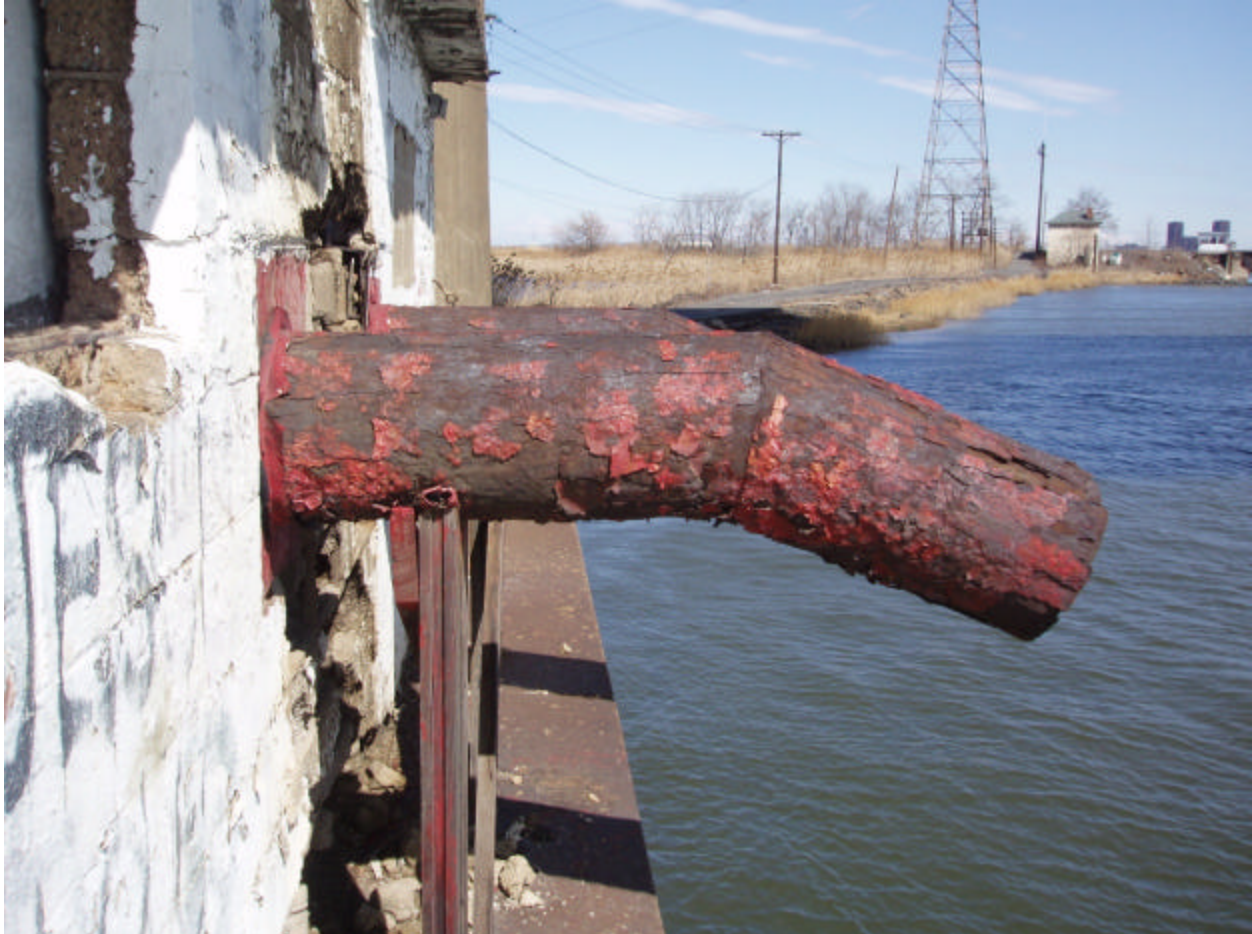
**Photo 3 Description:** View of discharge pipes from pump station to Hackensack River
