# **Hackensack Meadowlands Tide Gates Inspection Report**

**The National Flood Insurance Program  
Community Rating System**

**The New Jersey Meadowlands Commission  
One DeKorte Park Plaza  
Lyndhurst, New Jersey**

**March 27, 2006**

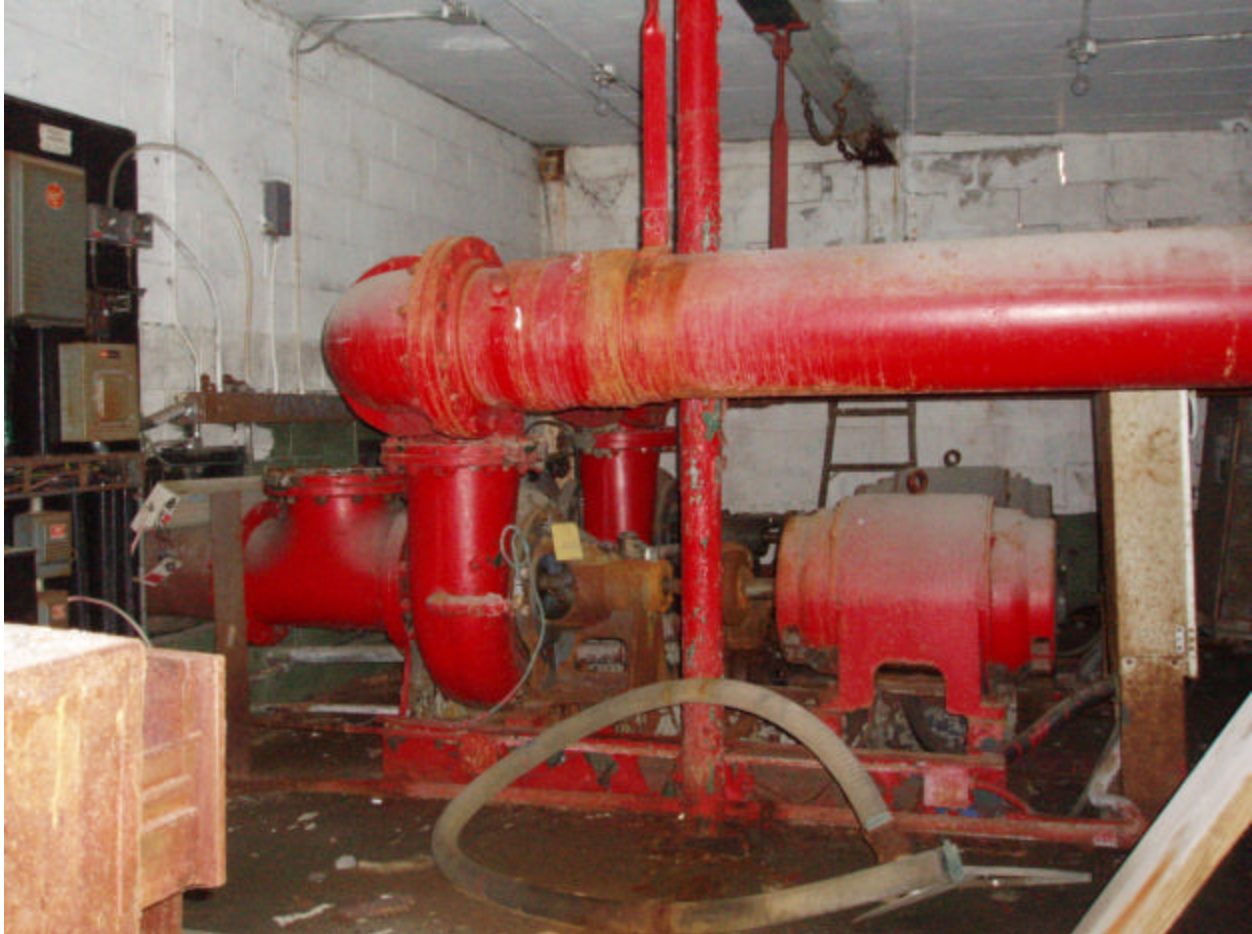
**Photo 4 Description: Looking inside of the Cayuga Dike Pump Station**

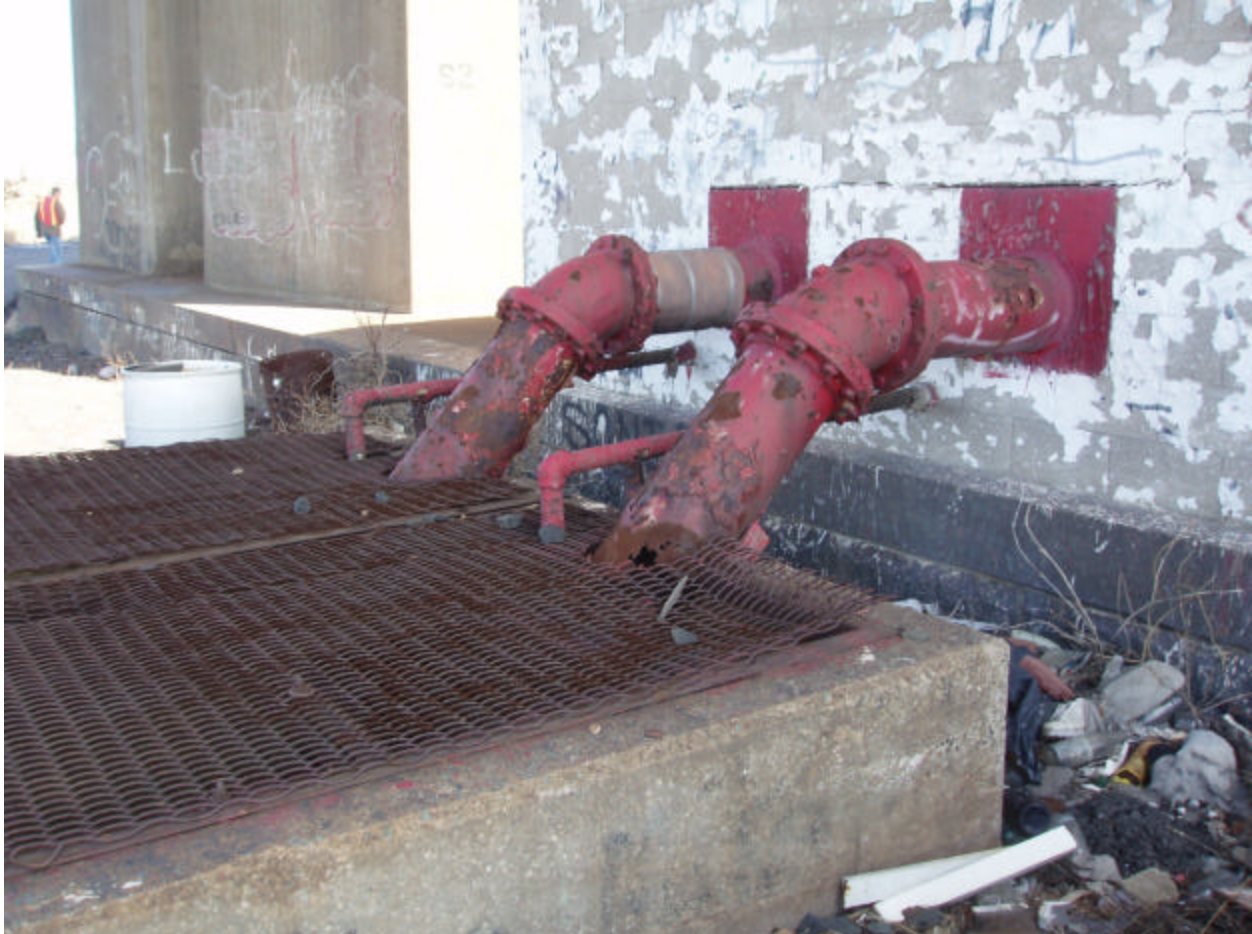
**Photo 5 Description:** View of Cayuga Dike Pump Station's intake structure

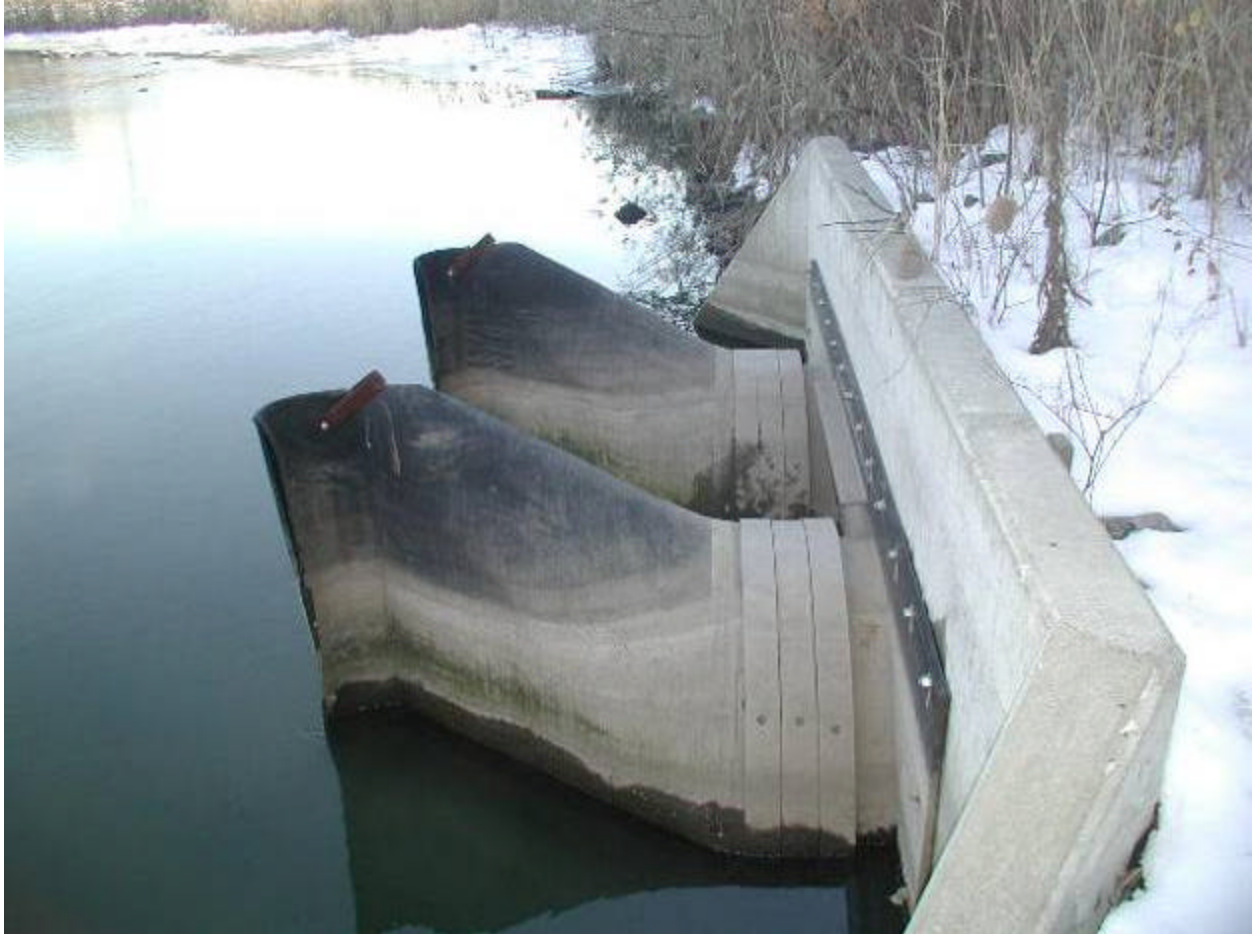
**Photo 1 Description:** Tideflex<sup>TM</sup> check valve structure

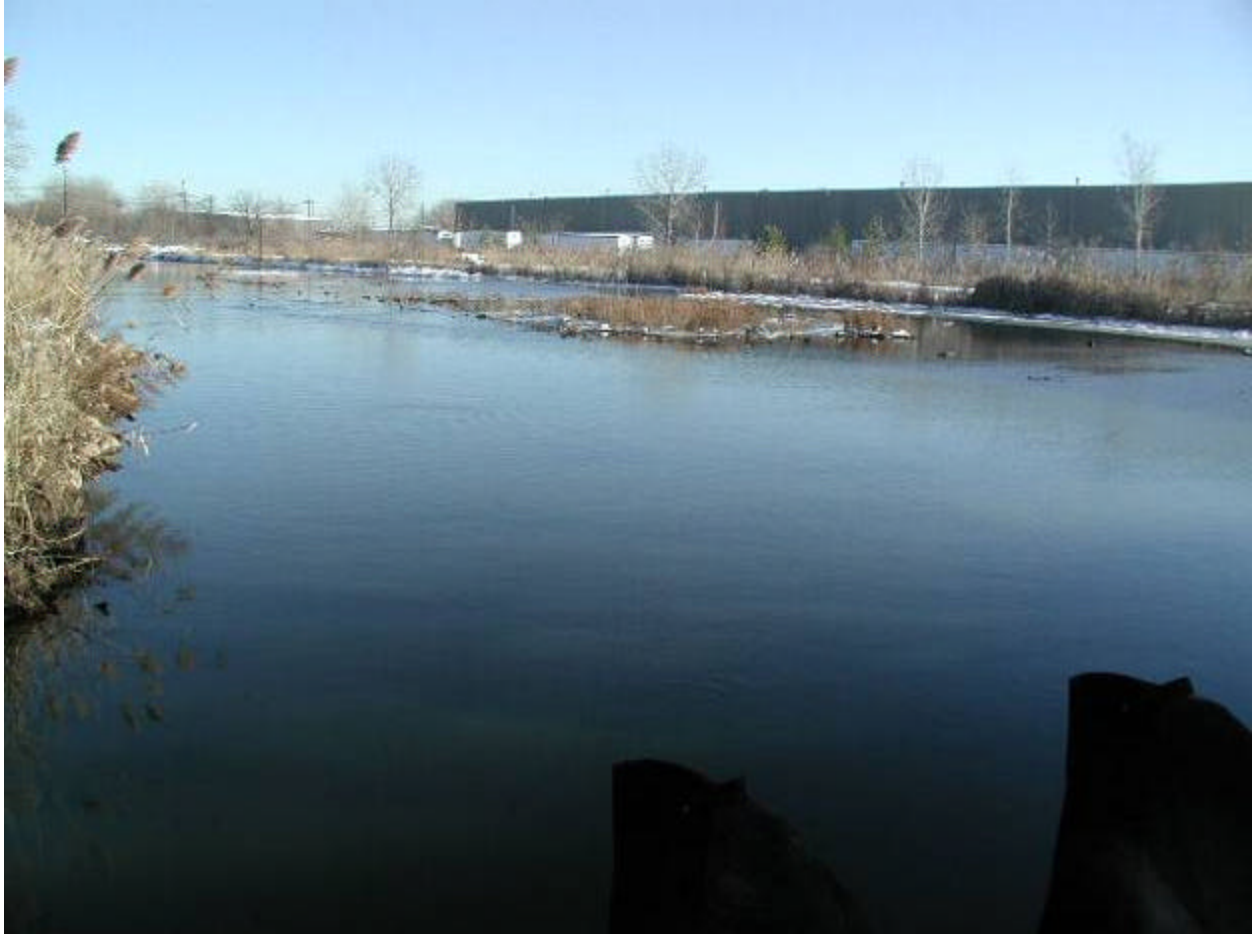
**Photo 2 Description: Downstream view from tide gates**

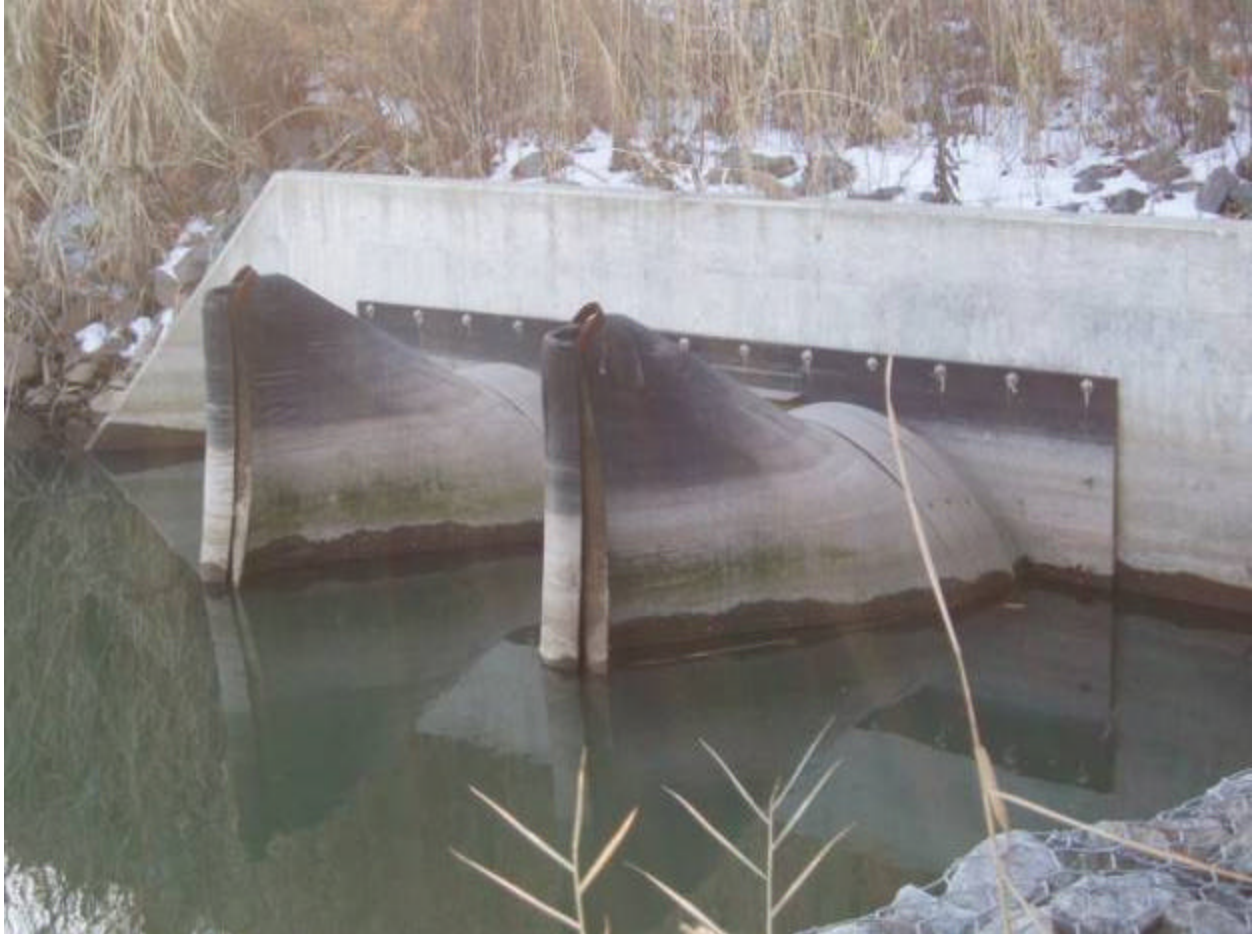
**Photo 1 Description: Tideflex™ check valve structure**

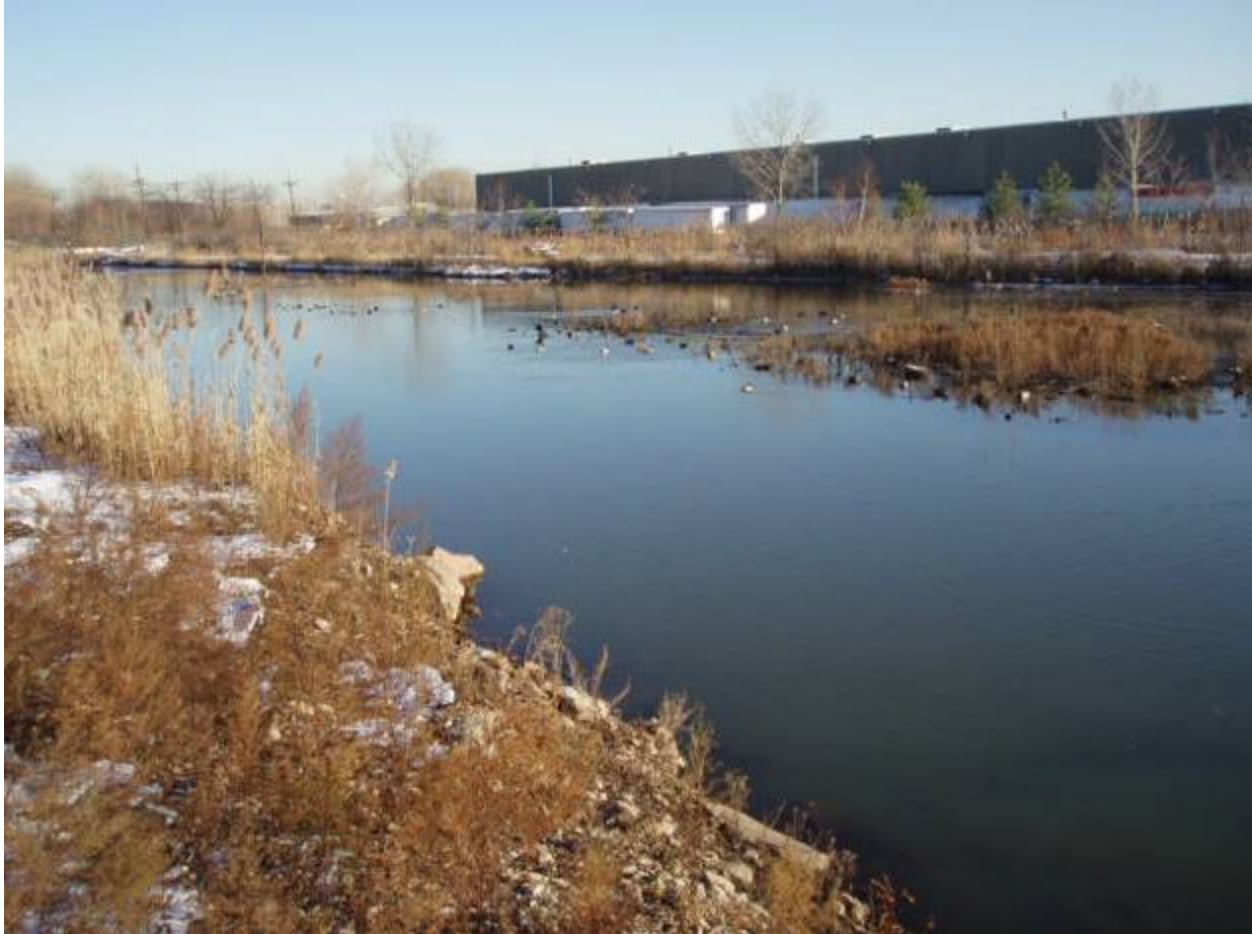
**Photo 2 Description: Downstream view from tide gates**

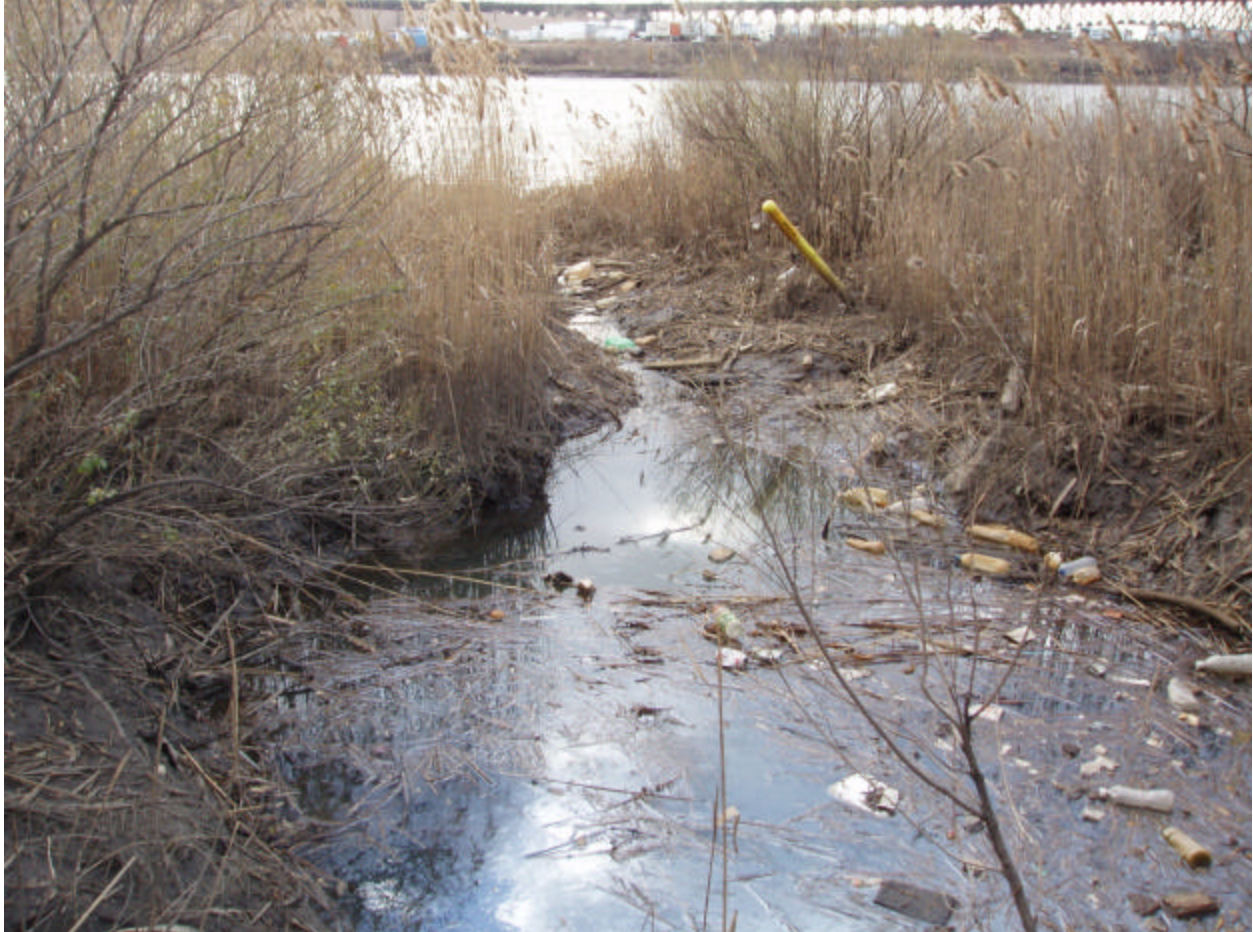
The site contains a Tideflex<sup>TM</sup> check valve; it appears to be functional during low tide conditions. The discharge channel is clogged with debris and sediment.

**Photo 1 Description: Downstream view from tide gate**

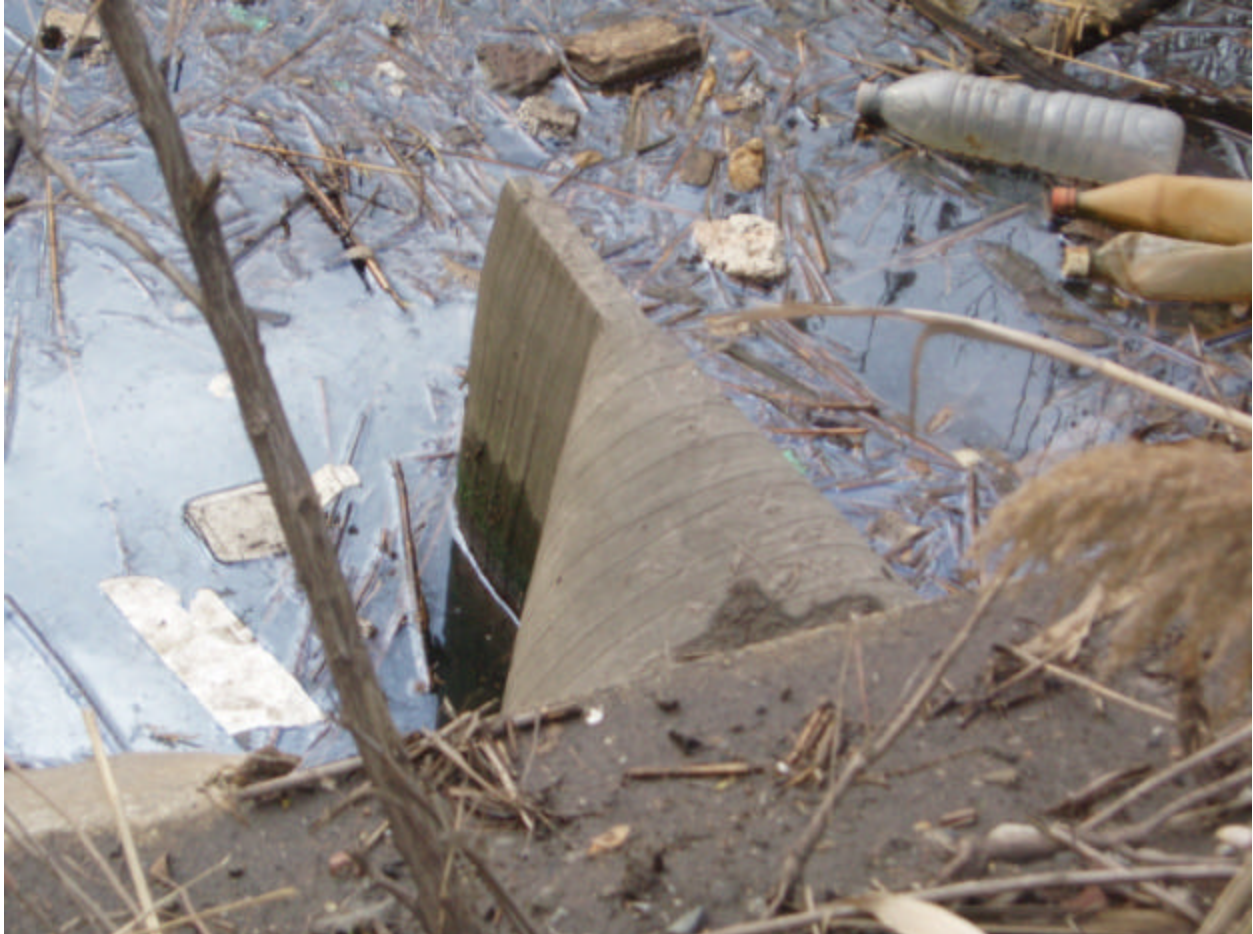
**Photo 2 Description: Tideflex™ check valve**

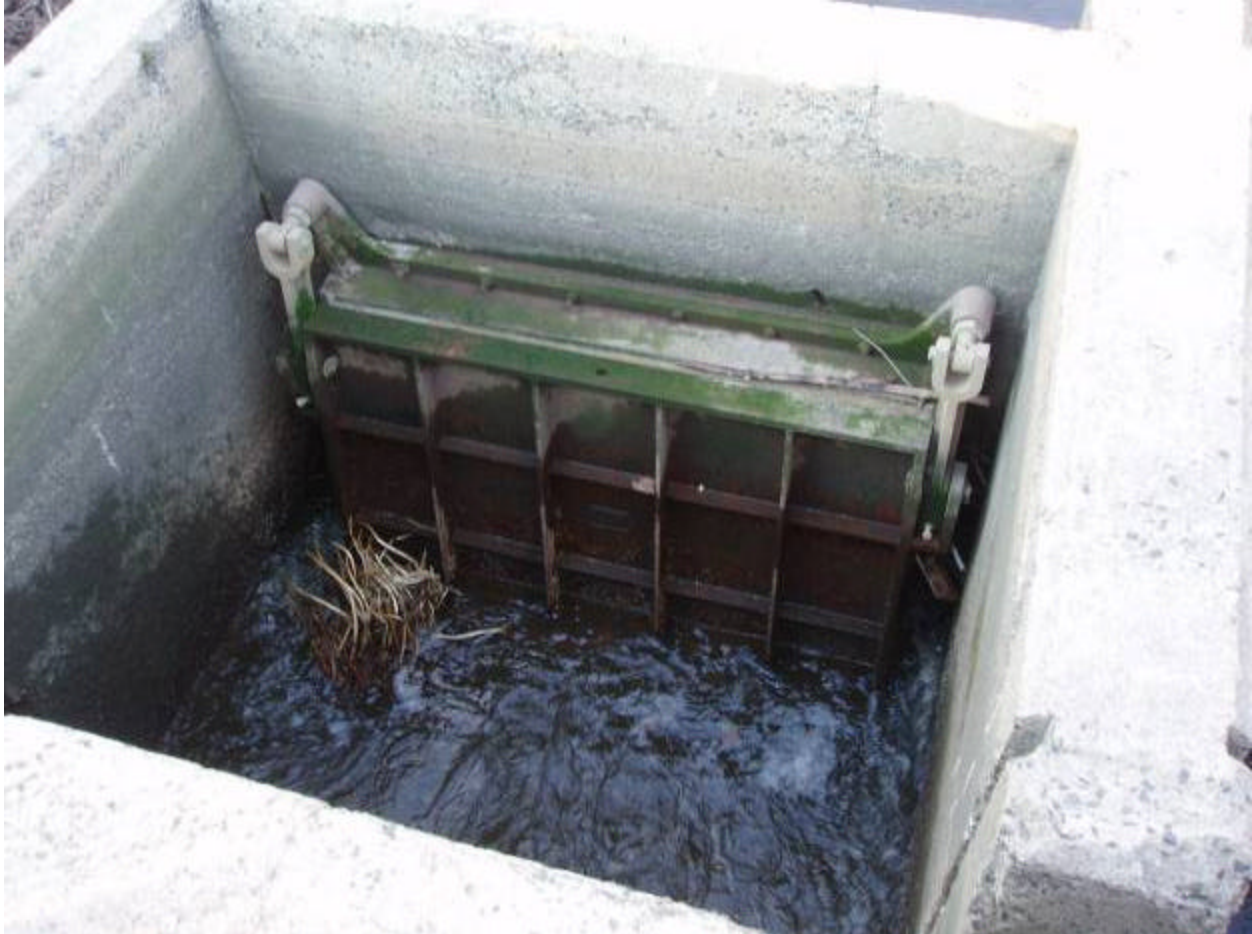
**Photo 1 Description:** Tide gate shown during low tide

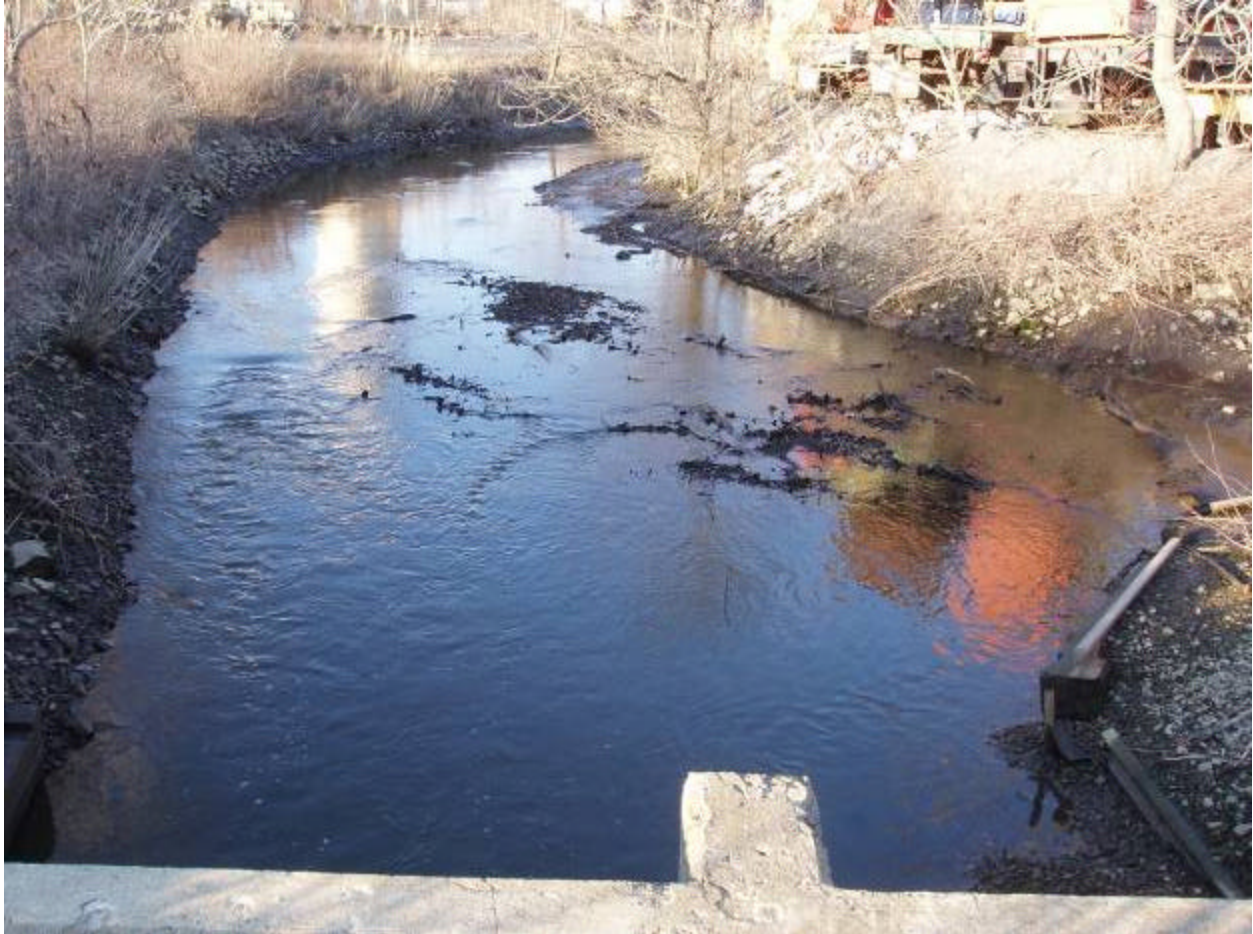
**Photo 3 Description:** Upstream view from the tide gates

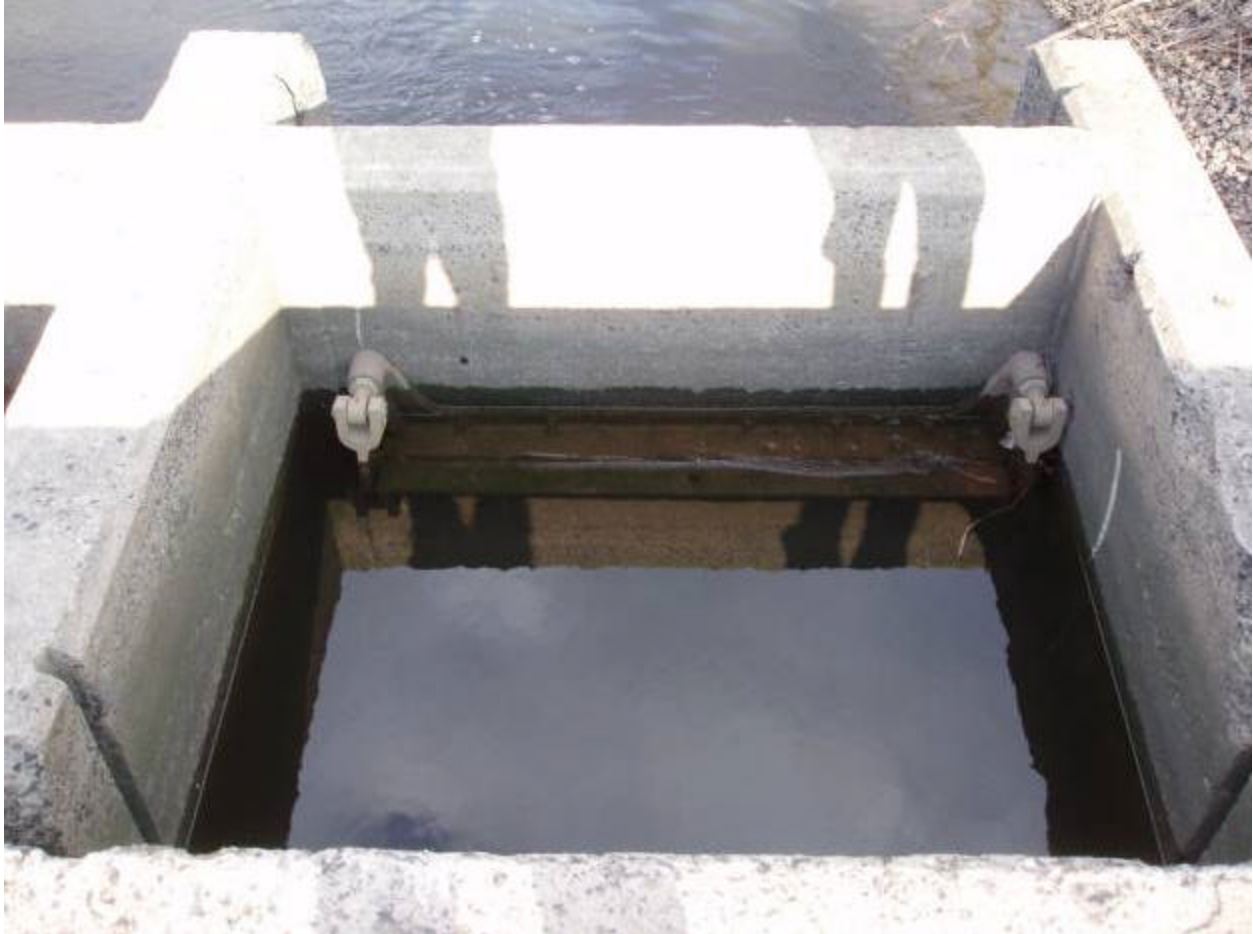
The tide gates are not functioning properly. Water is seeping through during high tide conditions due to the tide gates not seating properly.

**Photo 2 Description: One of two metal flap gates**

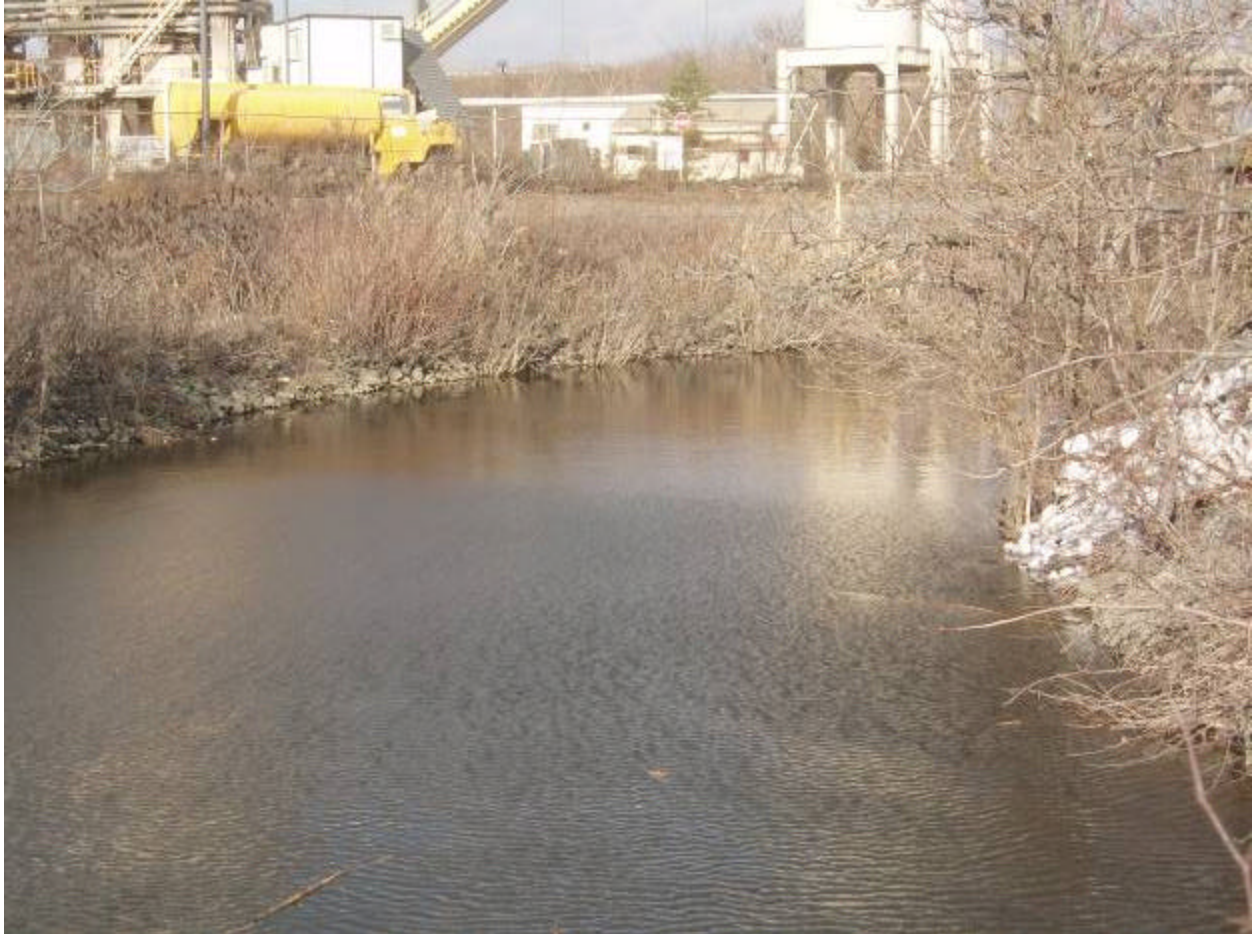
**Photo 3 Description:** Upstream view from tide gates

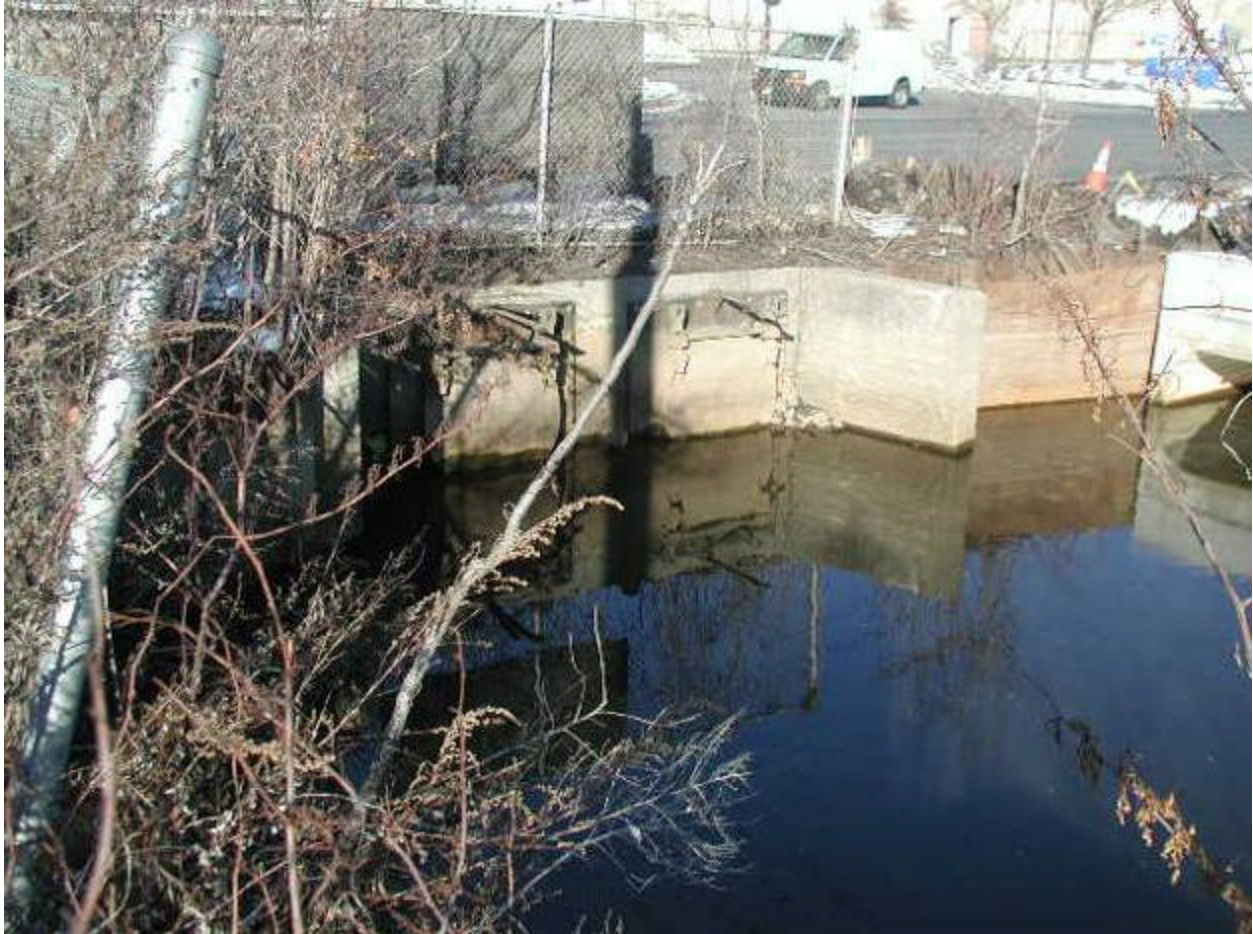
**Photo 1 Description: Tide gate structure**

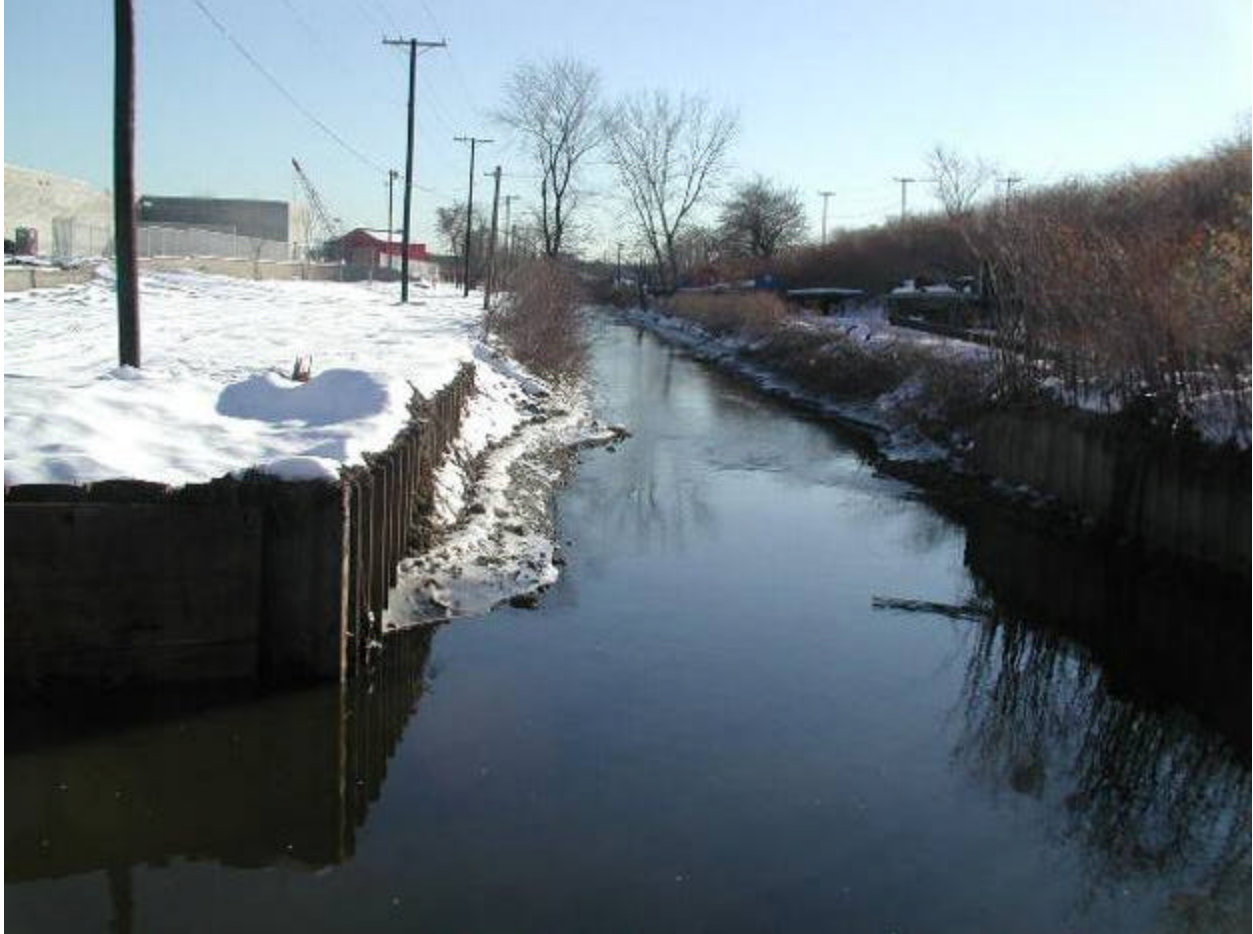
**Photo 2 Description:** Downstream view from the tide gate

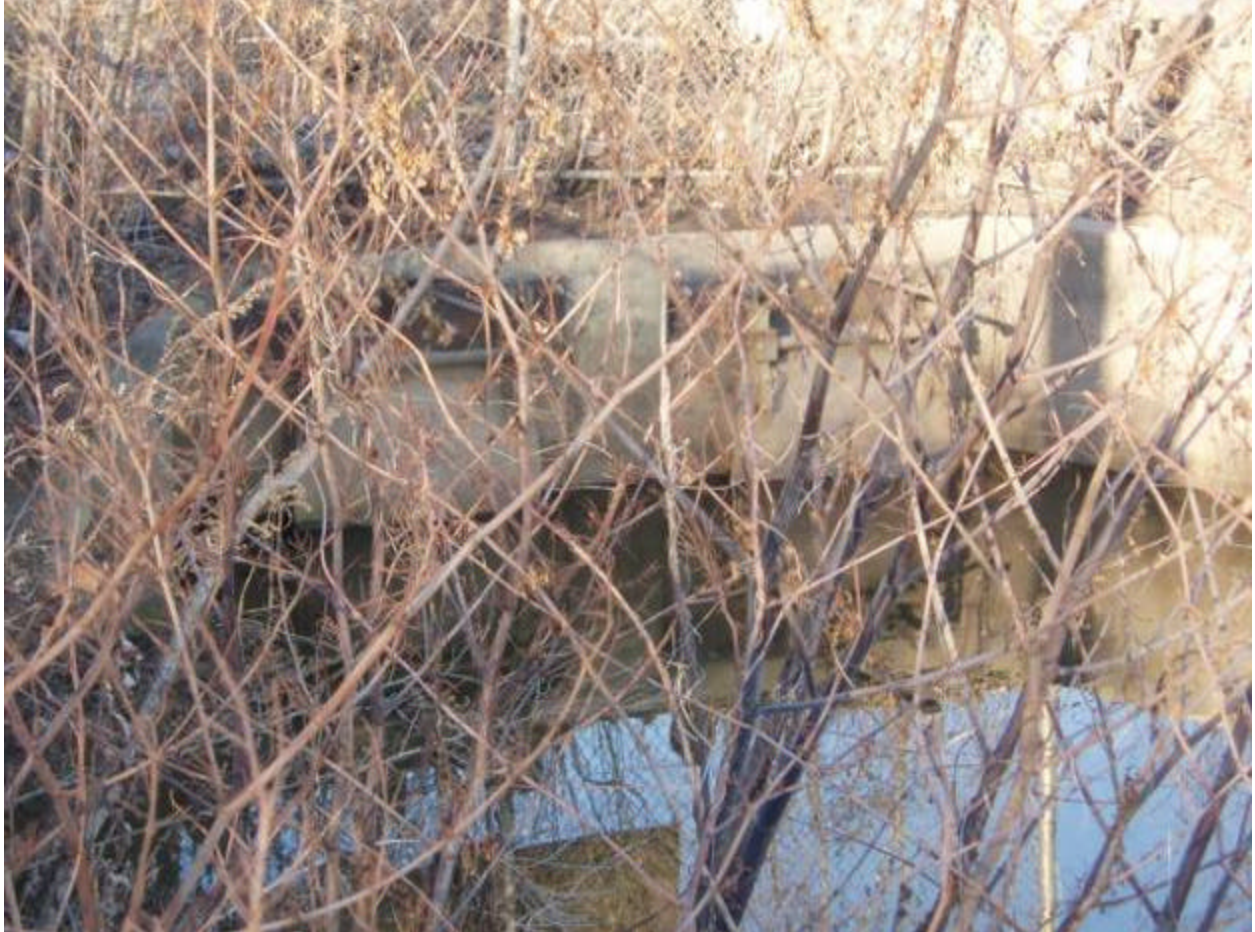
**Photo 1 Description: Tide gate structure**

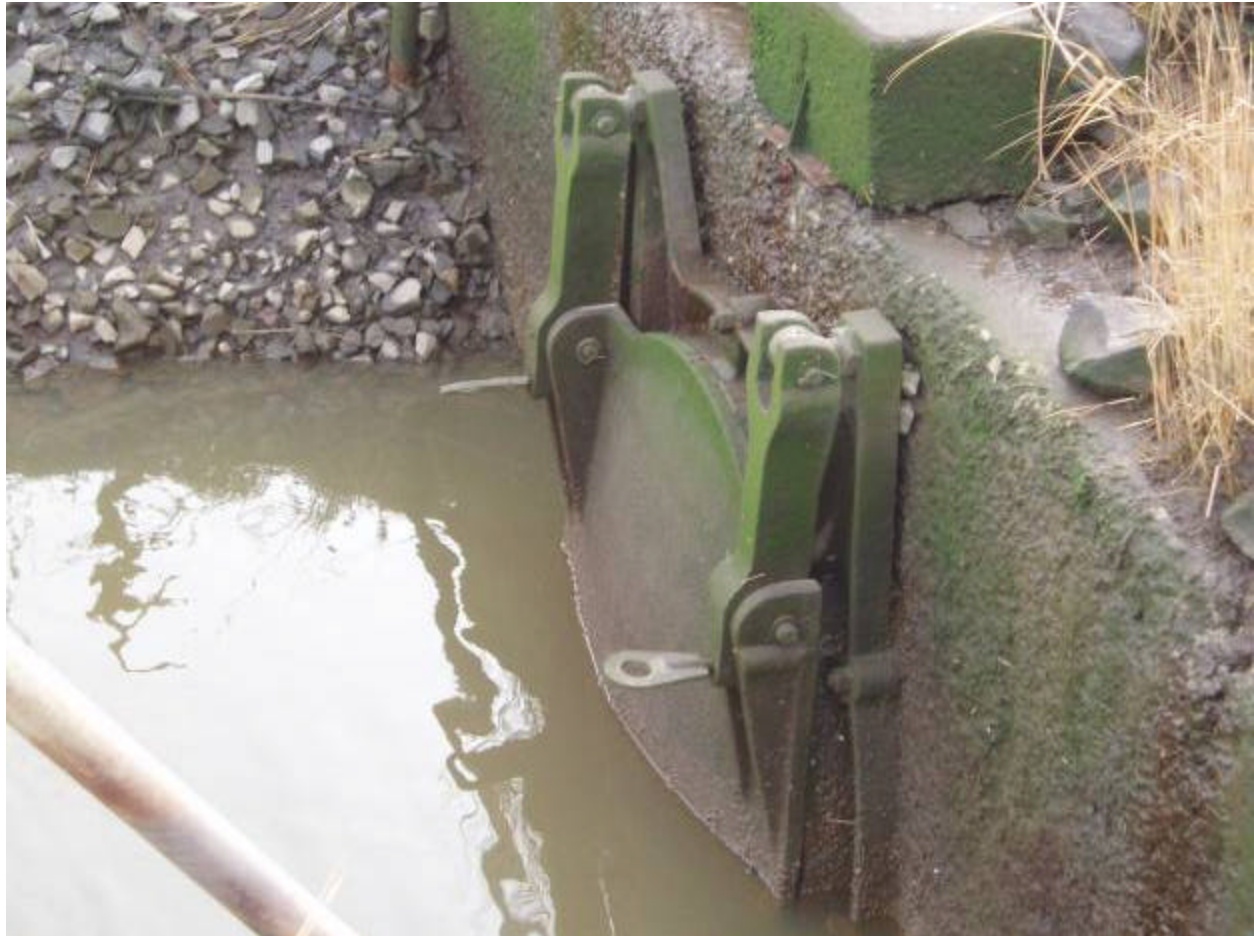
**Photo 1 Description: Metal flap gate**

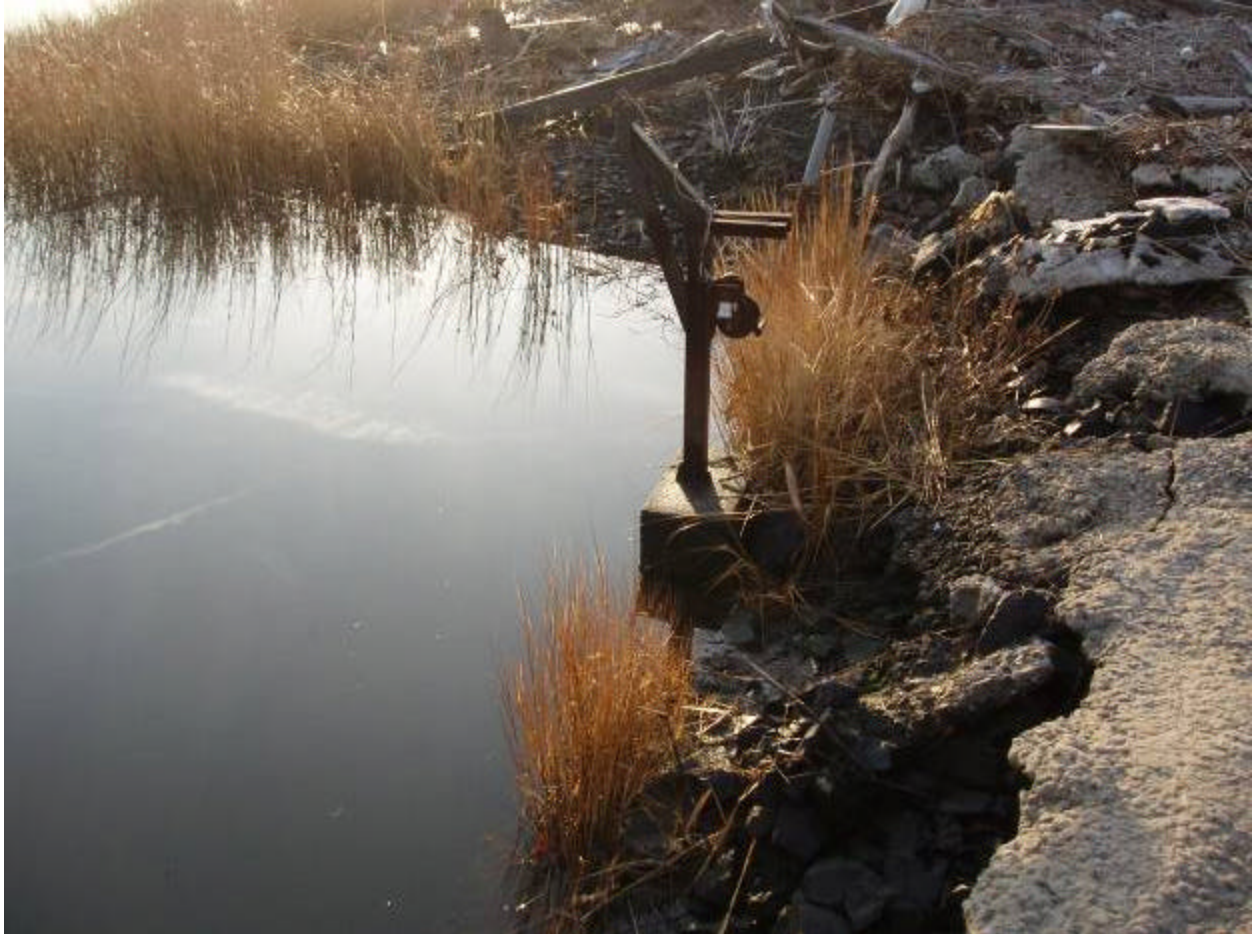
**Photo 1 Description: Side view of tide gate**

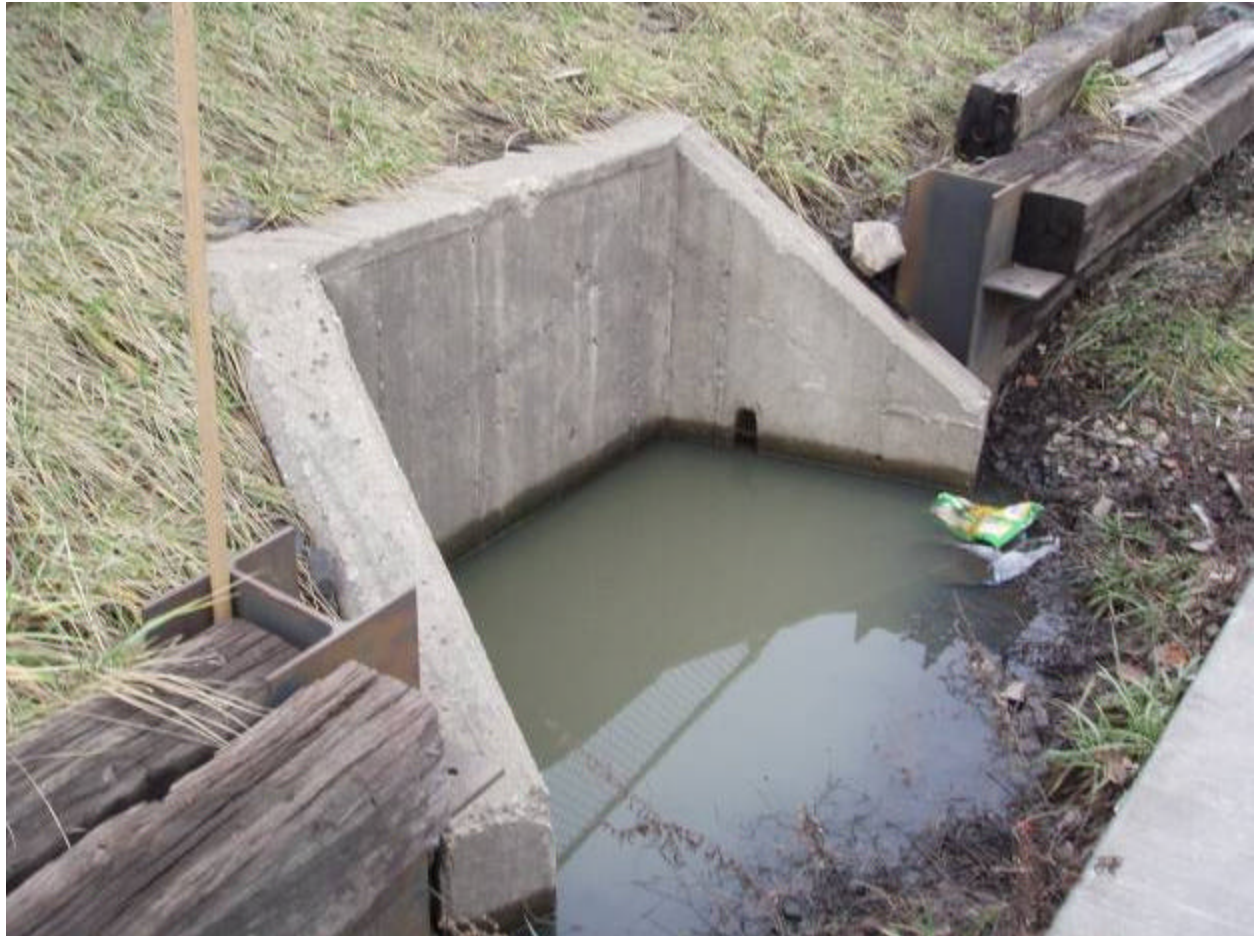
Headwalls were found during the inspection. The tide gate can not be found due to stagnant water around the structures.

**Photo 1 Description:** Location of possible submersed tide gate

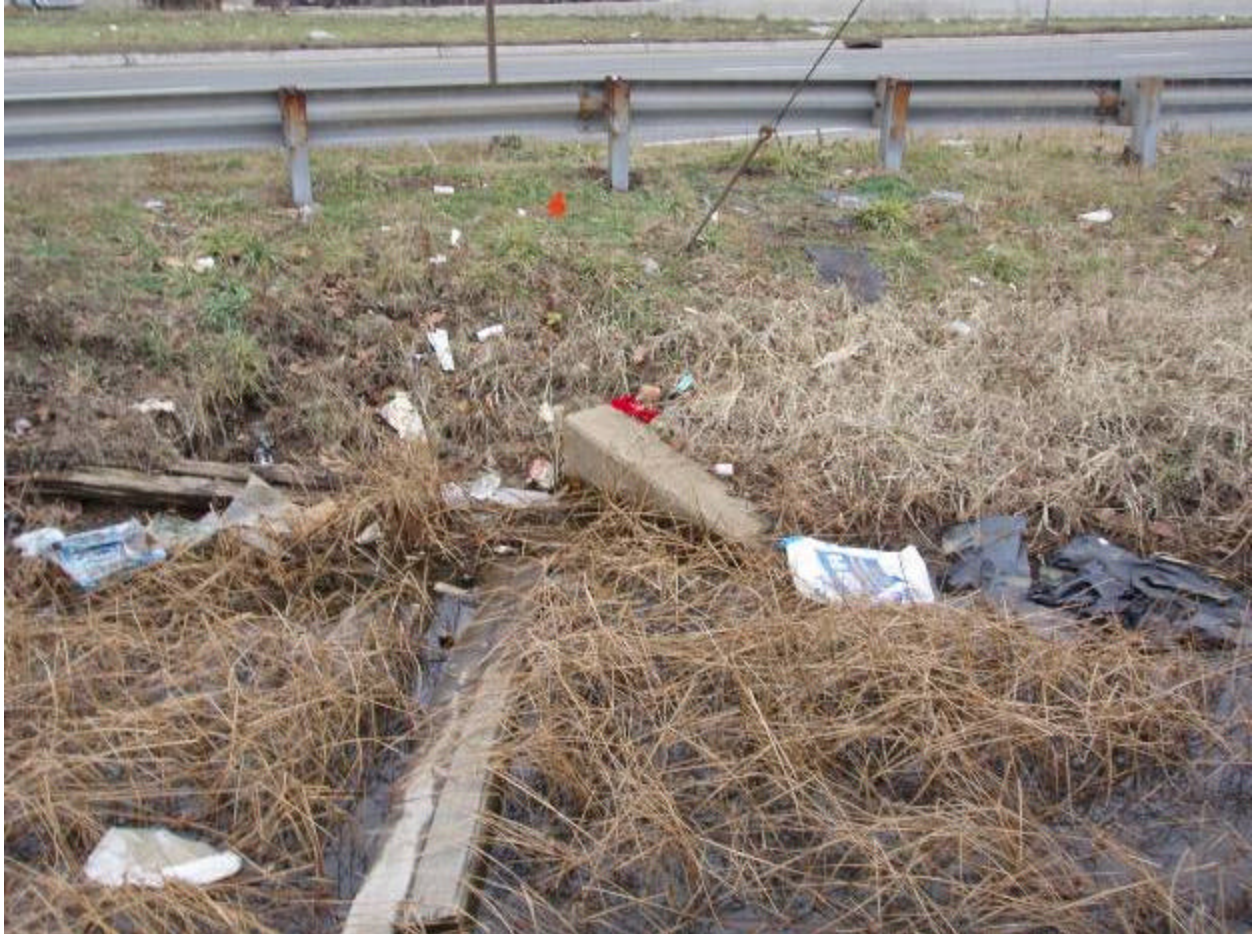
**Photo 2 Description:** Possible location of a old tide gate
