# **Hackensack Meadowlands Tide Gates Inspection Report**

**The National Flood Insurance Program  
Community Rating System**

**The New Jersey Meadowlands Commission  
One DeKorte Park Plaza  
Lyndhurst, New Jersey**

**March 27, 2006**

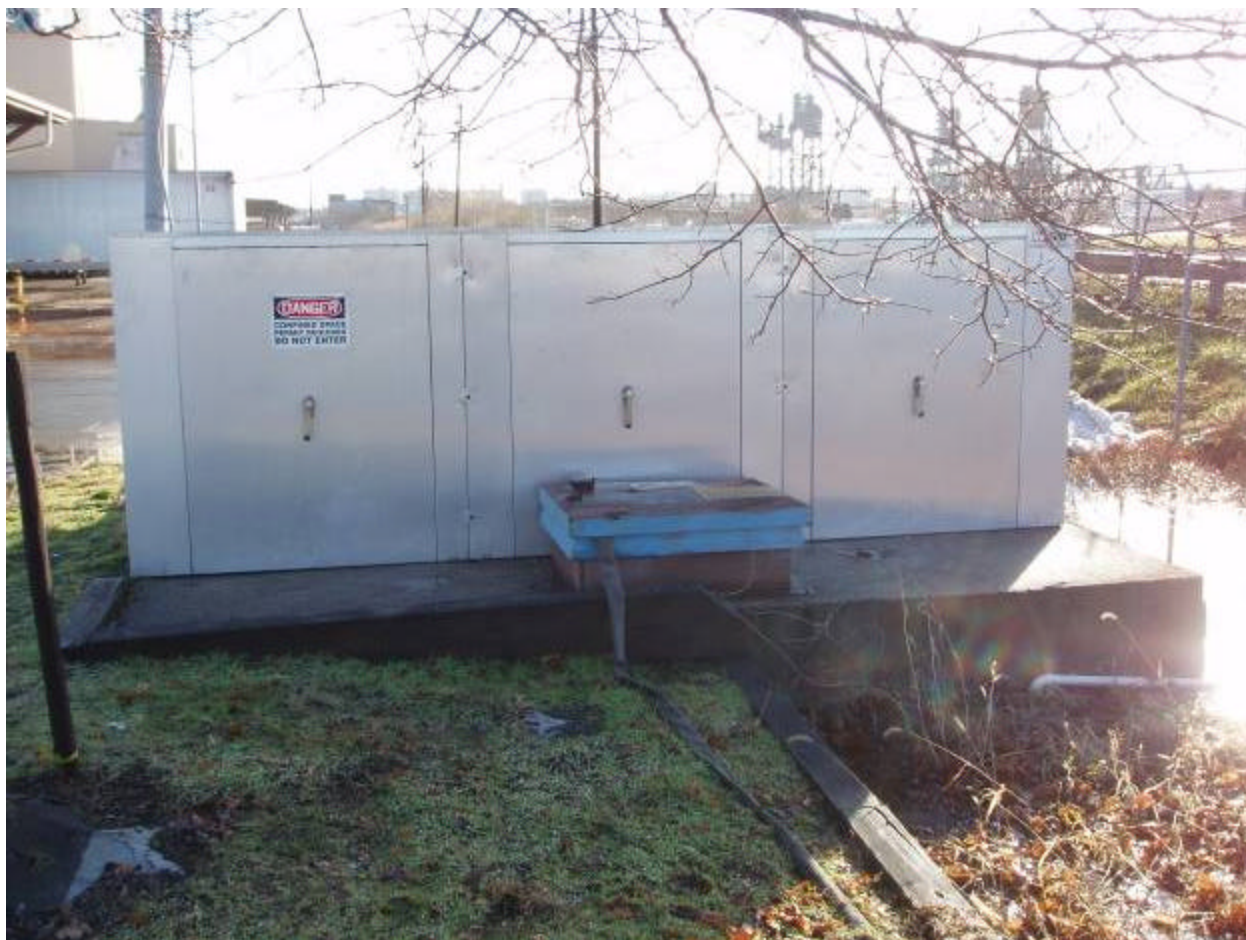
**Photo 1 Description: Sump pump system**

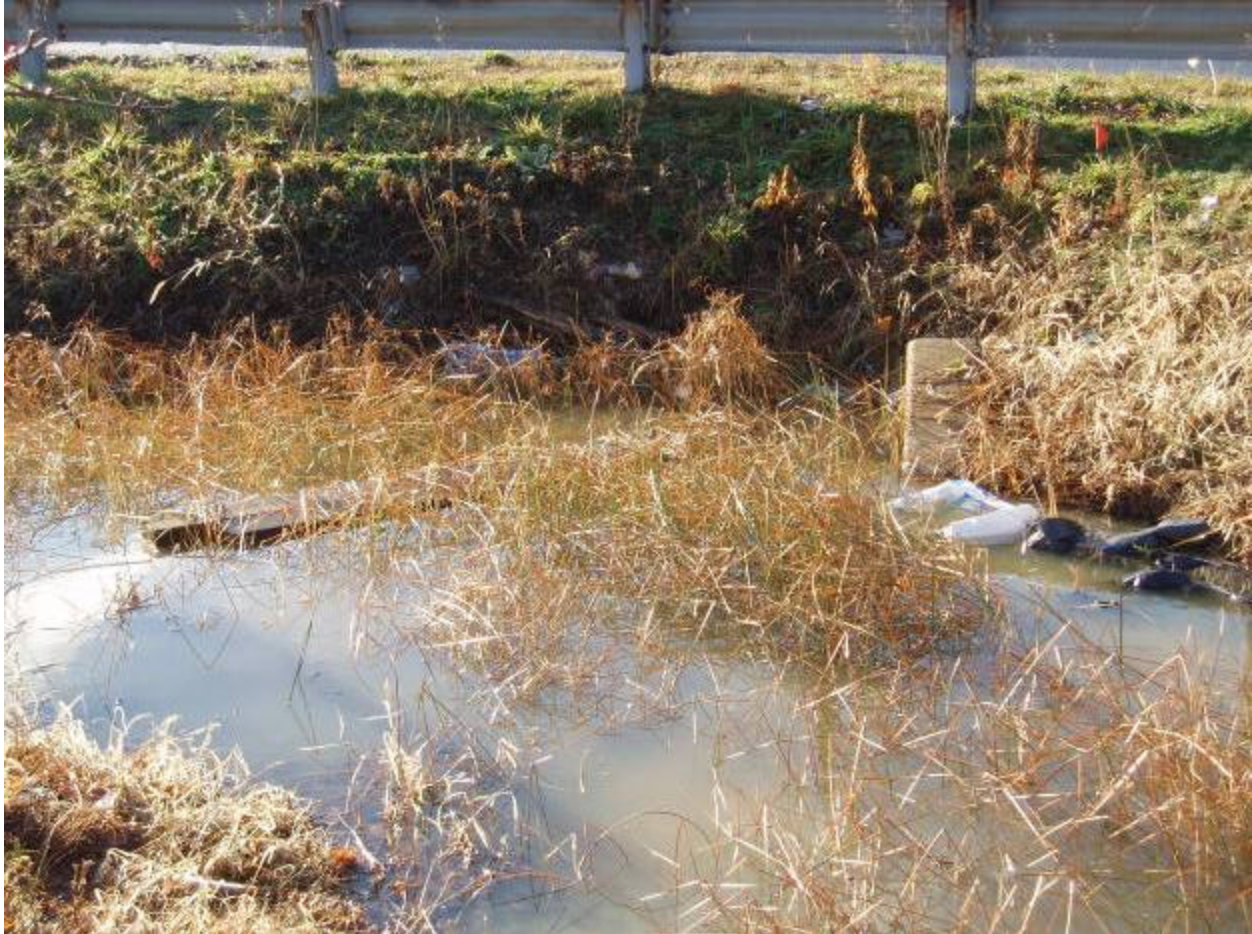
**Photo 2 Description: Location of old headwall**

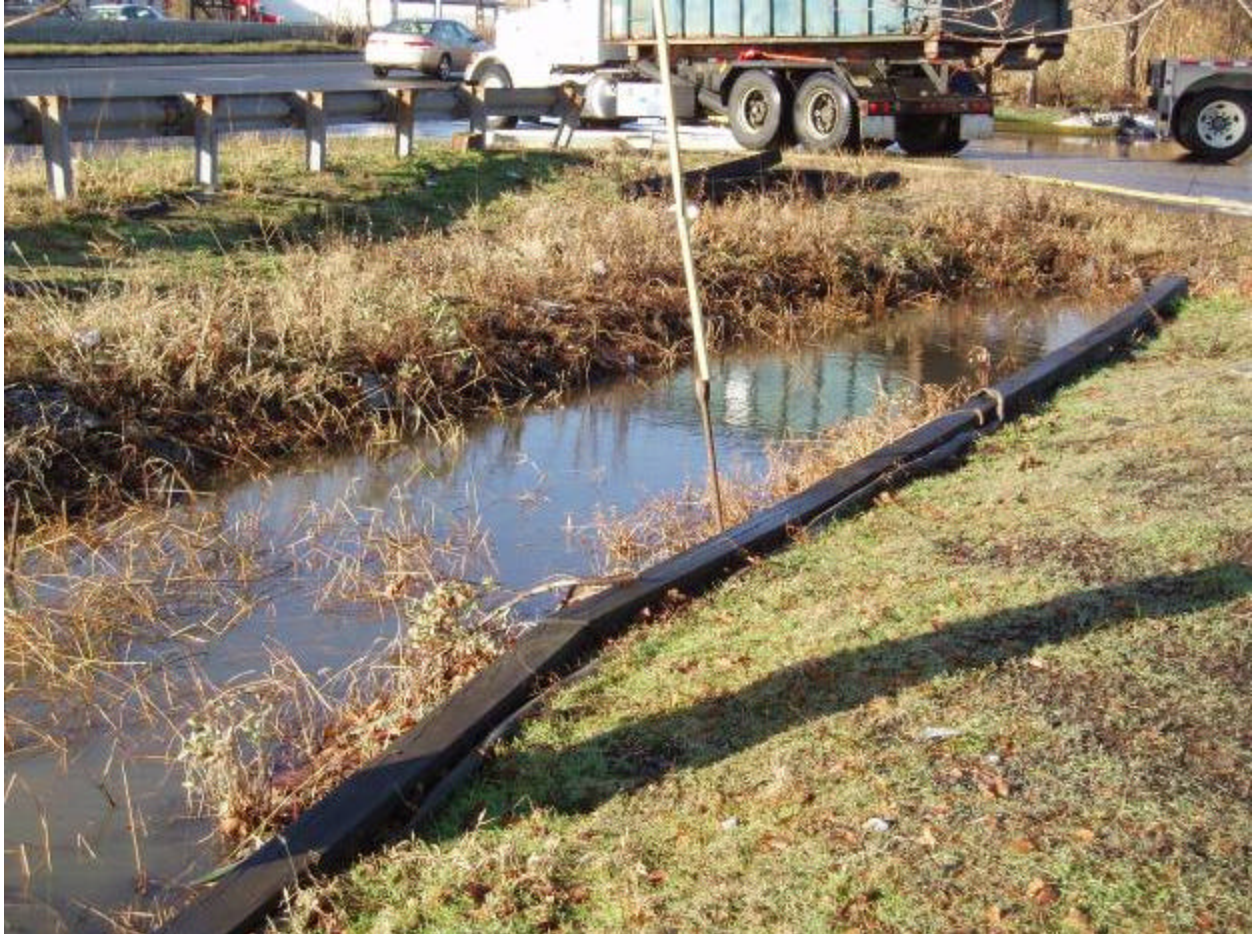
**Photo 3 Description: Possible location of tide gate**

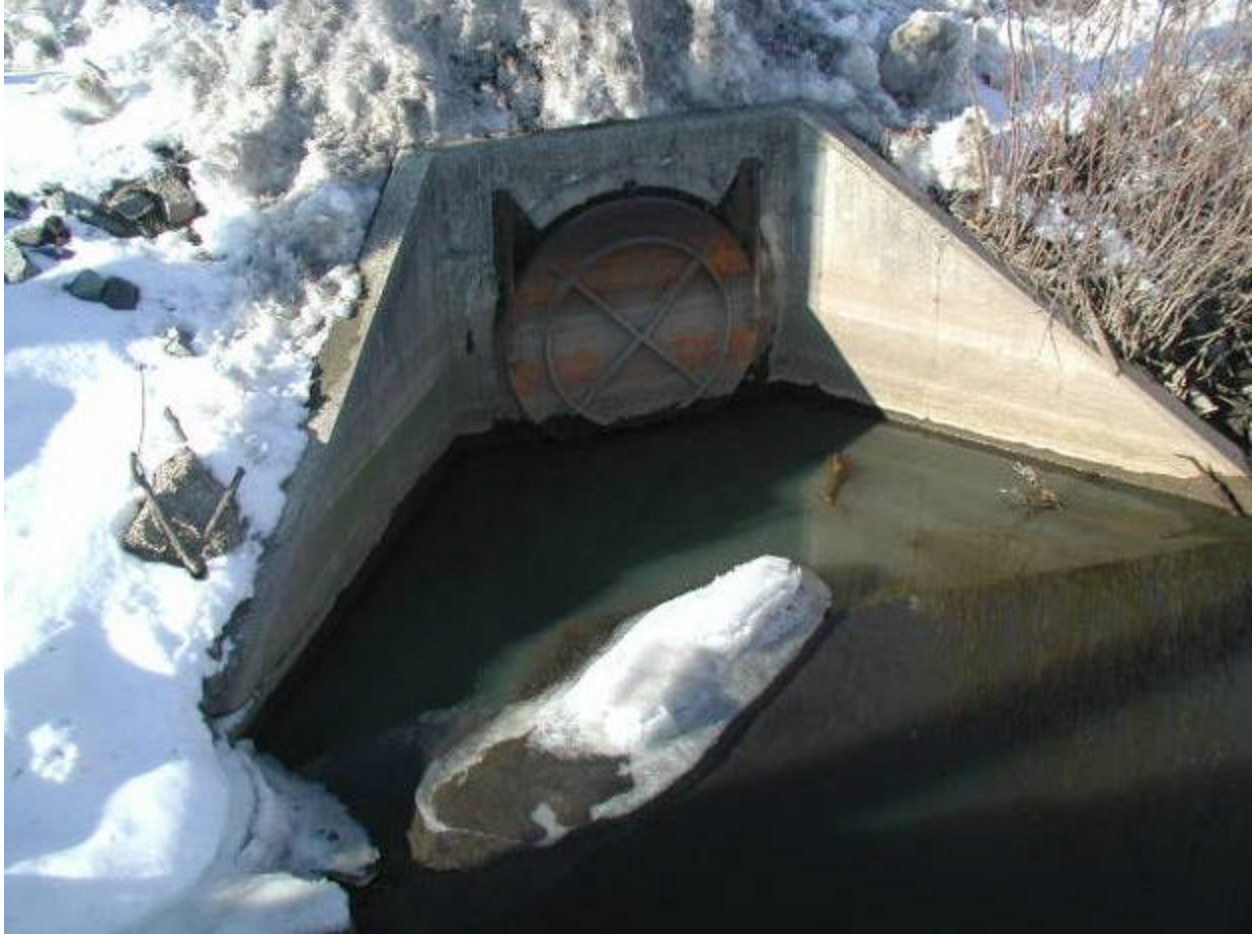
**Photo 1 Description: Metal flap gate**

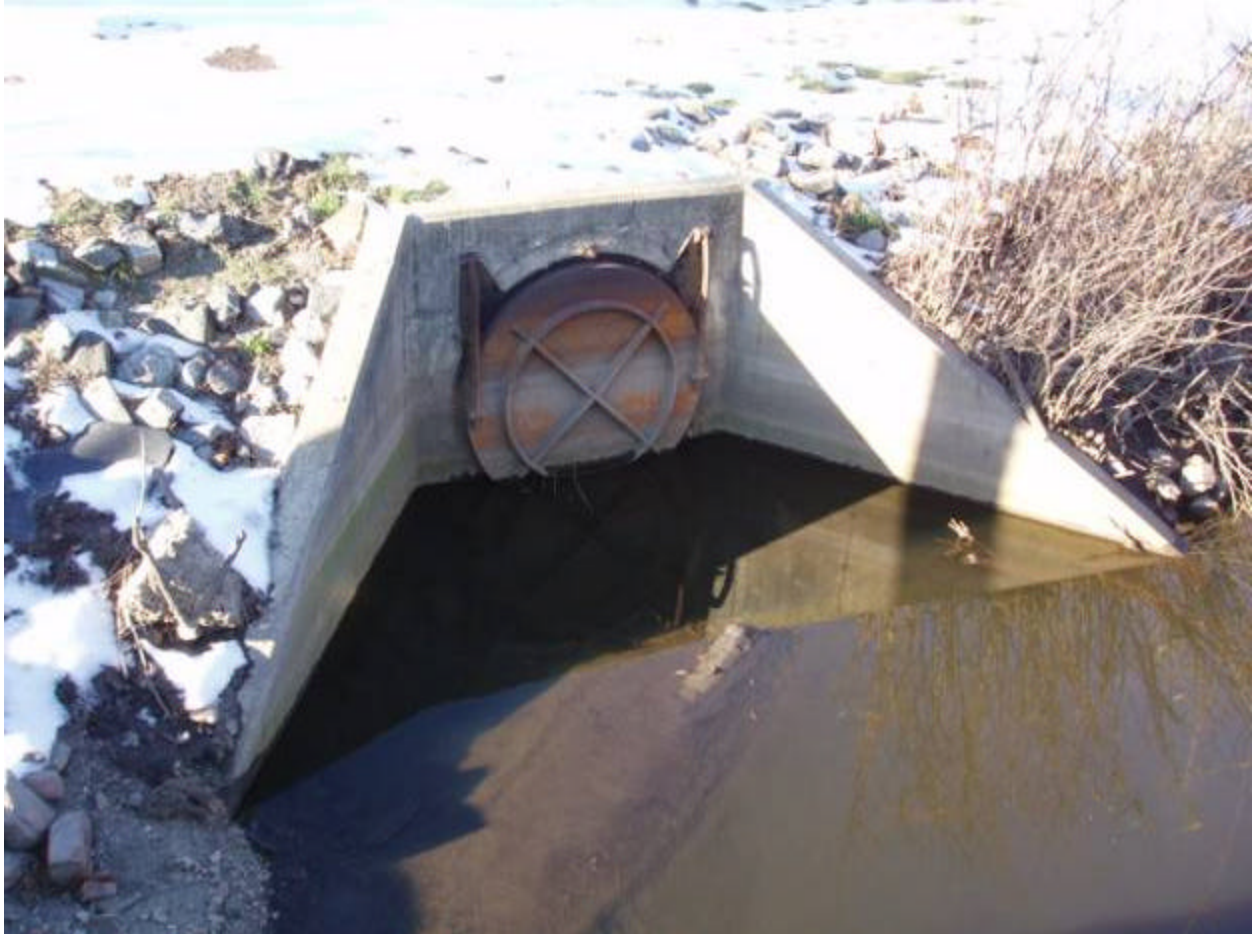
**Photo 1 Description: Metal flap gate**

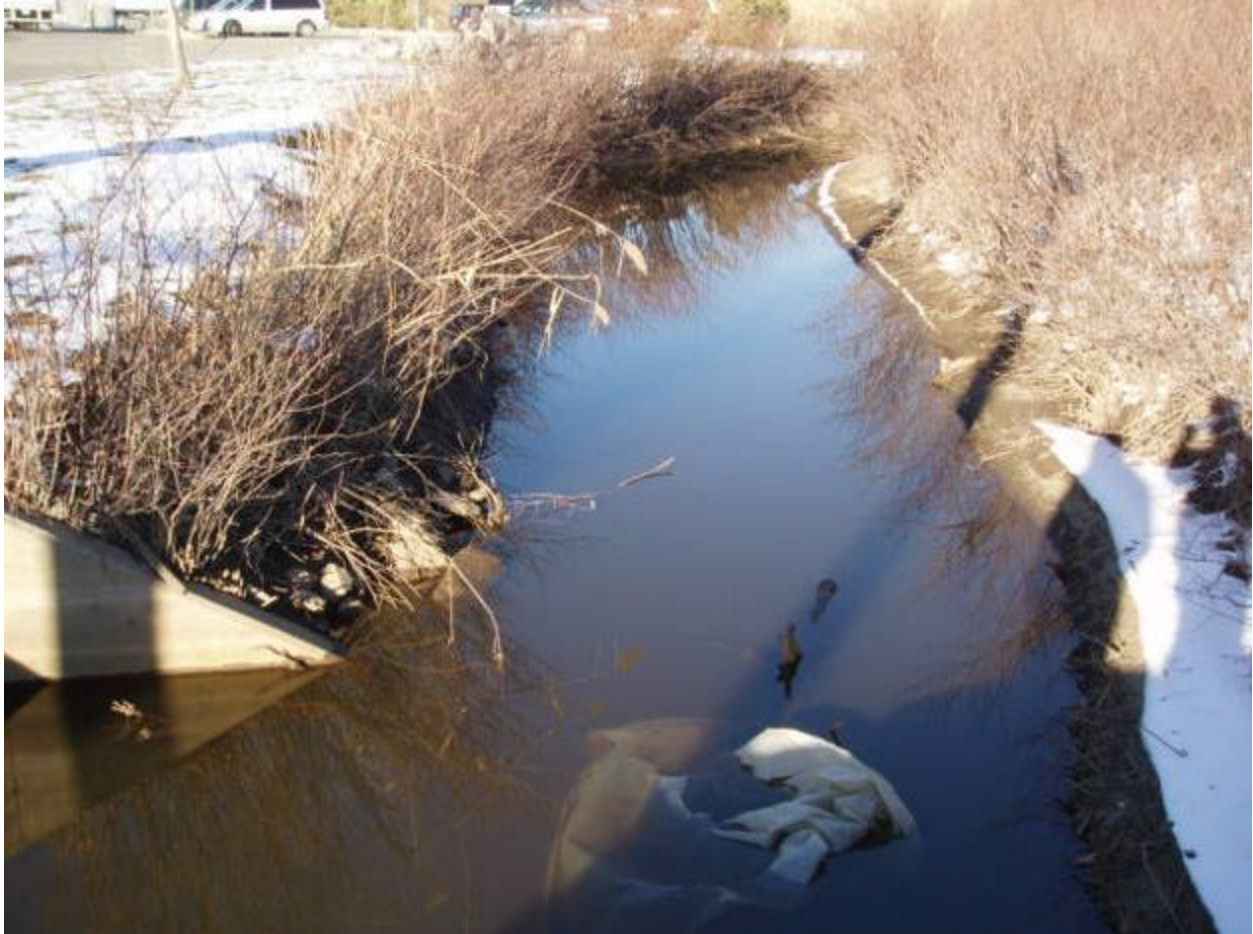
**Photo 2 Description:** Upstream view from the tide gate

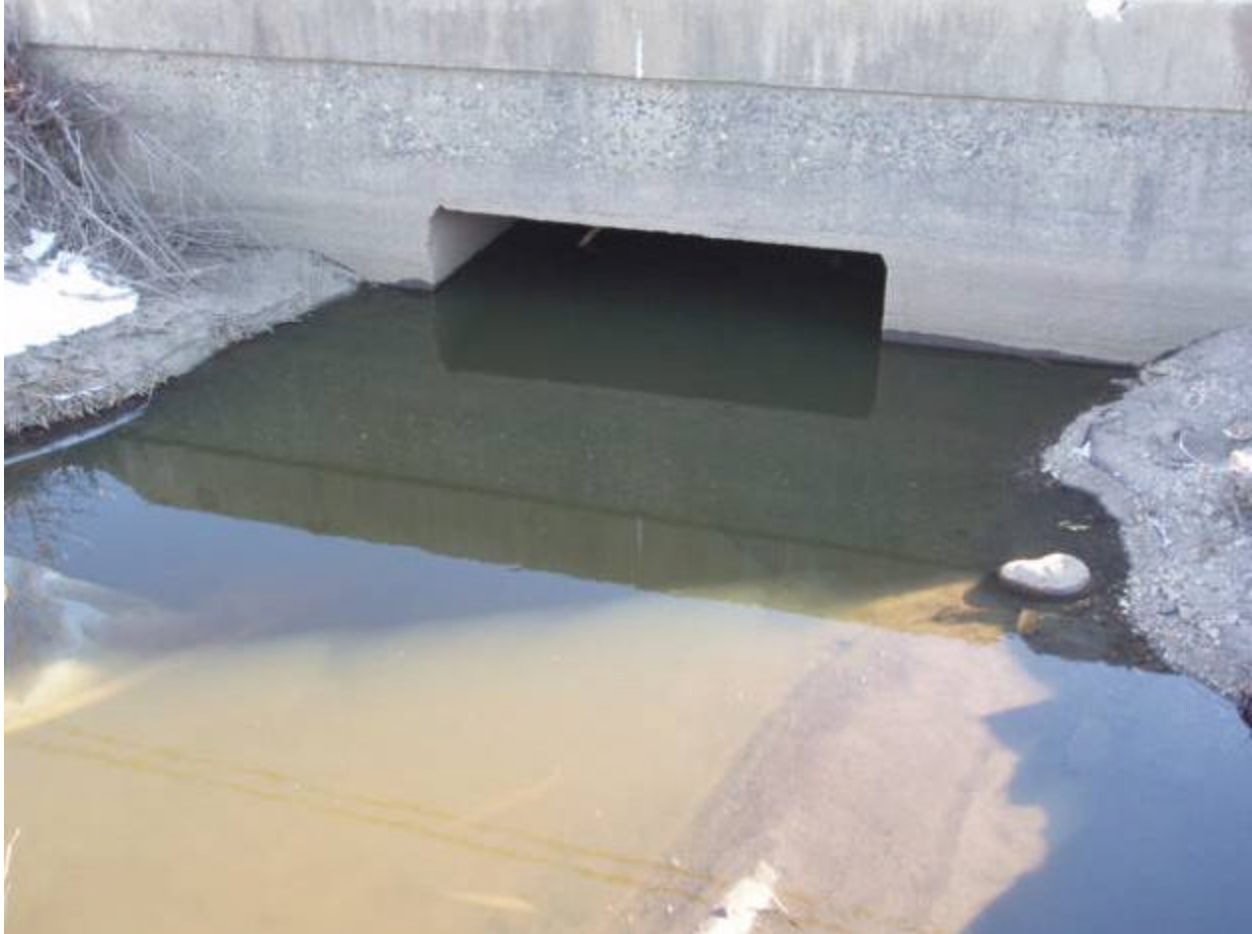
**Photo 3 Description:** Box culvert downstream from gate

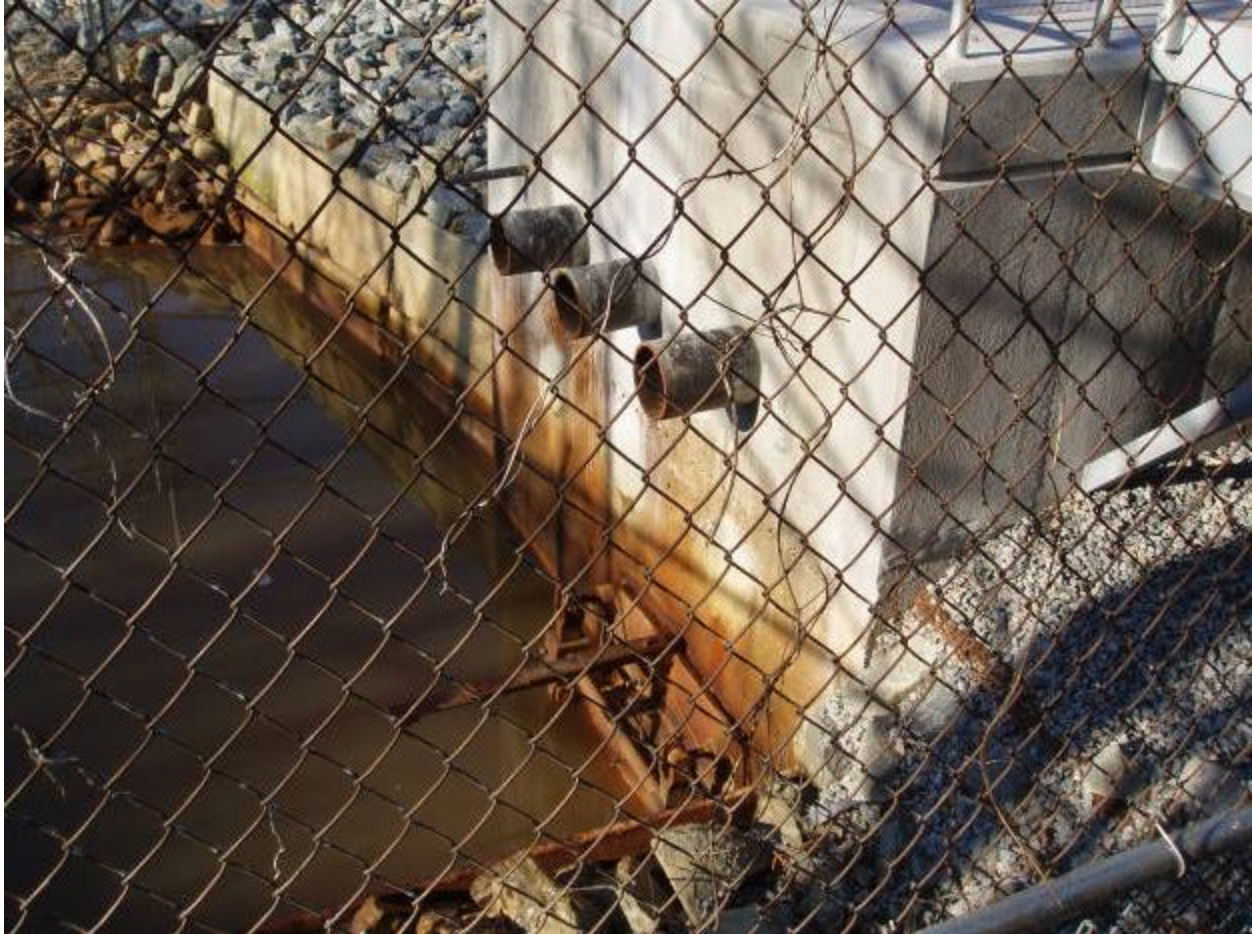
**Photo 1 Description:** View of tide gate and the outlet pipes for the pump station

Make sure that the debris is routinely removed. Install aerator system per DPW recommendation.

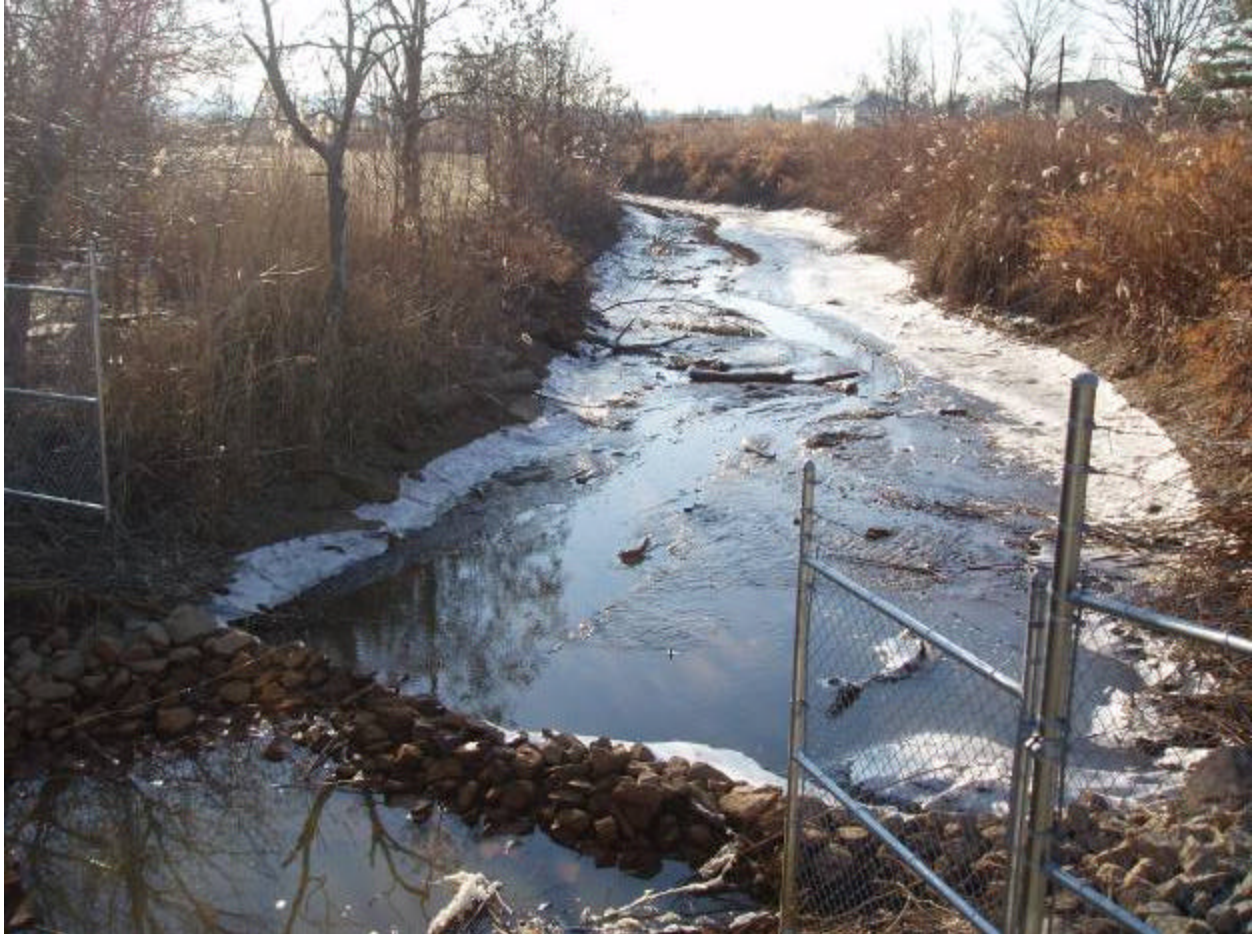
**Photo 2 Description: Downstream view from the pump station**

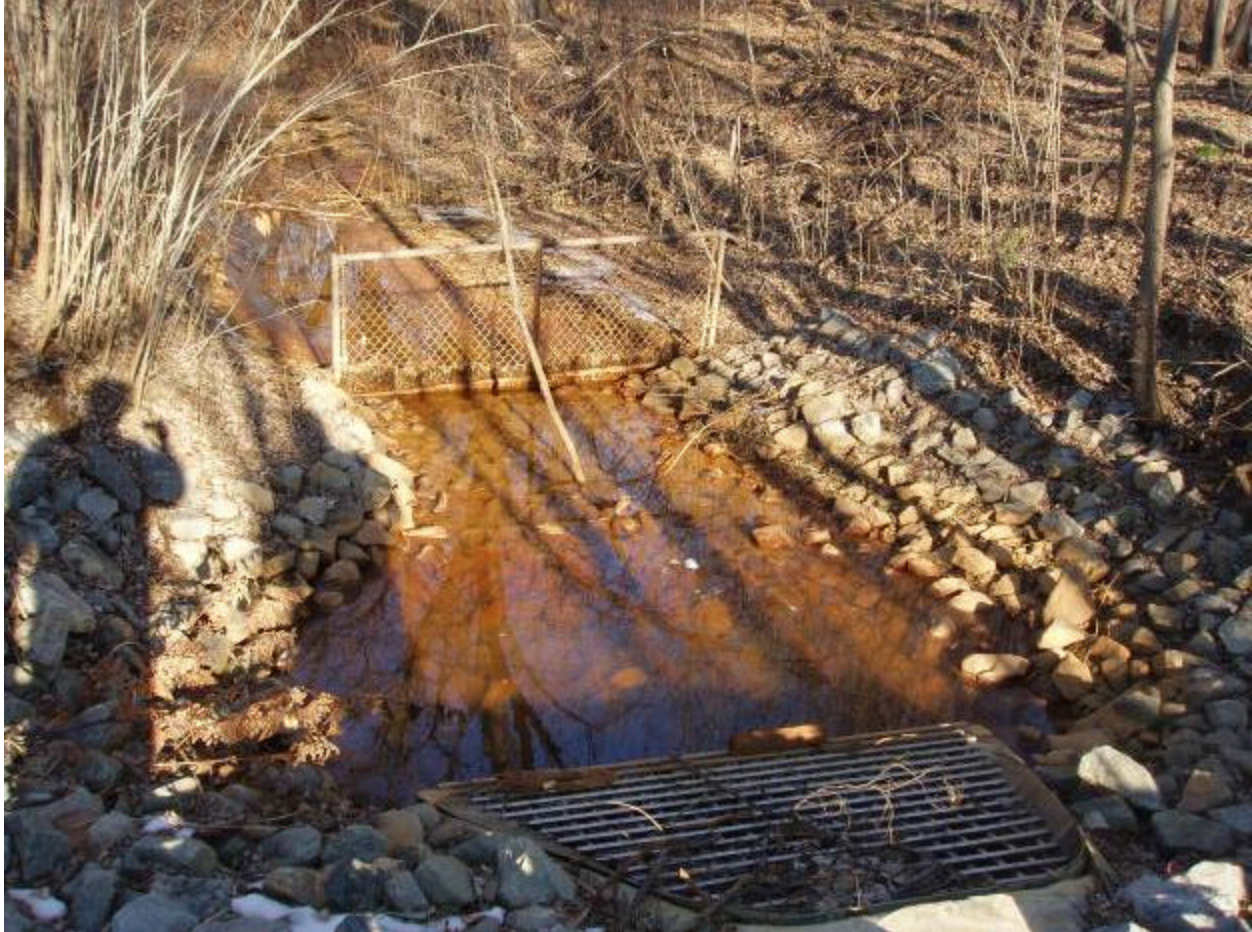
**Photo 3 Description:** Upstream view from pump station

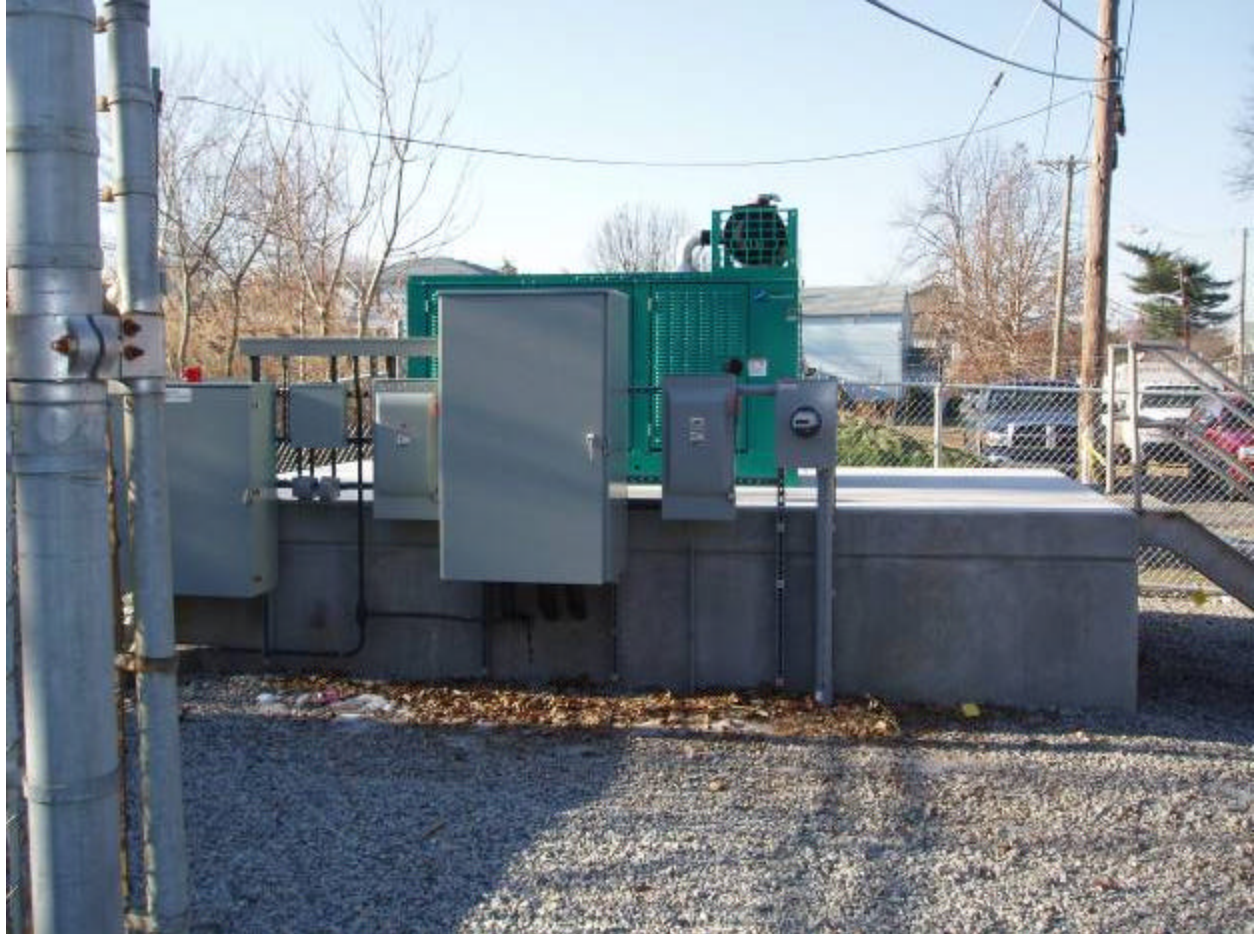
**Photo 4 Description: View of generator system**

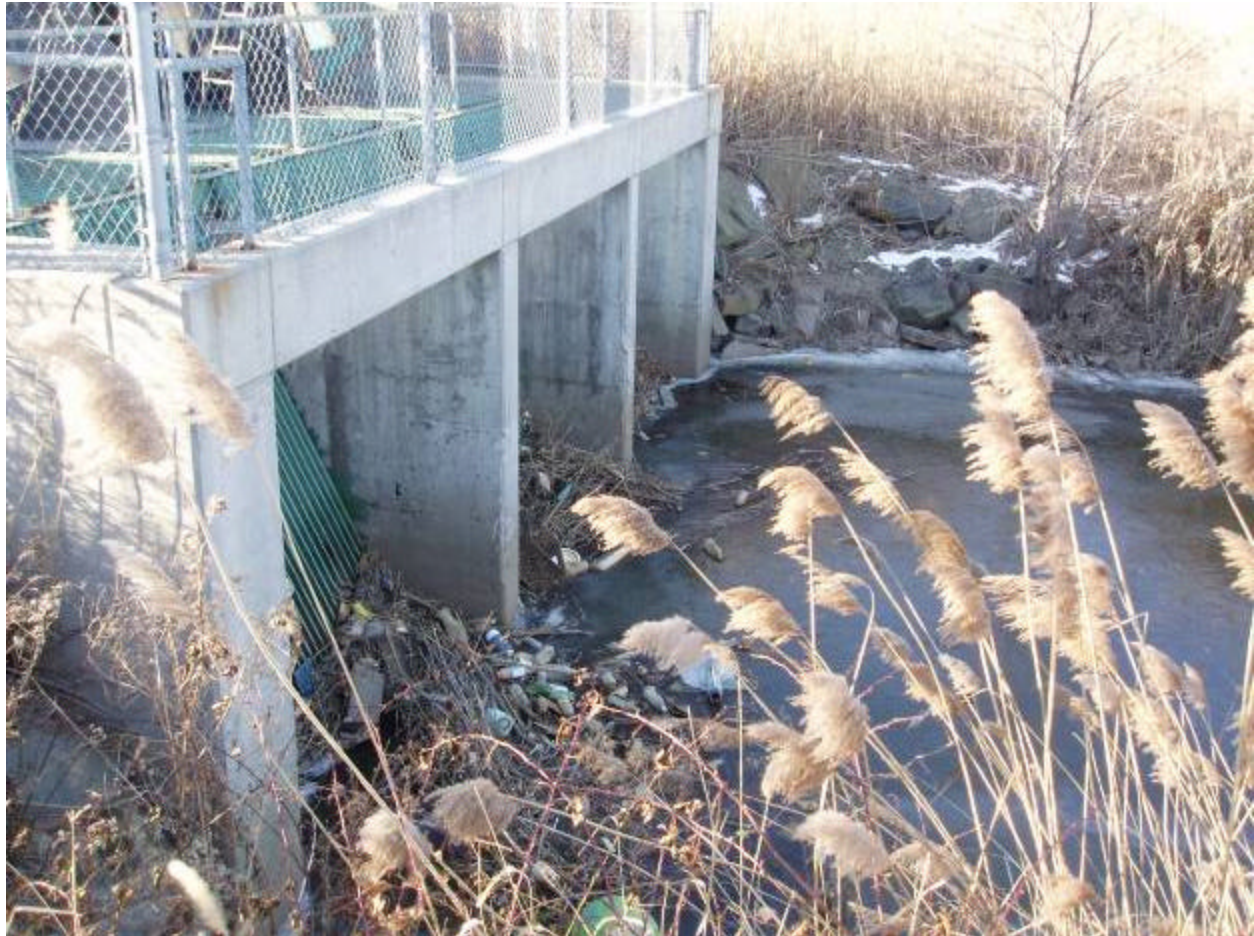
**Photo 1 Description:** View of trash racks at in-take structure

Drainage ditch needs to be cleaned out. The gates need cleaning and repairs made. Gates are timber and in the future may need to be replaced. A trash rack system also needs to be installed to keep debris out of the tide gates. The metal access walkway appears to be deteriorating and needs to be cleaned and repainted.

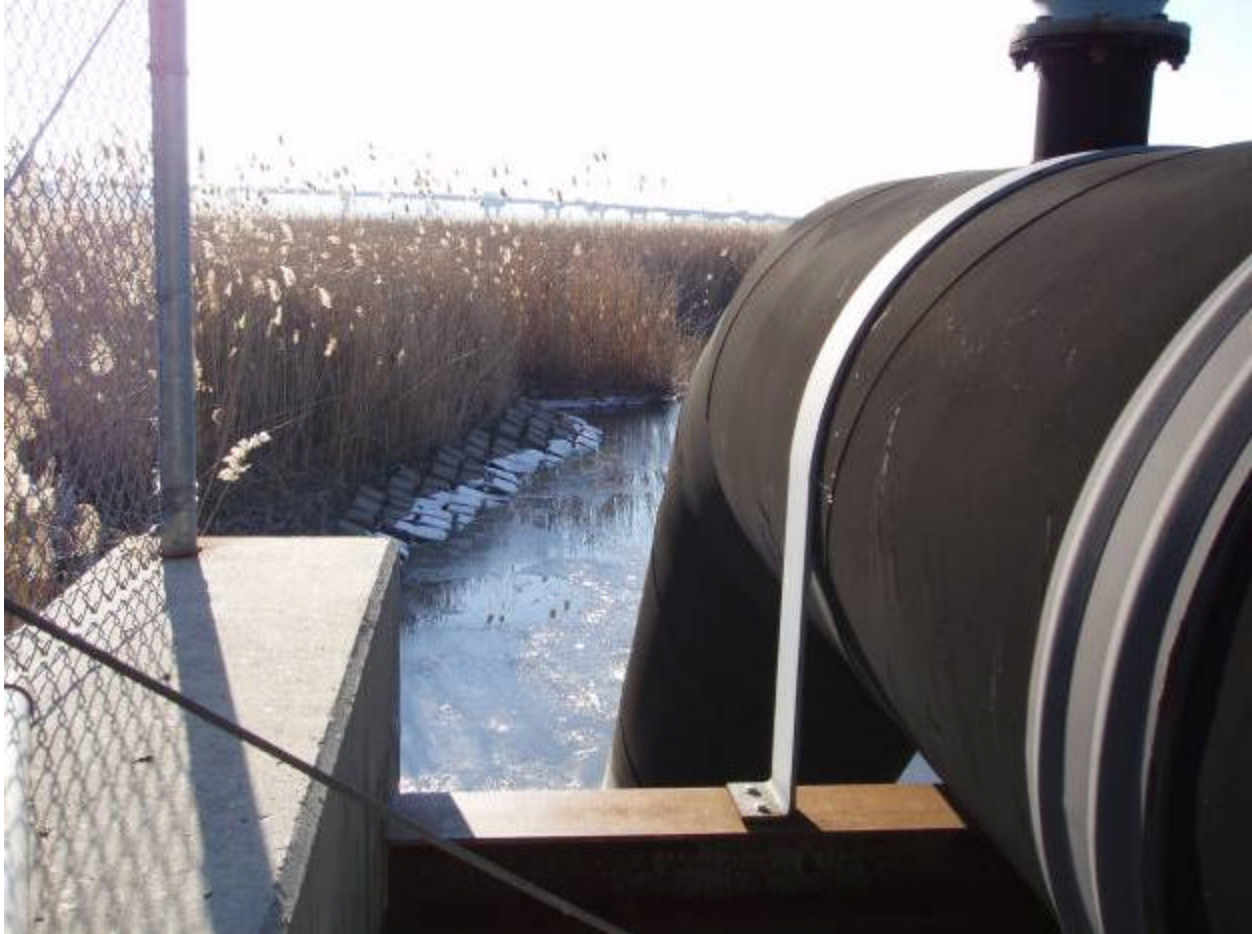
**Photo 2 Description:** Looking downstream at pump system

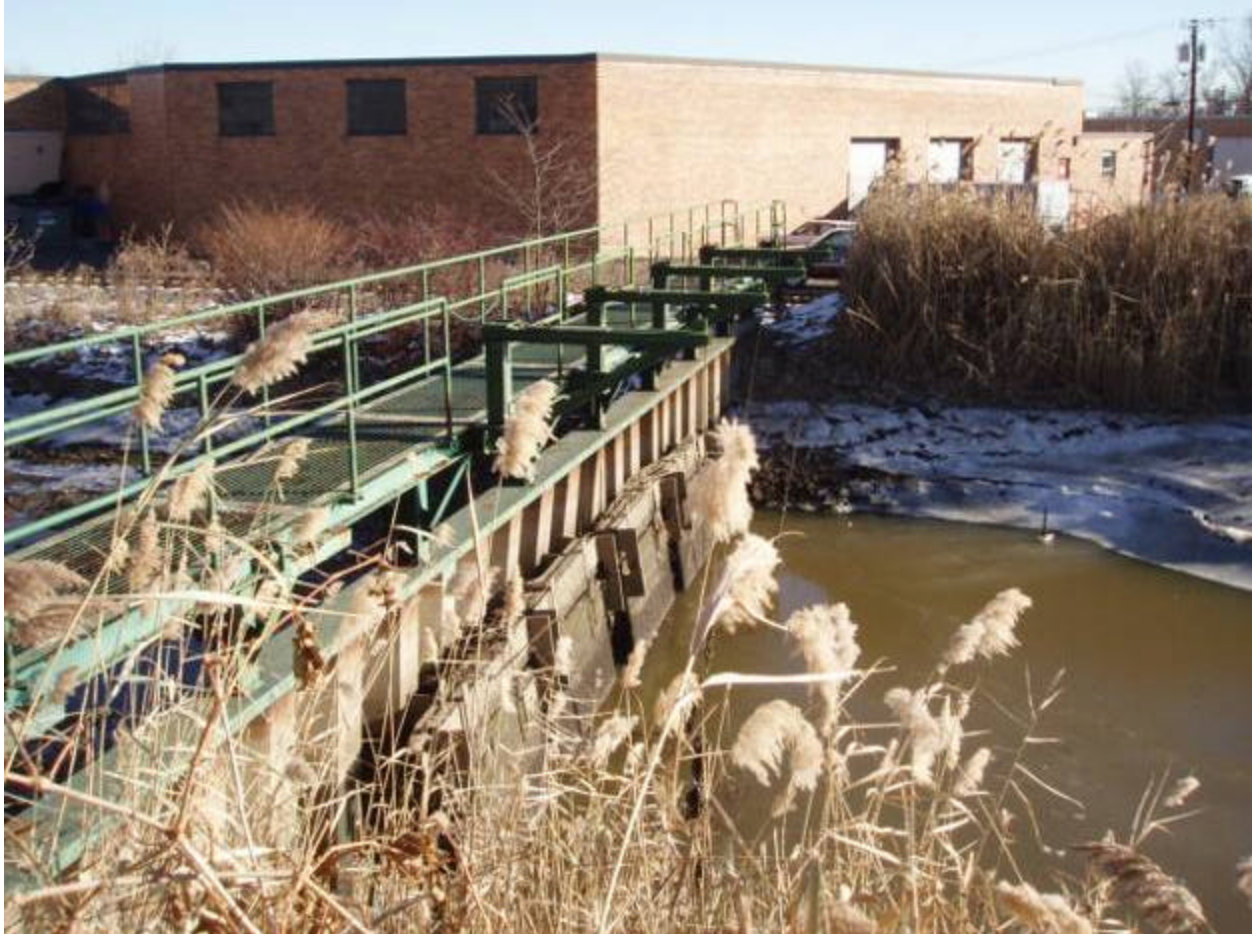
**Photo 1 Description: 4 timber tide gates**

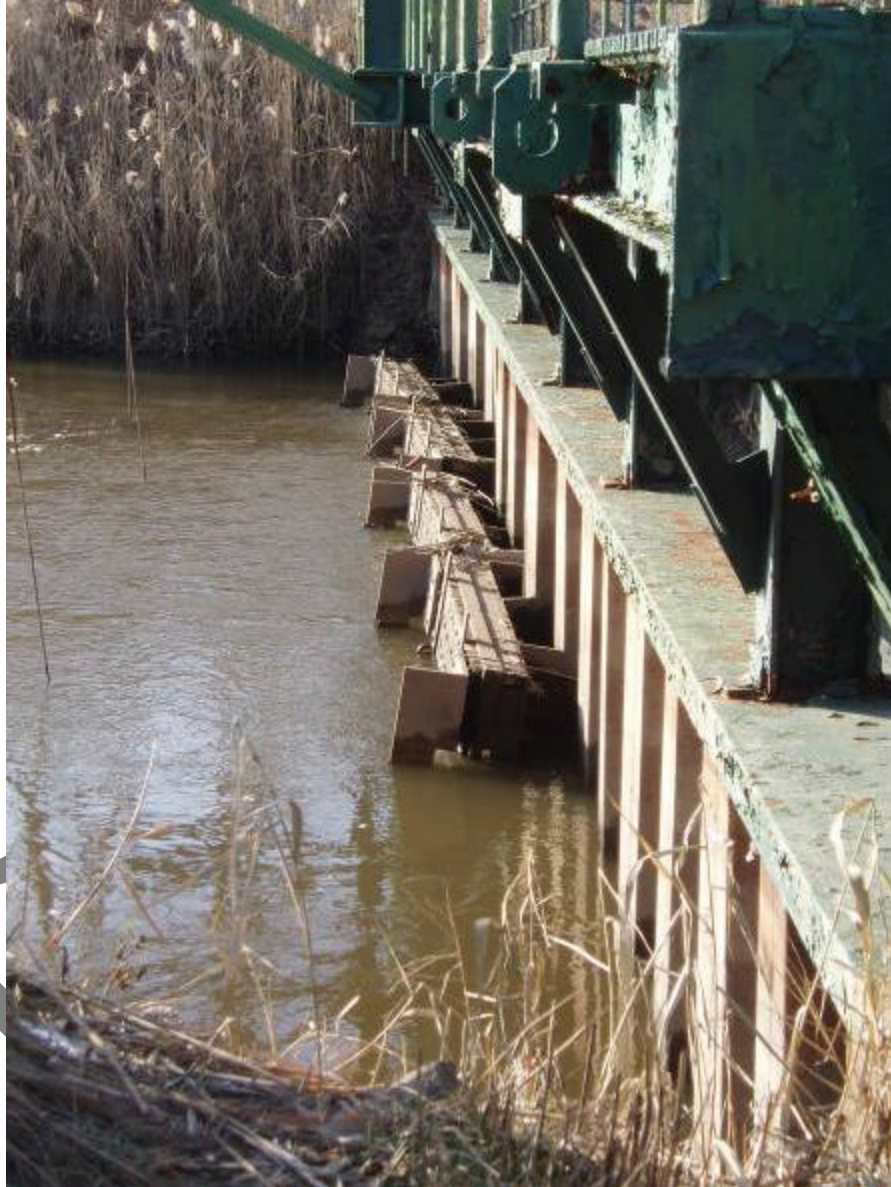
Tide gates are not seating properly. Maintenance needs to be performed on the gates. The gates foundation is also being undermined.

**Photo 1 Description: 4 timber tide gates**

Routine cleaning will help keep the gates operating properly. Gates may need to be replaced with metal flap gates in the future, currently they are timber. A trash rack system would also help to alleviate the collection of debris.

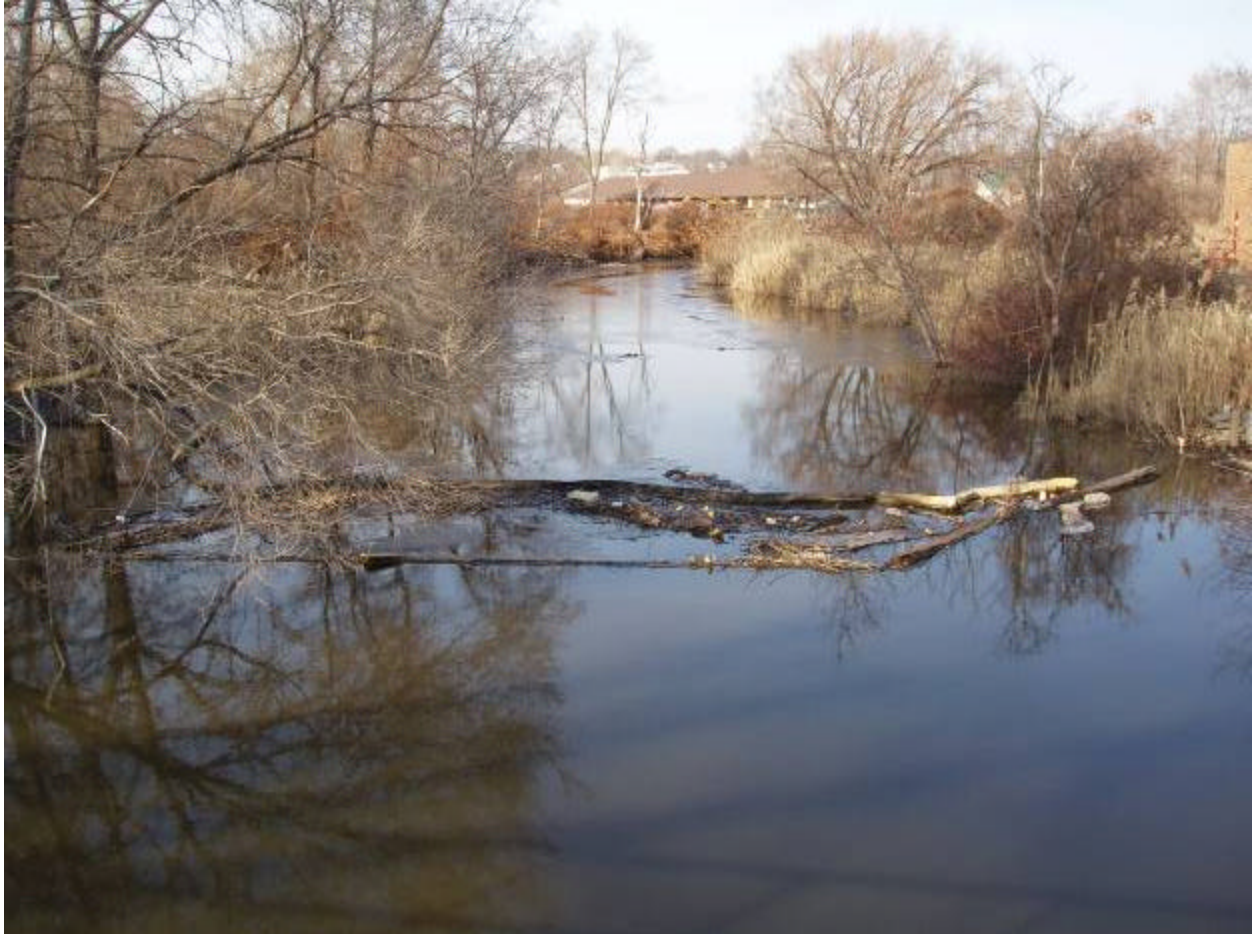
**Photo 2 Description:** Upstream view of trash rack system

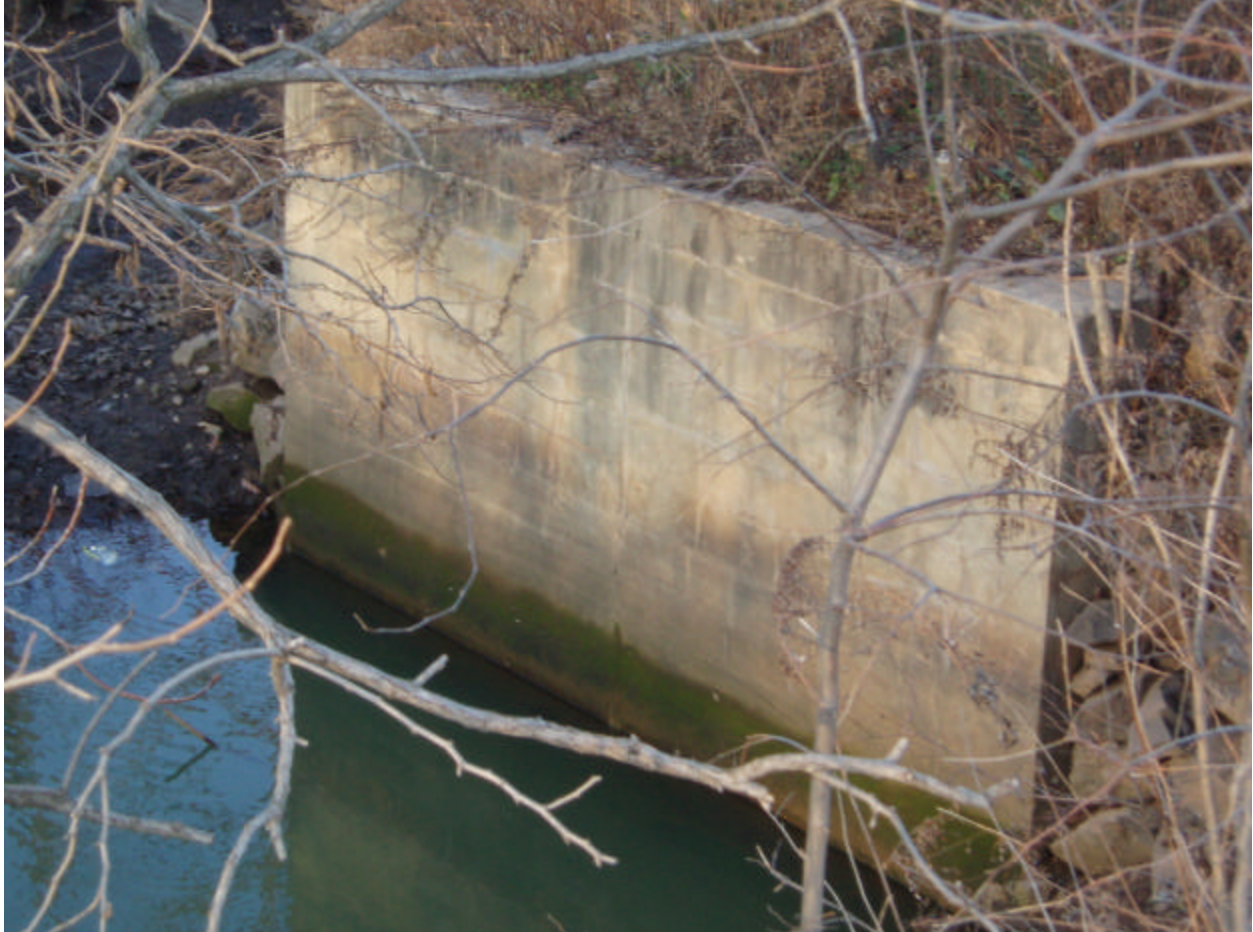
**Photo 1 Description:** Location of removed tide gates

Tide gate was removed according to a microstation drawing file from Army Corps of Engineers. This information could not be verified during high tide conditions.

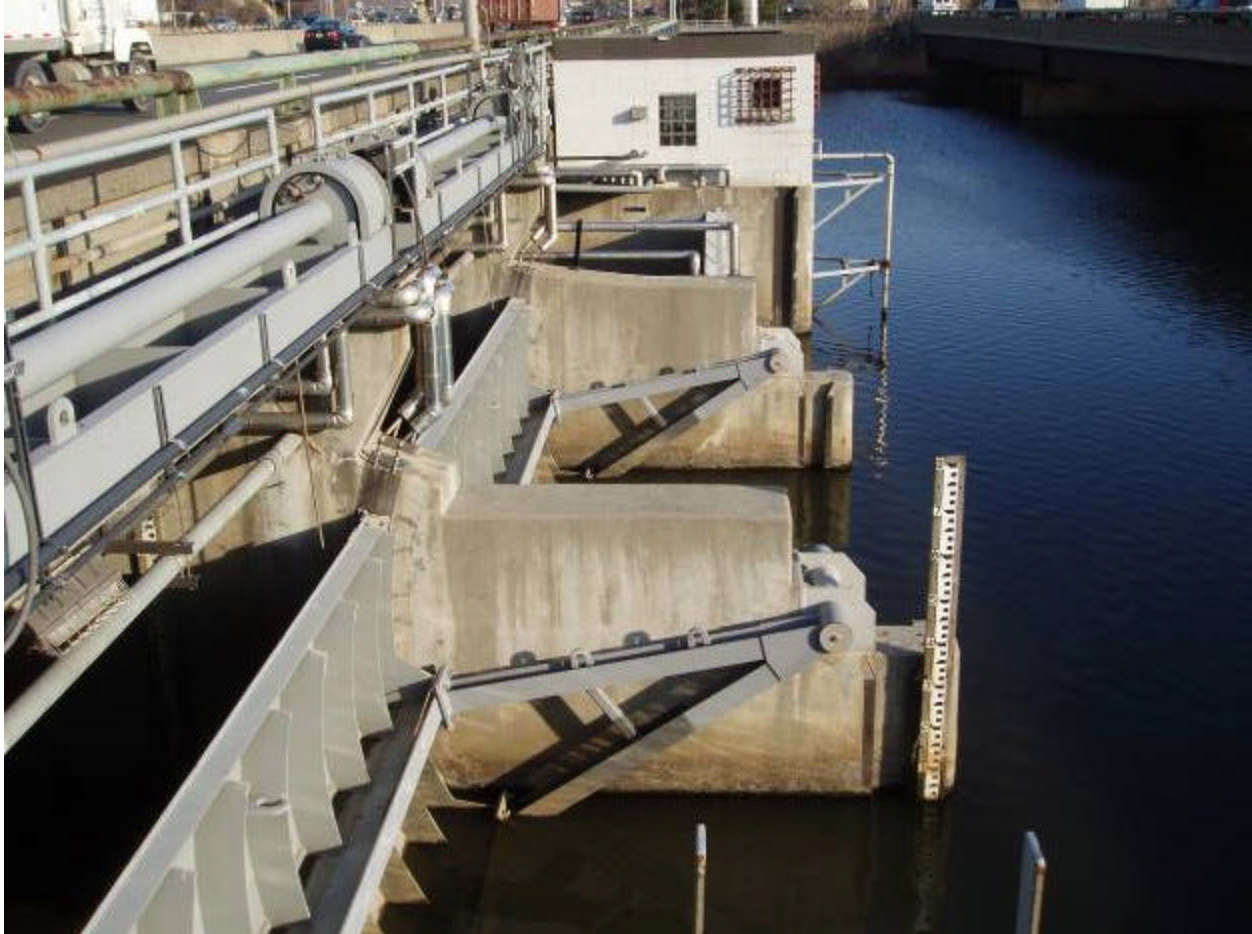
The system is in excellent condition.

**Photo 1 Description: View of the tide gates**

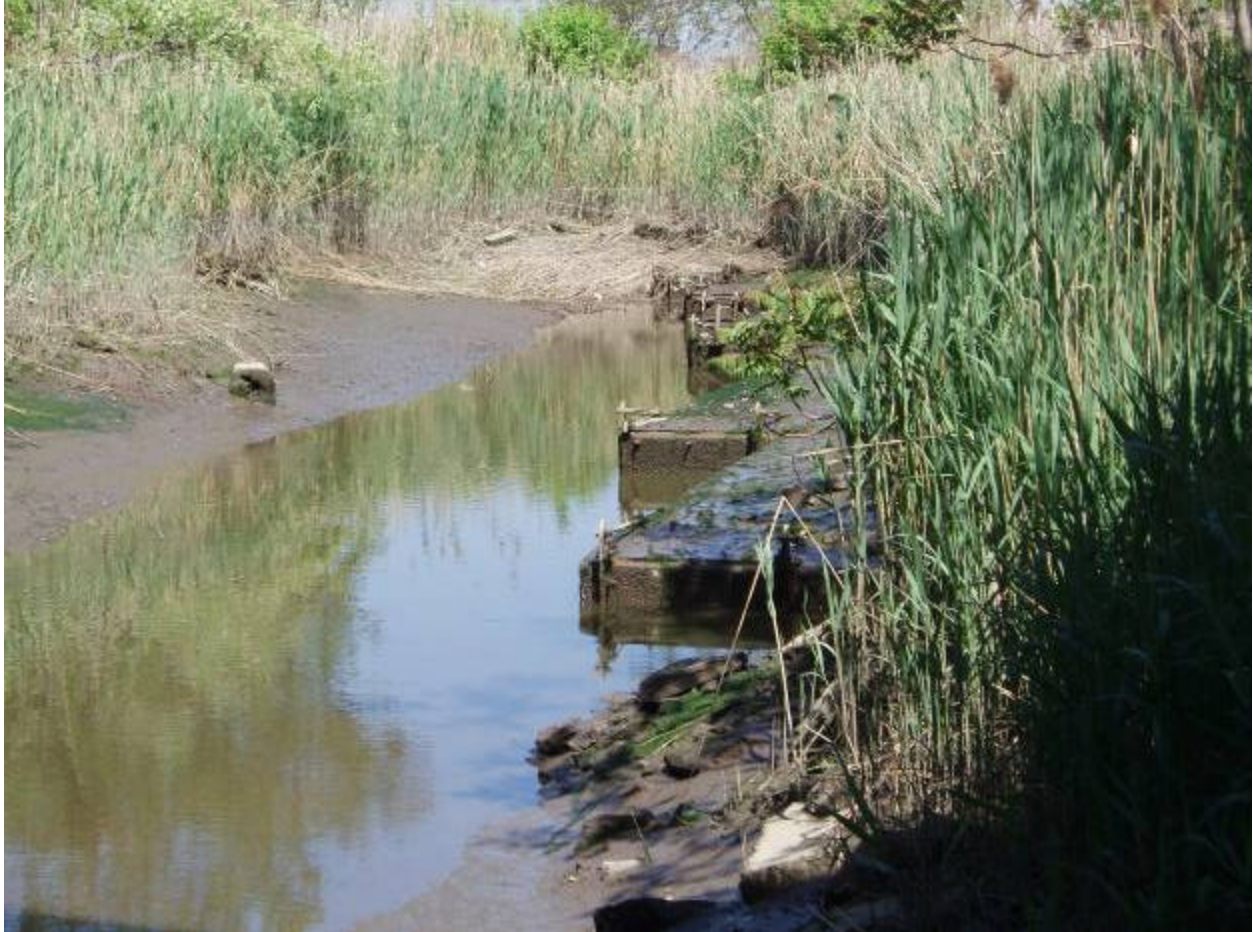
Water continues to seep through the gates and enter the upstream system. Of the five original designed 3 foot pipes, only three are functional and they are partially silted with their flap gates in varying degrees of damage. Two of the flap gates (culvert no. 4 and 5) have been welded closed.

**Photo 1 Description: View of tide gates**
