# **Hackensack Meadowlands Tide Gates Inspection Report**

**The National Flood Insurance Program  
Community Rating System**

**The New Jersey Meadowlands Commission  
One DeKorte Park Plaza  
Lyndhurst, New Jersey**

**March 27, 2006**

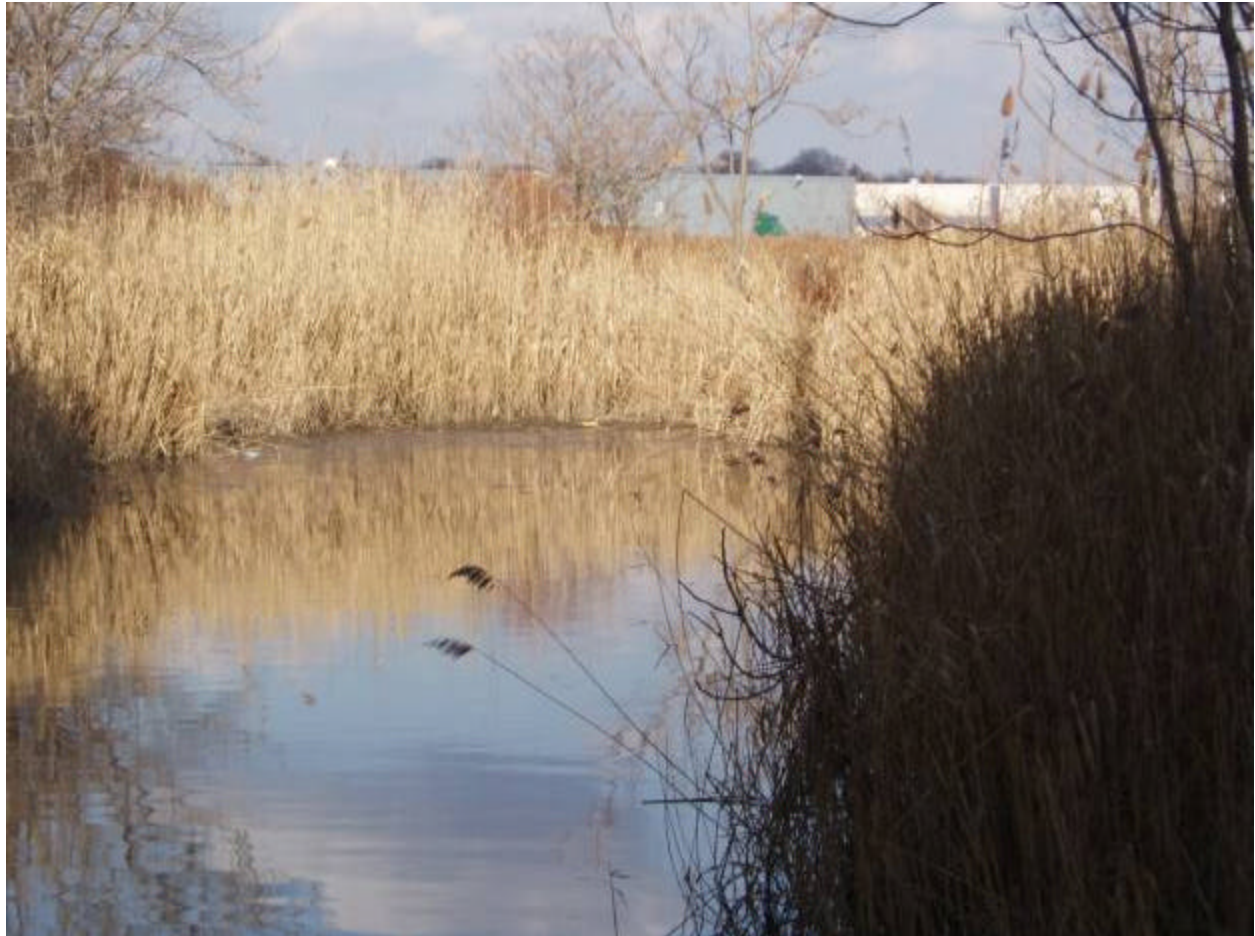
Water continues to seep through the gates and enter the upstream system. Of the five original designed 3 foot pipes, only three are functional and they are partially silted with their flap gates in varying degrees of damage. Two of the flap gates (culvert no. 4 and 5) have been welded closed.

**Photo 1 Description: Location of the tide gates**

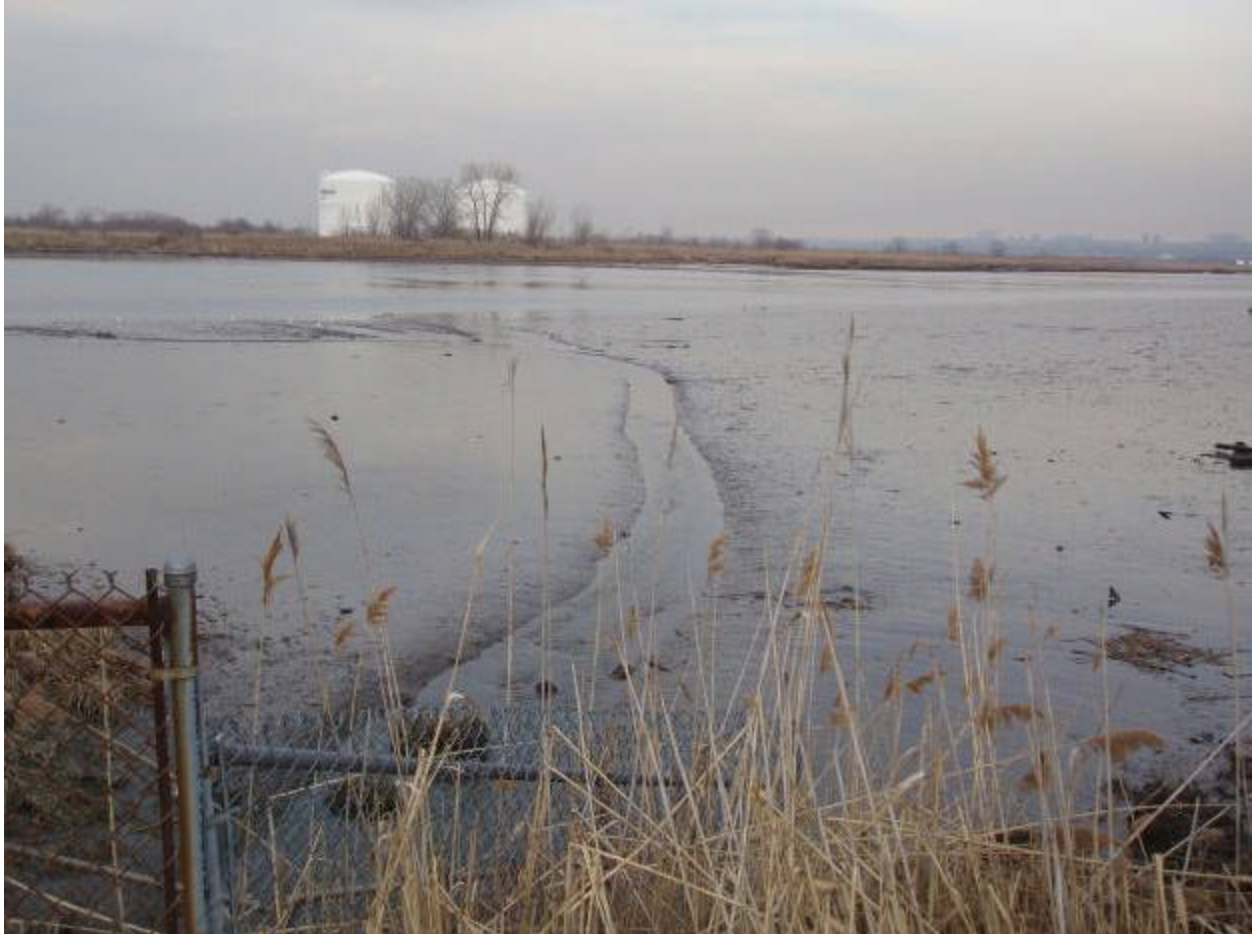
Tide gate appears to be in good condition and functioning properly.

**Photo 1 Description:** Downstream view from the tide gate

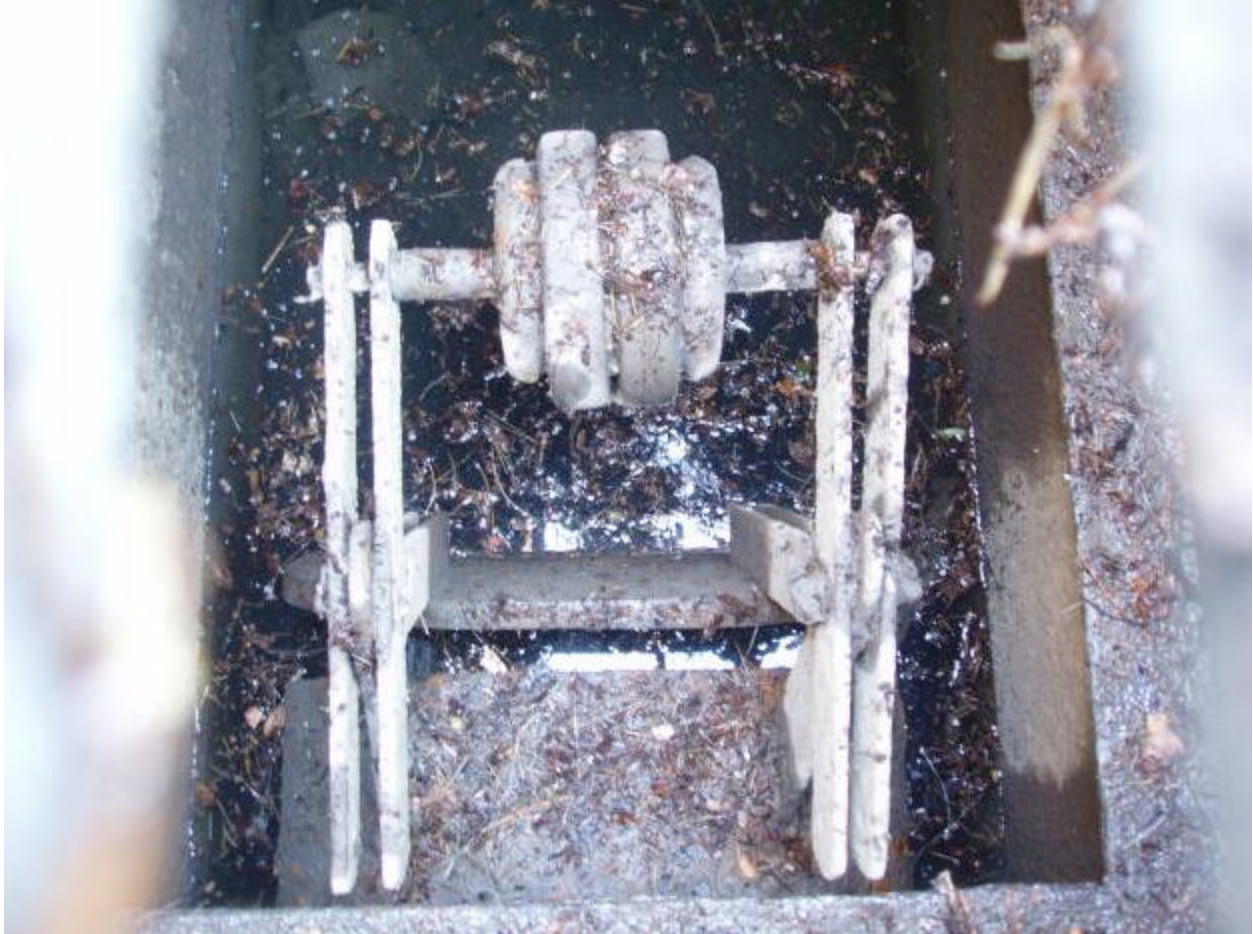
**Photo 2 Description:** View of metal flap gate

Gated access needs to be added at this location. The chamber in which the gates are housed needs to be cleaned out and repaired.

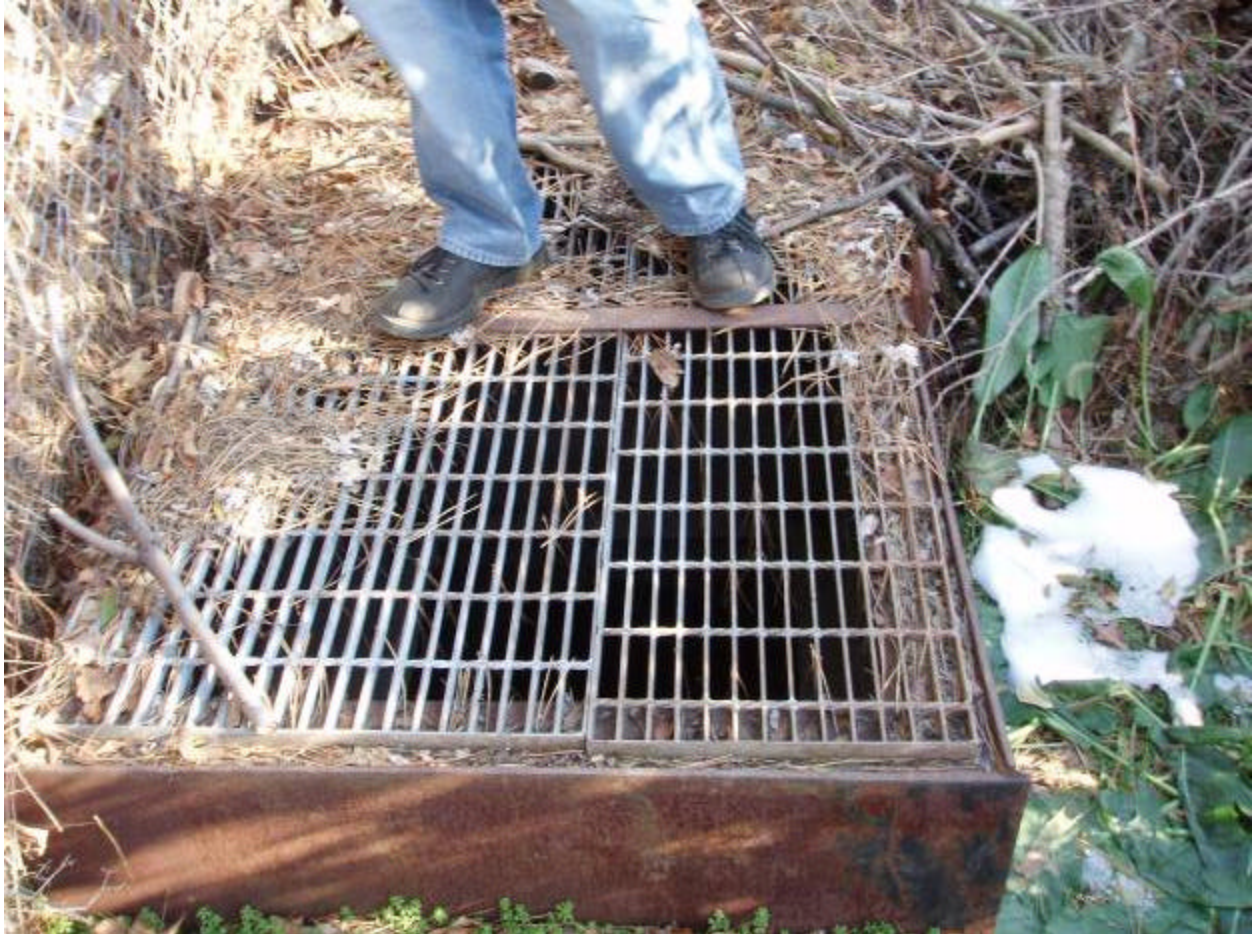
**Photo 3 Description: View of tide gate chamber**

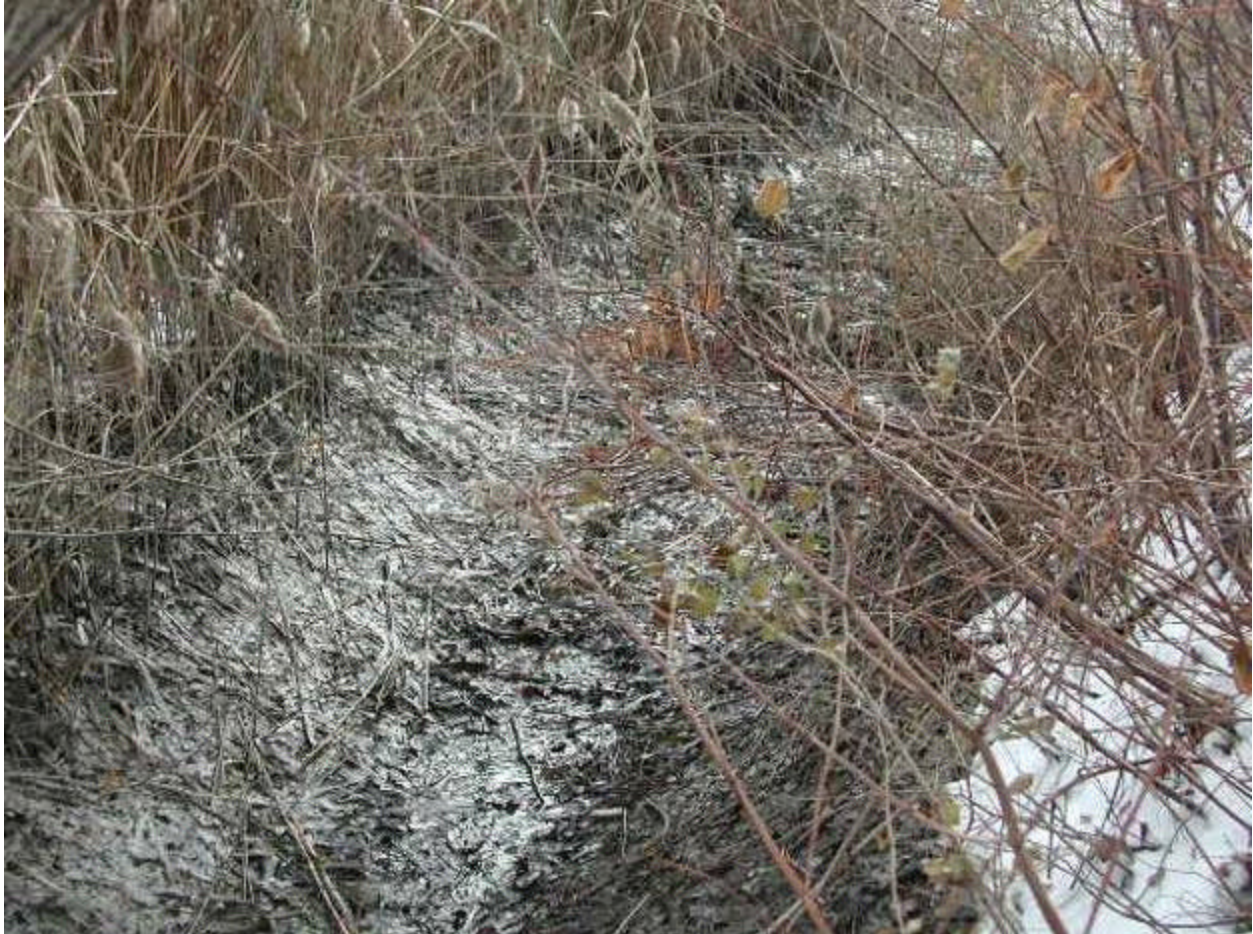
**Photo 2 Description:** Downstream view from the tide gate

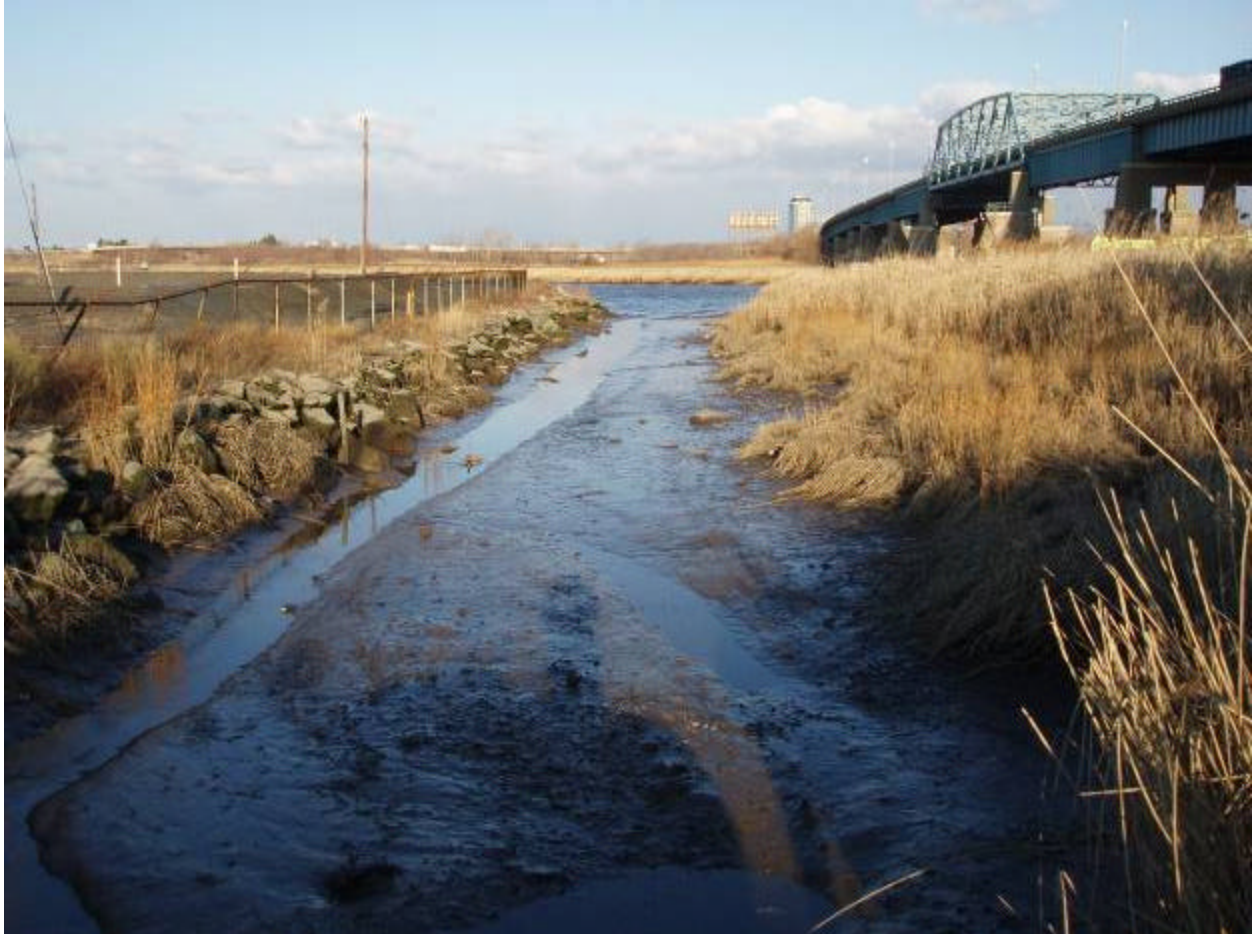
**Photo 1 Description:** Downstream view from tide gate

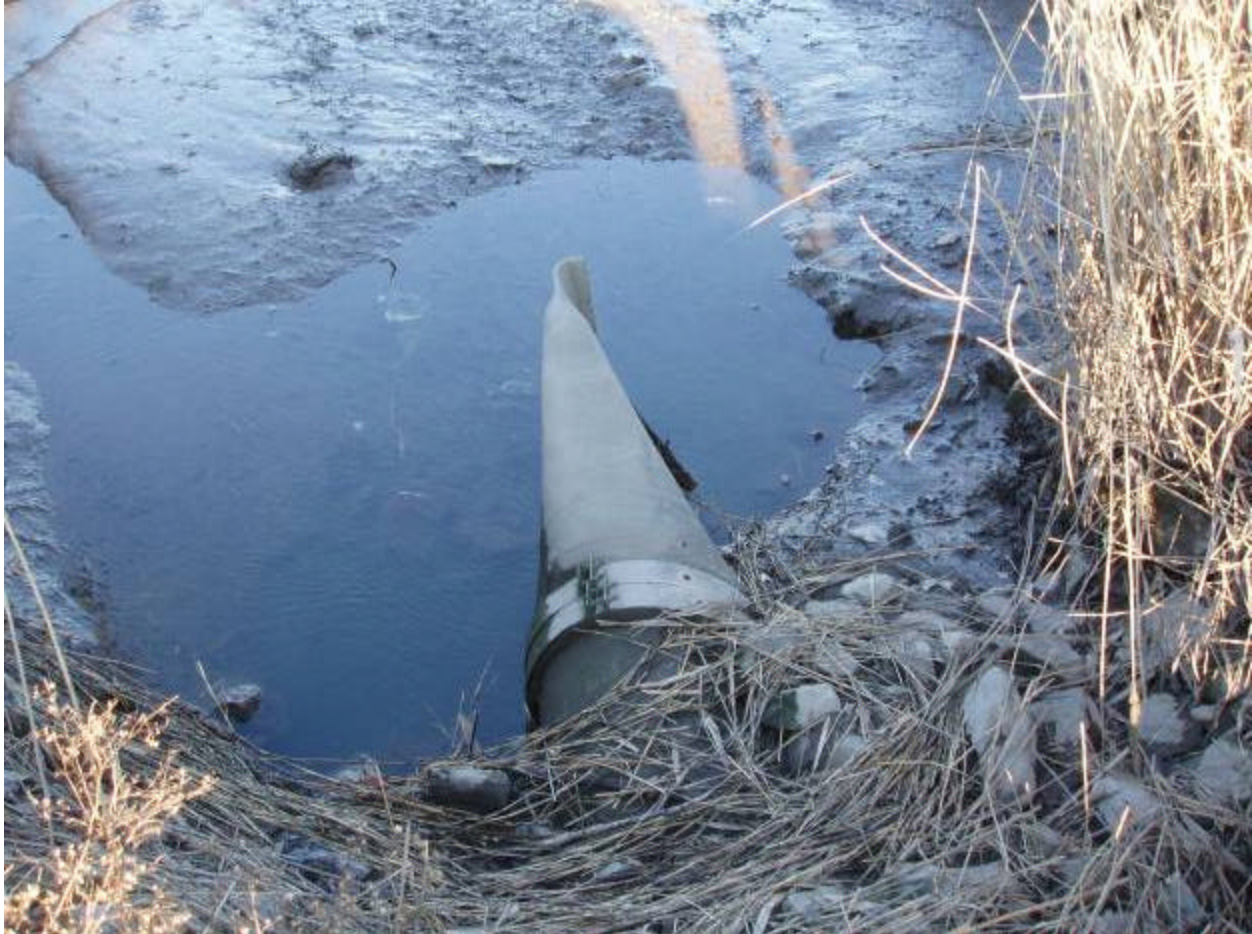
**Photo 2 Description:** Tideflex™ check valve

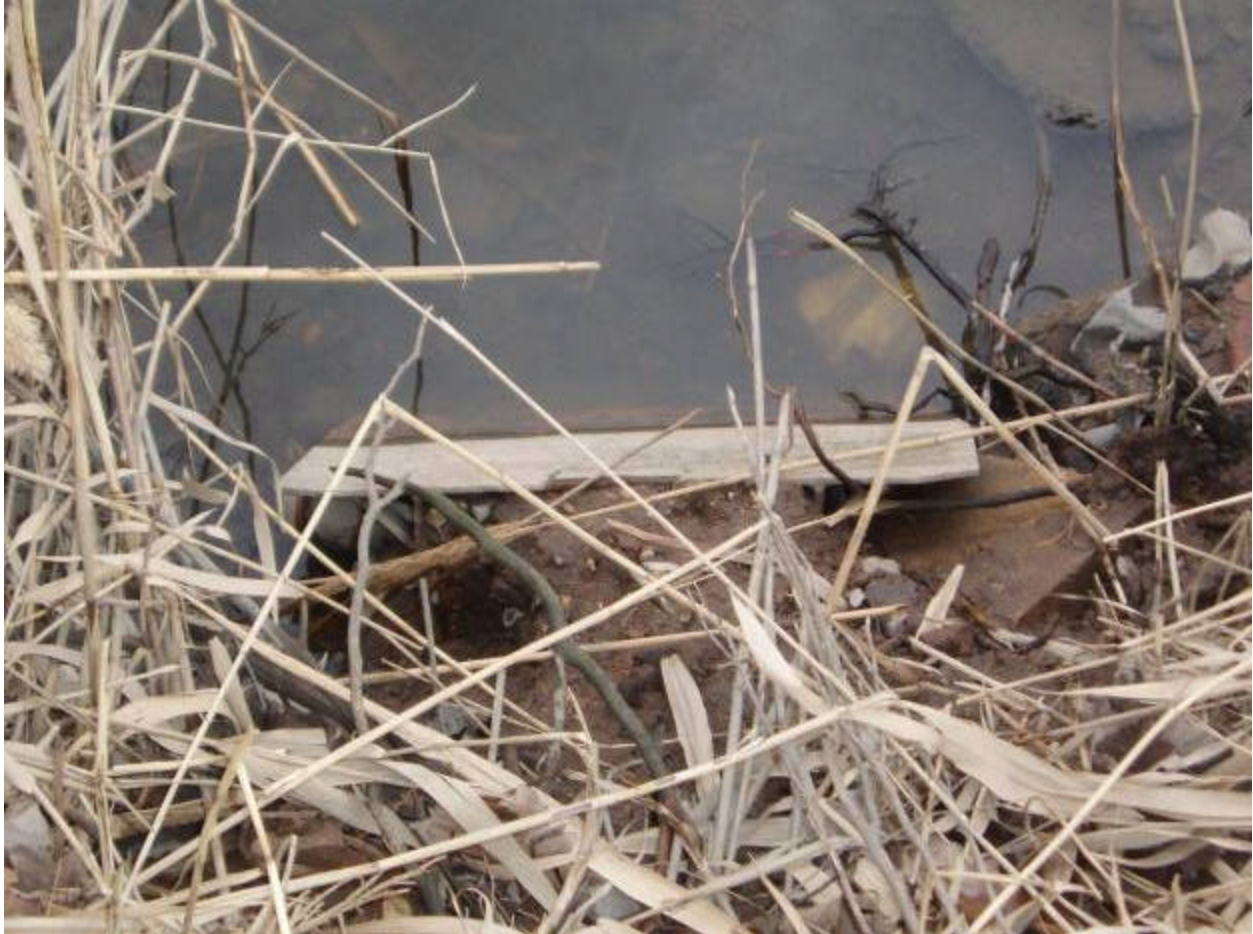
The hinges located on the gate appear to be rusted and need to be cleaned and lubricated.

**Photo 1 Description: Metal flap gate shown**

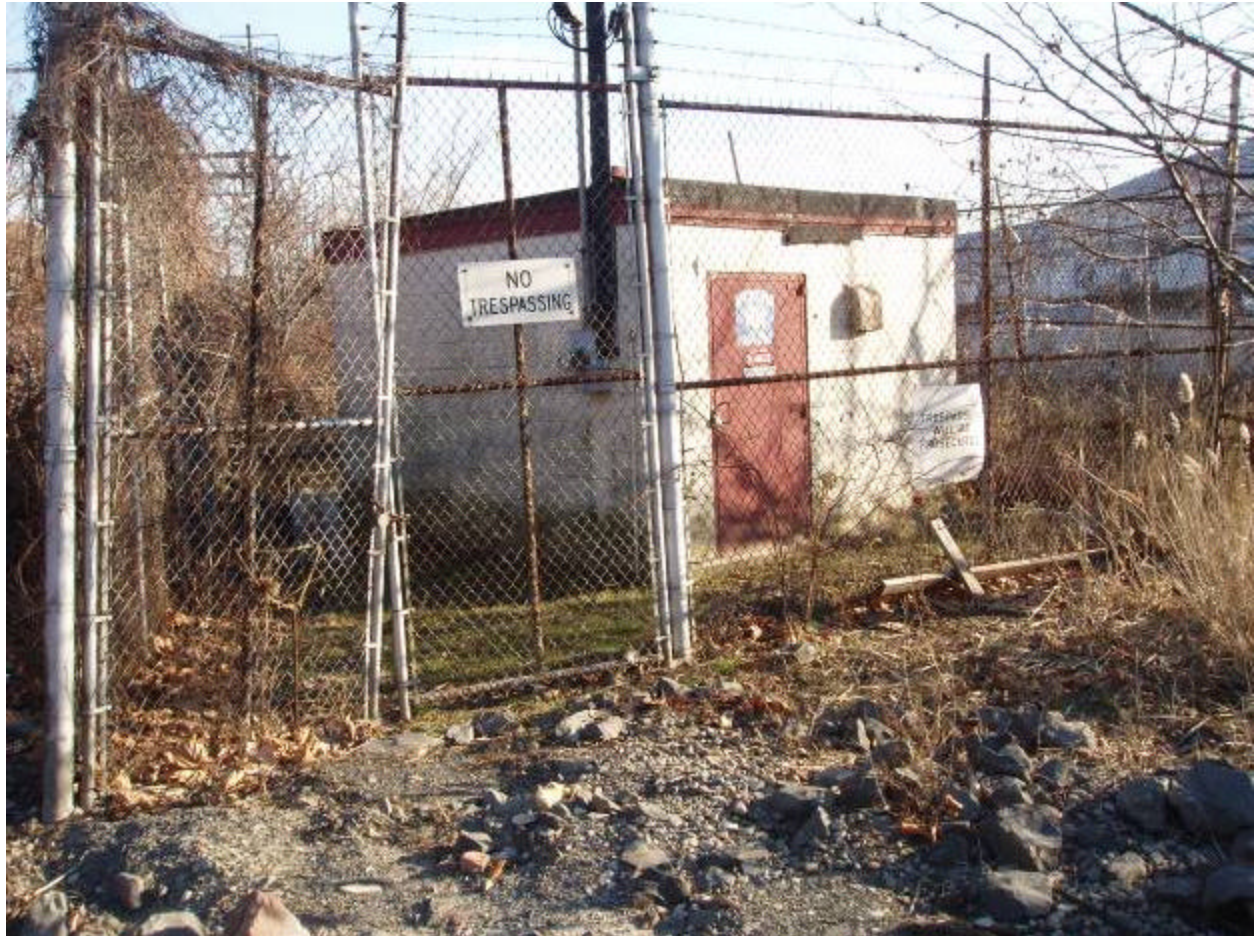
**Photo 1 Description: View of pump station**

Primer pipe must be replaced.

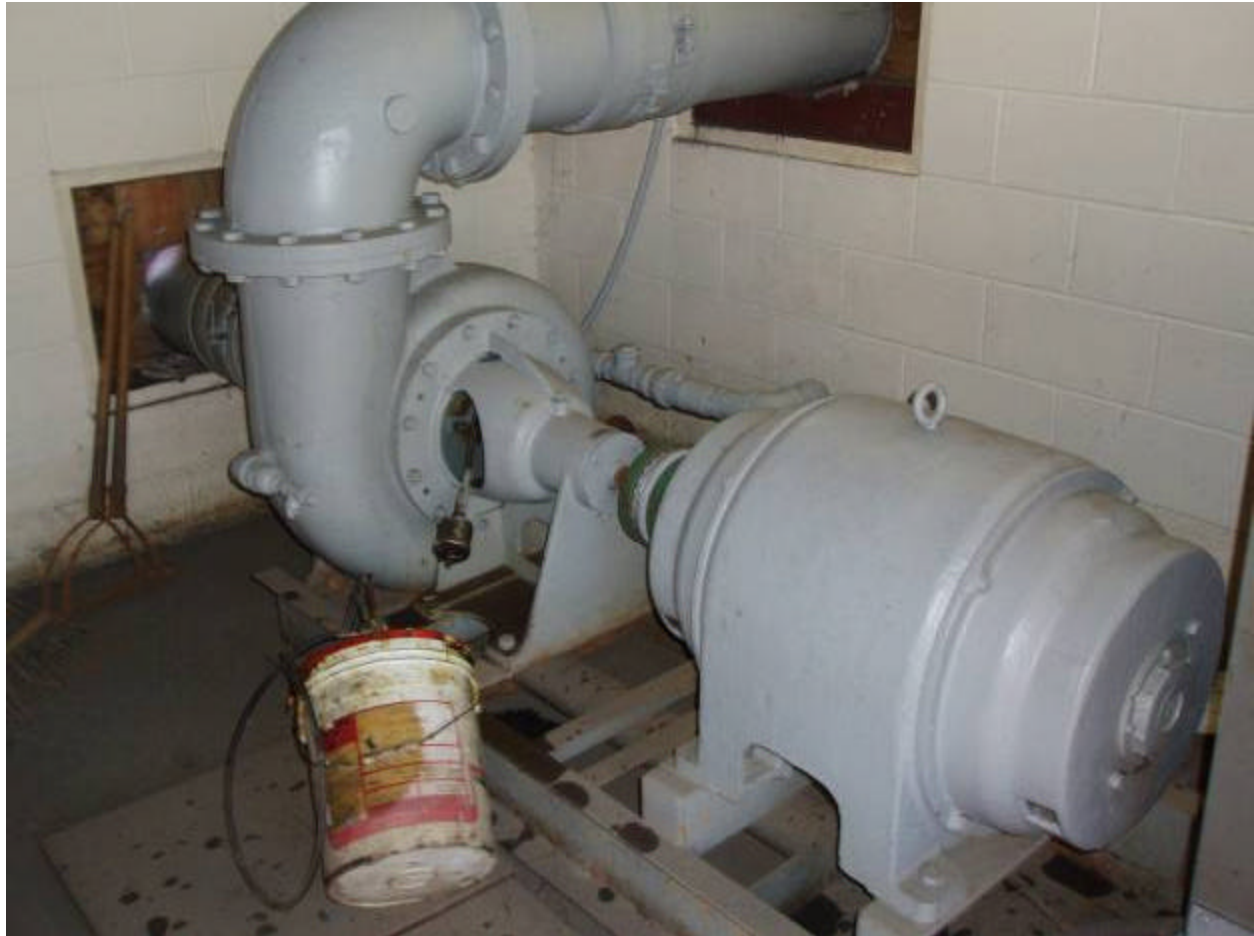
**Photo 2 Description: View of pump**

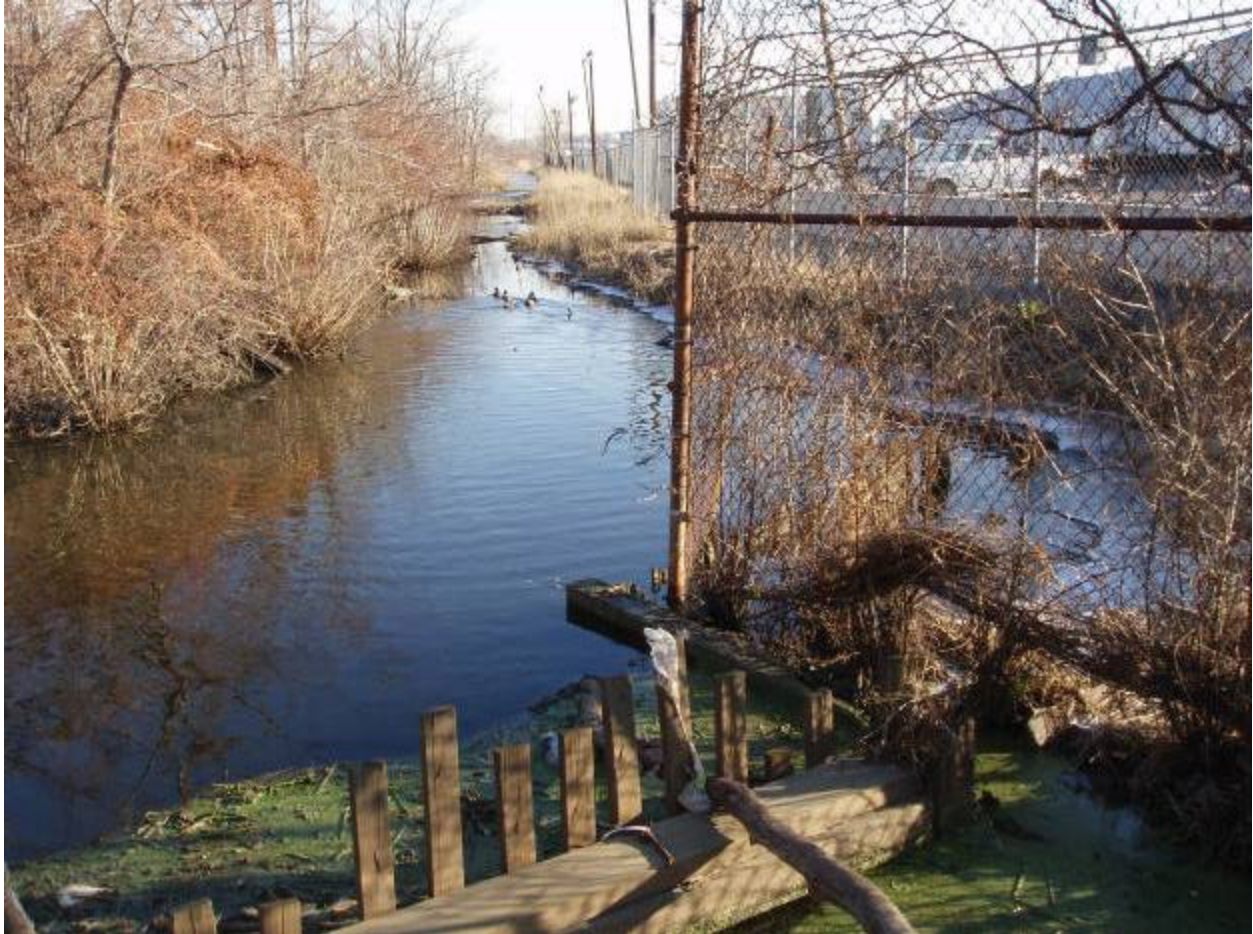
**Photo 3 Description: Upstream view from pump station**

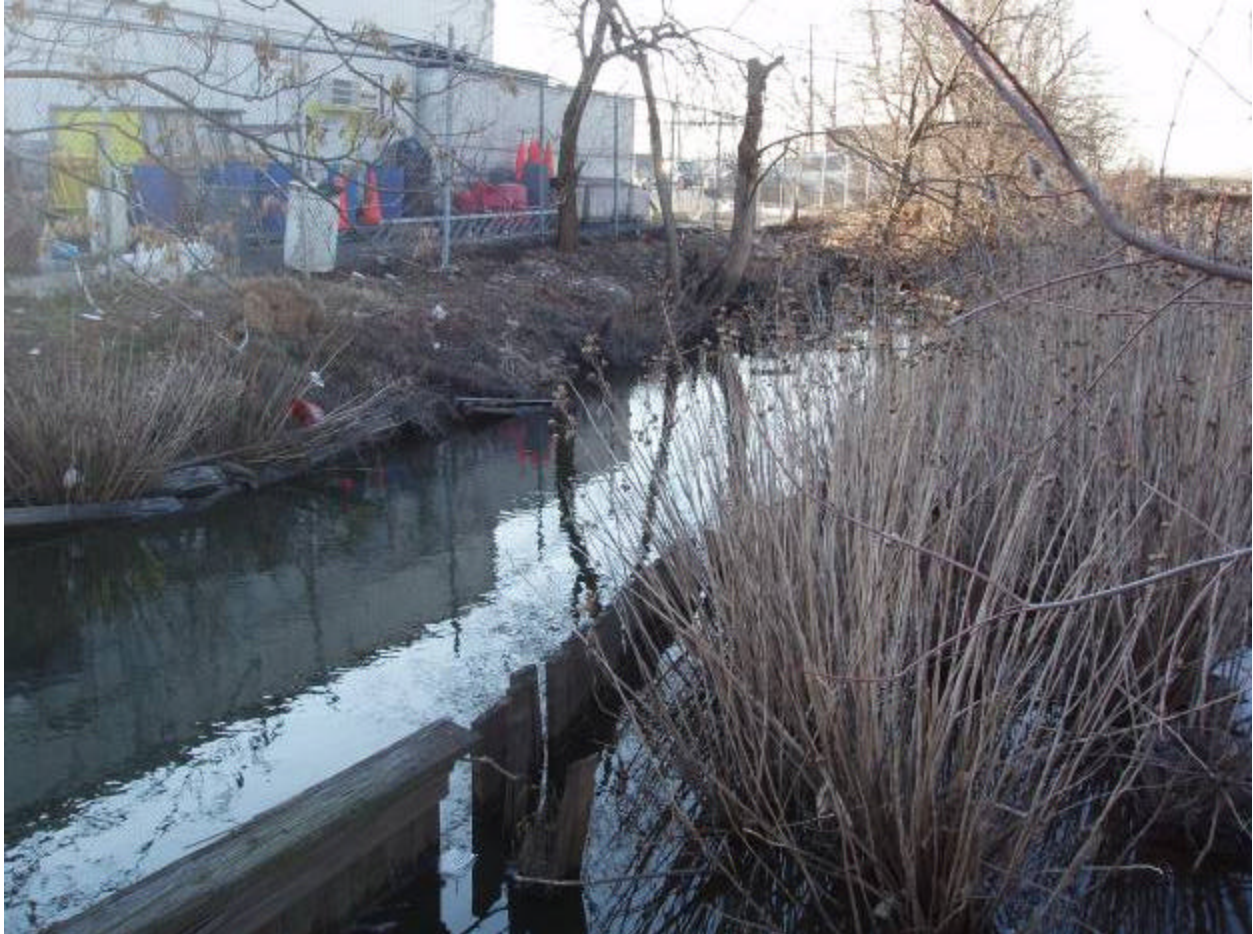
**Photo 4 Description: Downstream view from pump station**

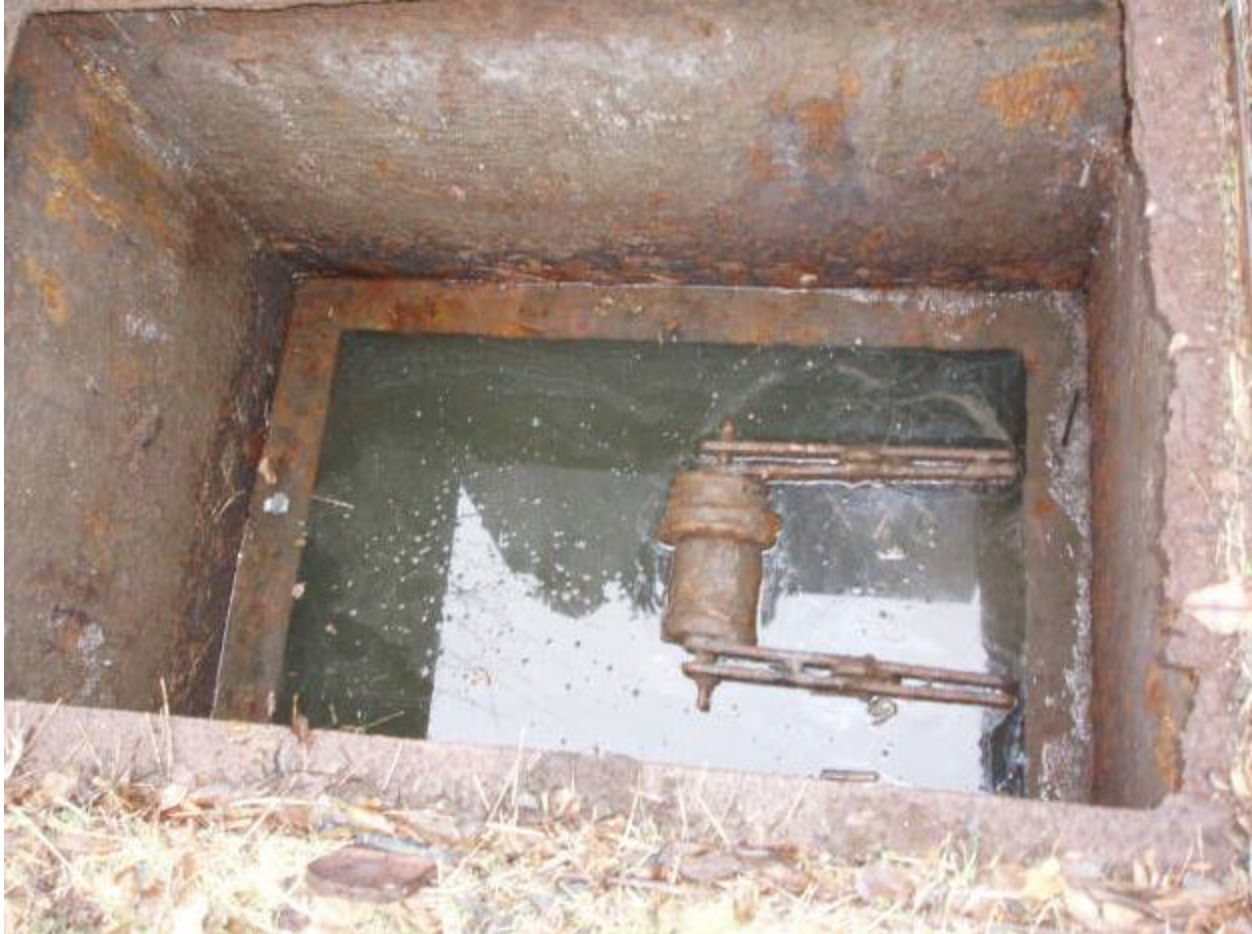
**Photo 1 Description: 1<sup>st</sup> 30-inch flap gate**

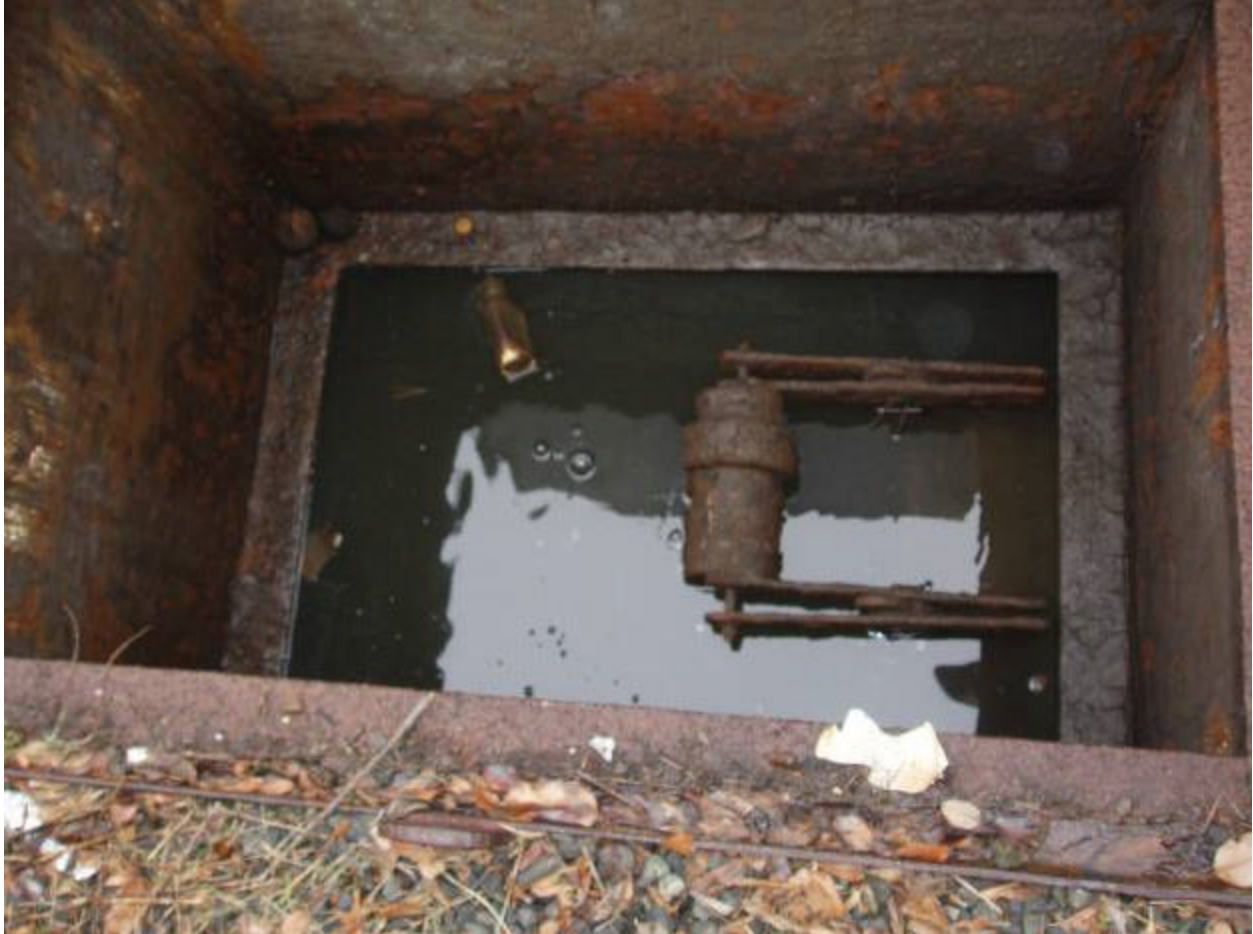
**Photo 2 Description: 2<sup>nd</sup> 30-inch flap gate**

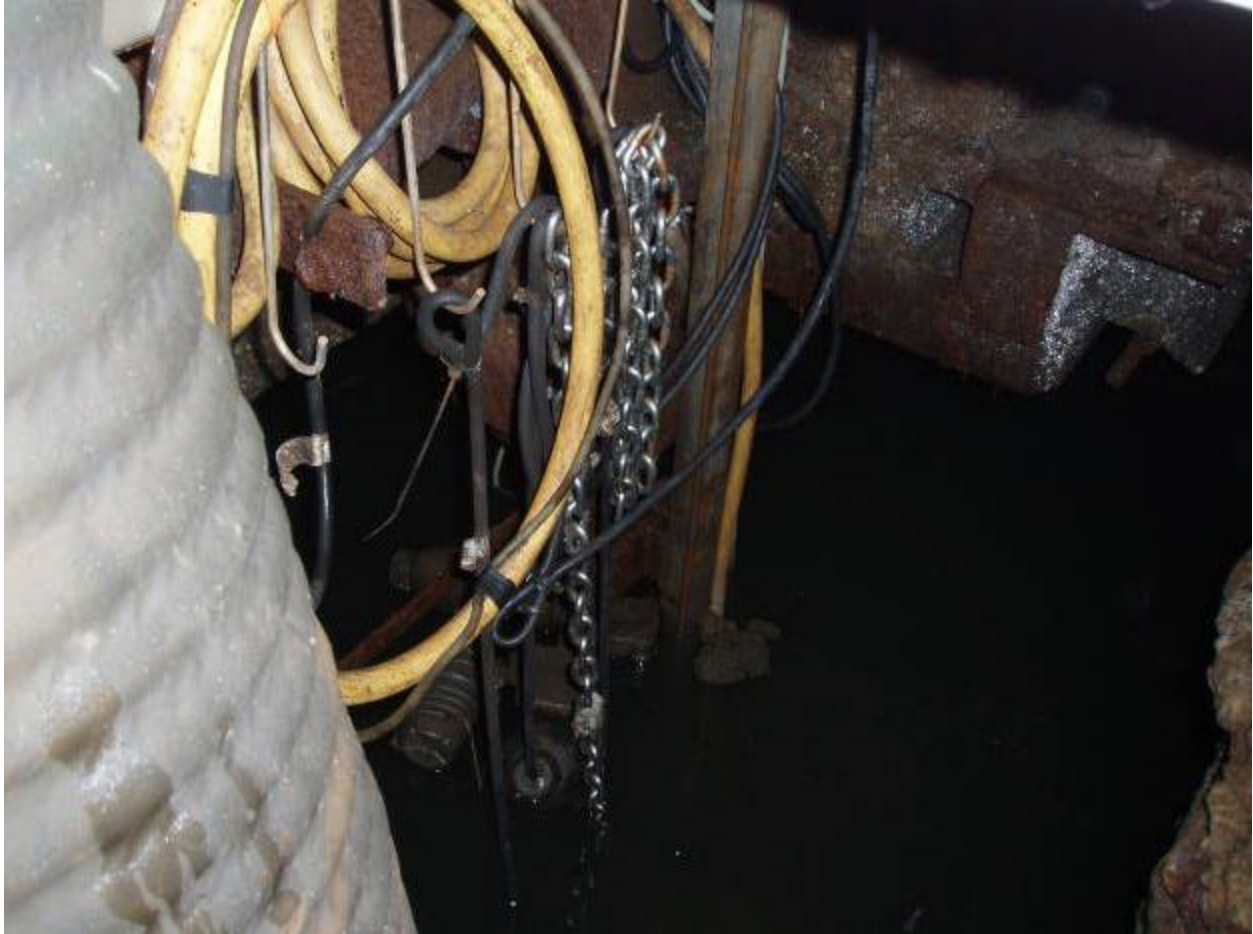
**Photo 3 Description: View of submersible pump**

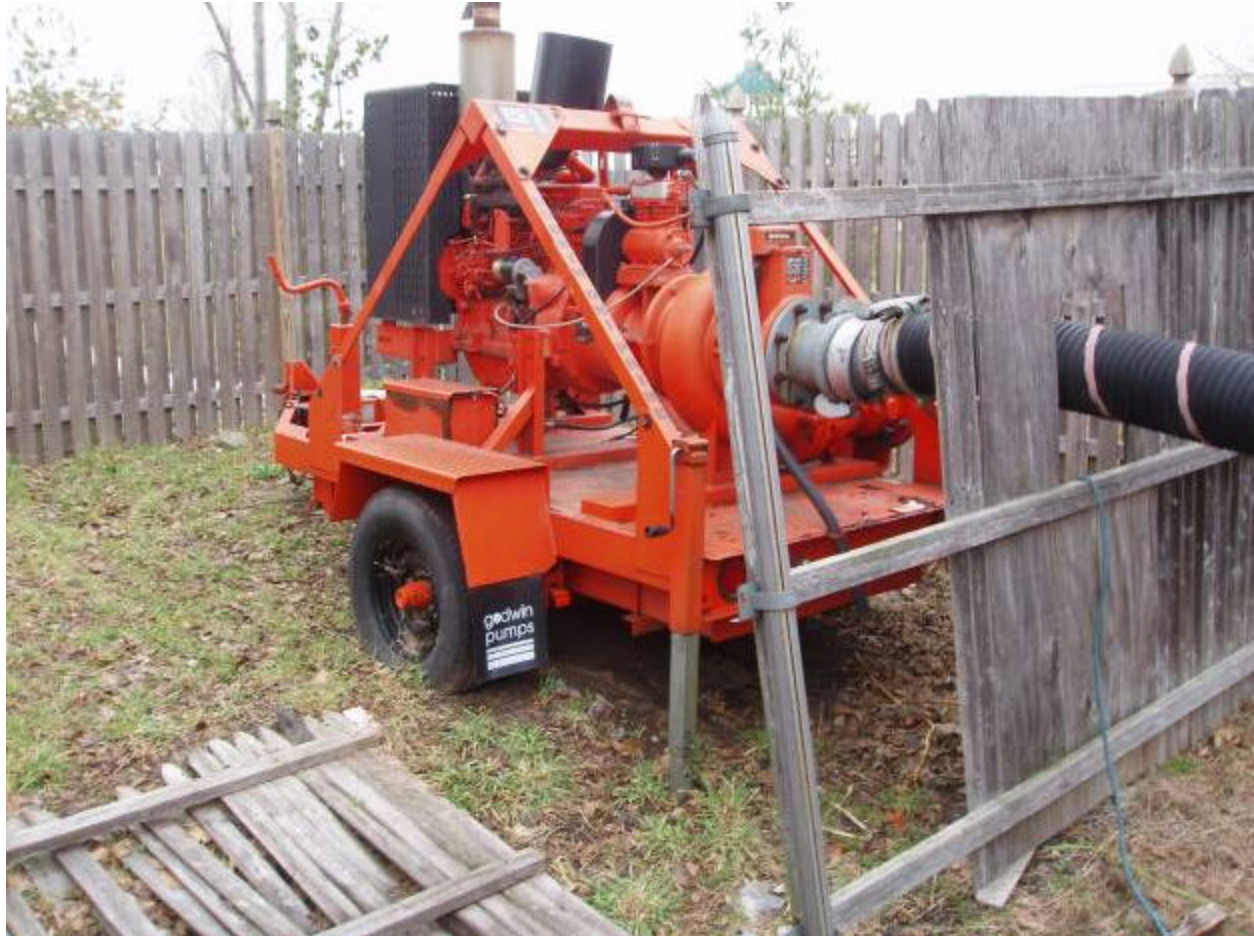
**Photo 4 Description: Godwin back-up pump**

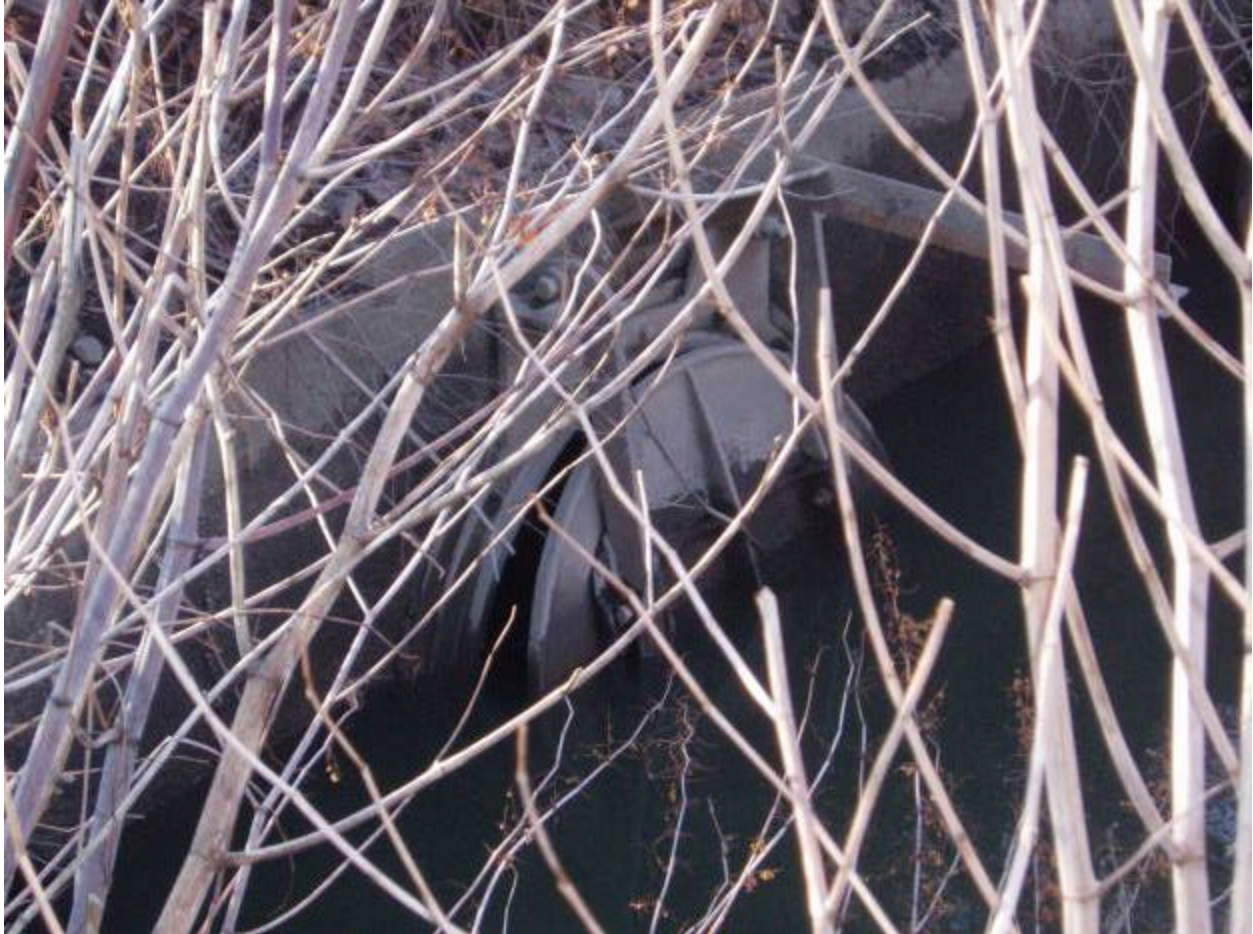
**Photo 1 Description: 1 metal flap gate**

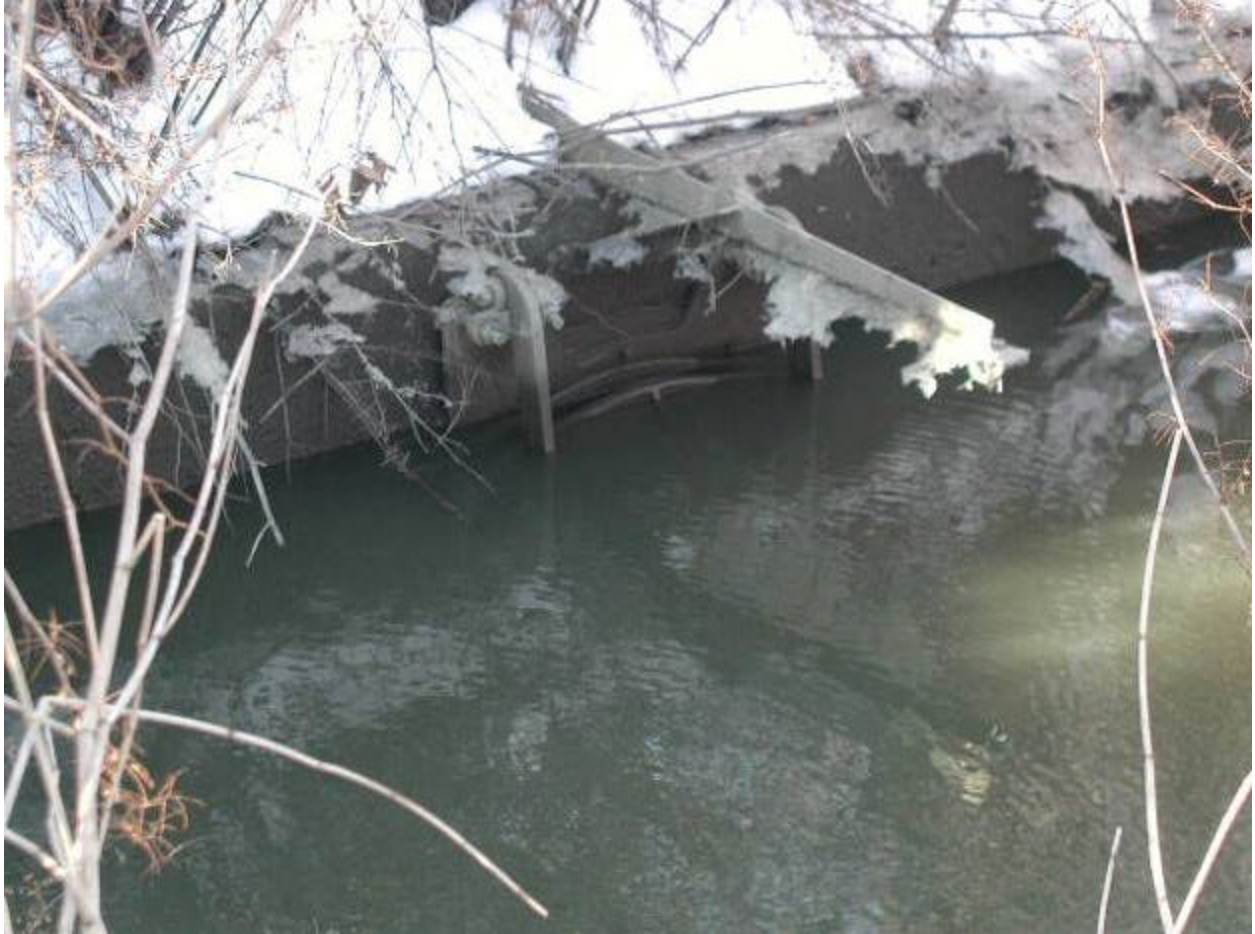
**Photo 1 Description: 1 metal flap gate**

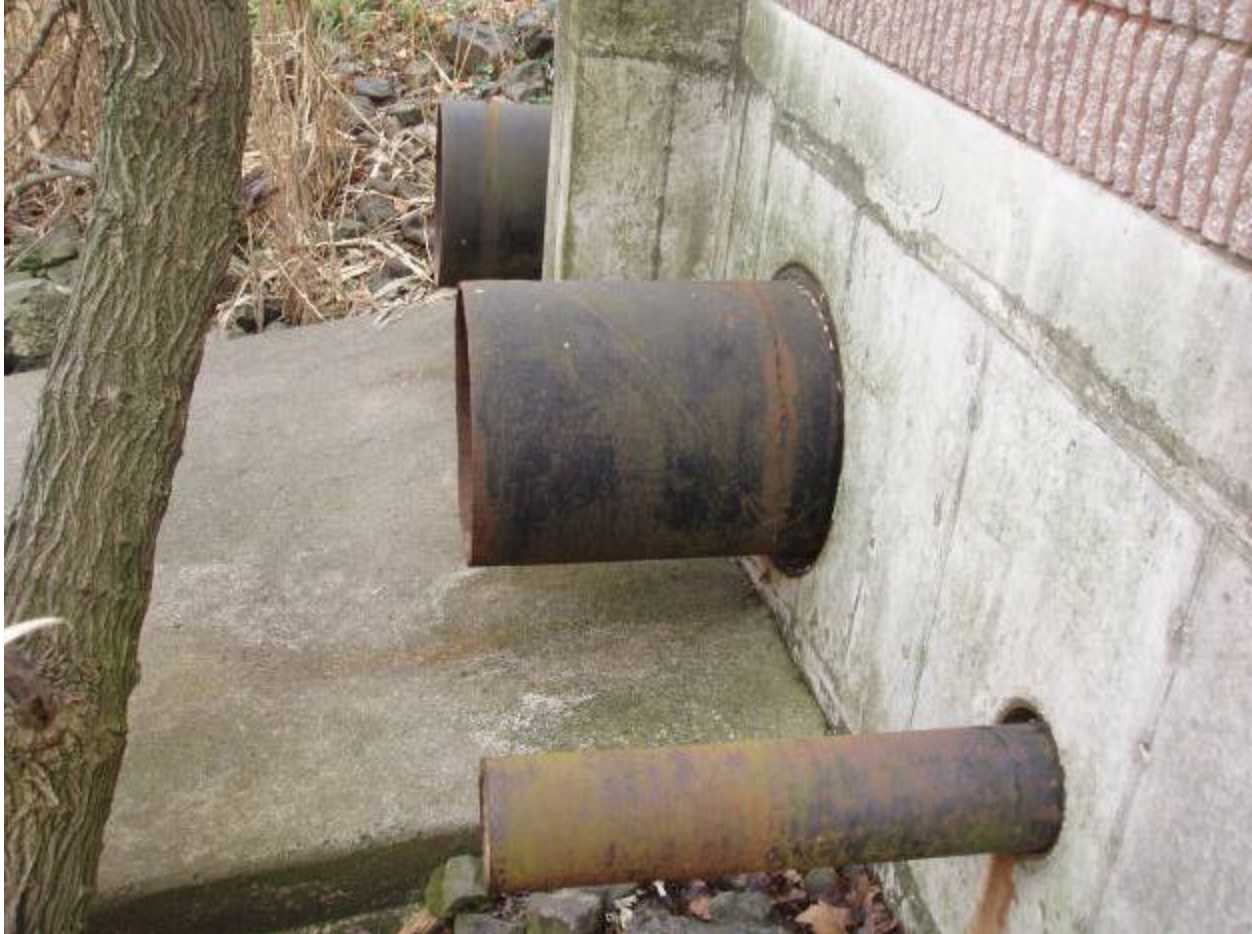
**Photo 1 Description: View of outlet pipes**
