# **Hackensack Meadowlands Tide Gates Inspection Report**

**The National Flood Insurance Program  
Community Rating System**

**The New Jersey Meadowlands Commission  
One DeKorte Park Plaza  
Lyndhurst, New Jersey**

**March 27, 2006**

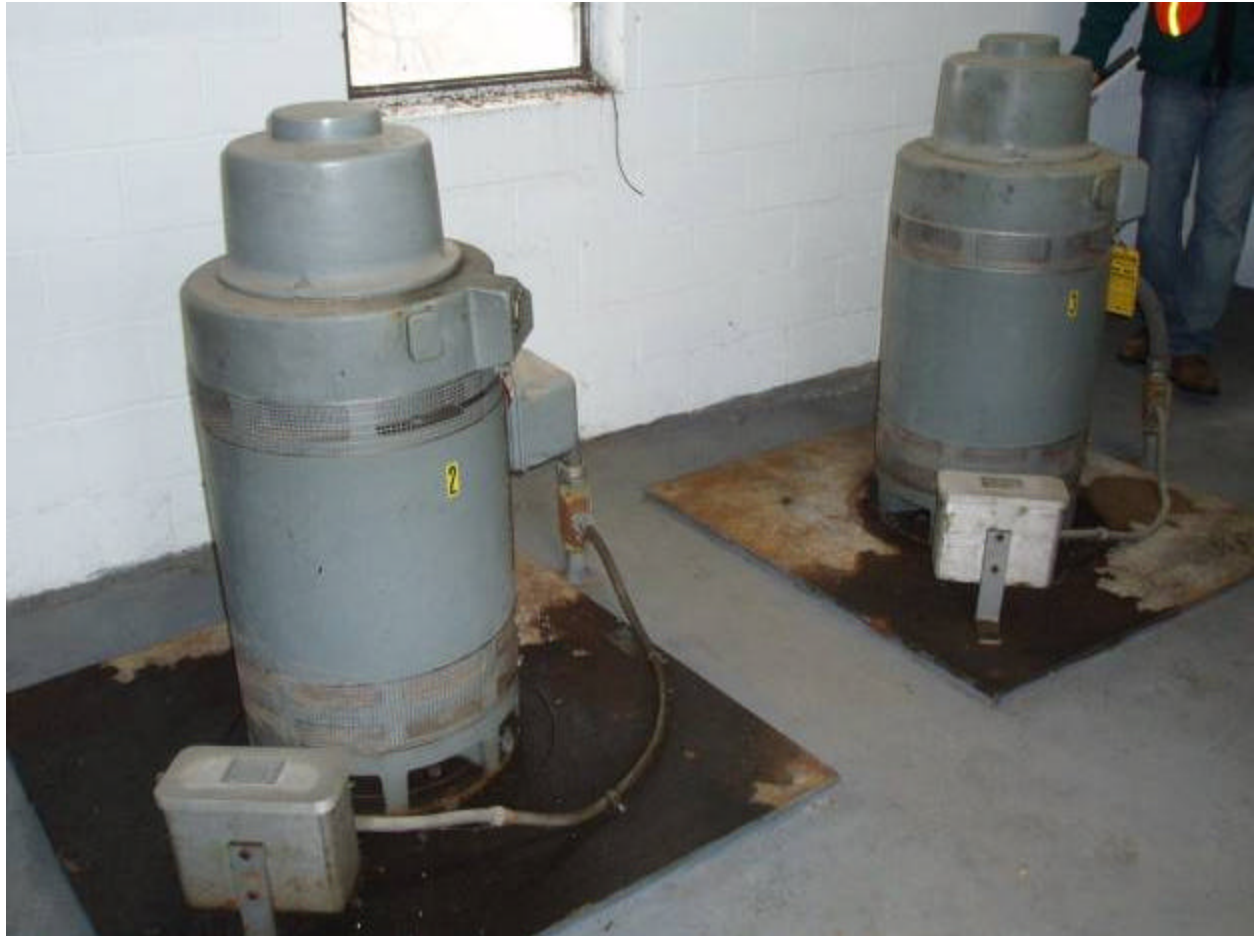
**Photo 2 Description: View of pump systems**

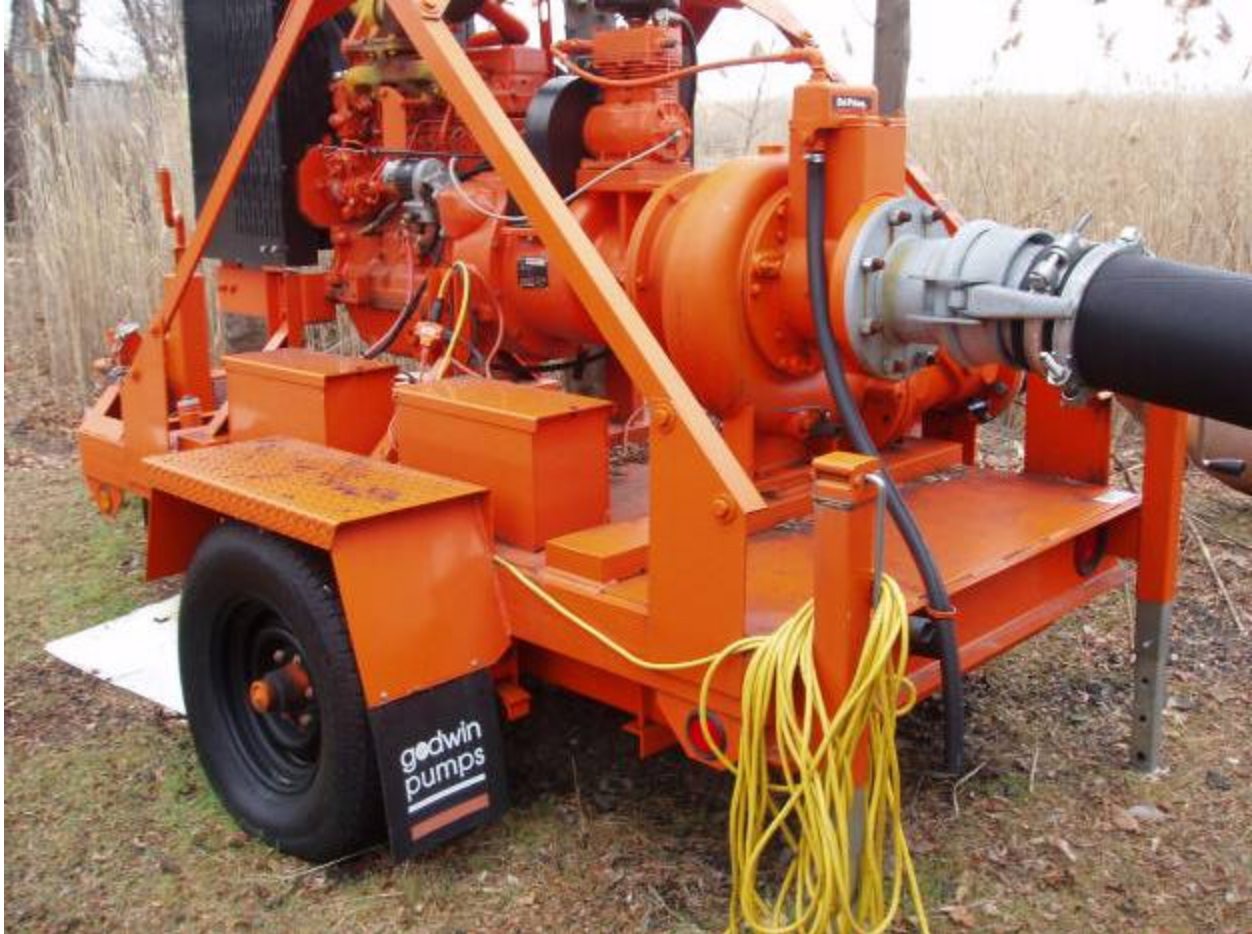
**Photo 3 Description:** Godwin diesel back-up pump system

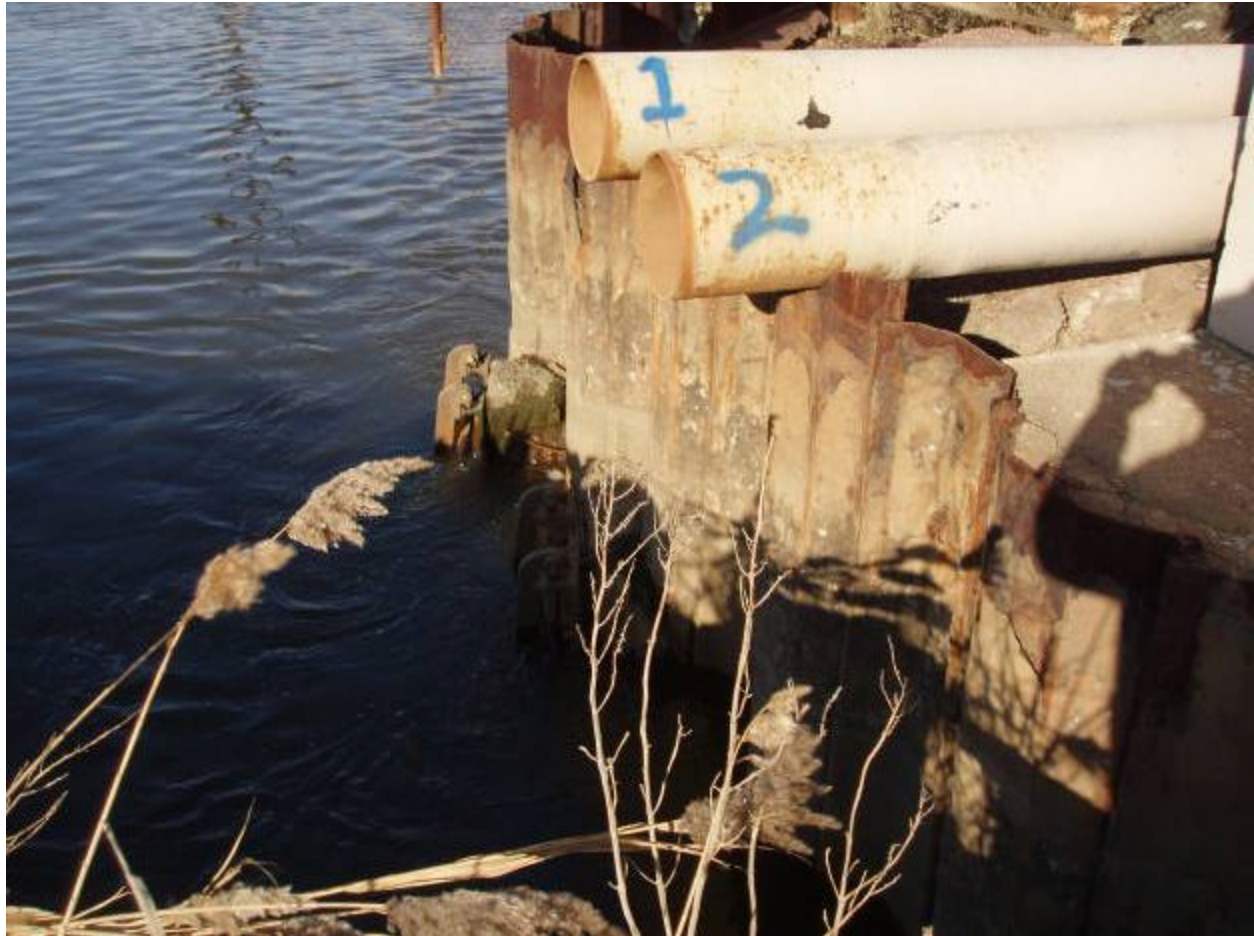
**Photo 2 Description: Pump discharge pipes**

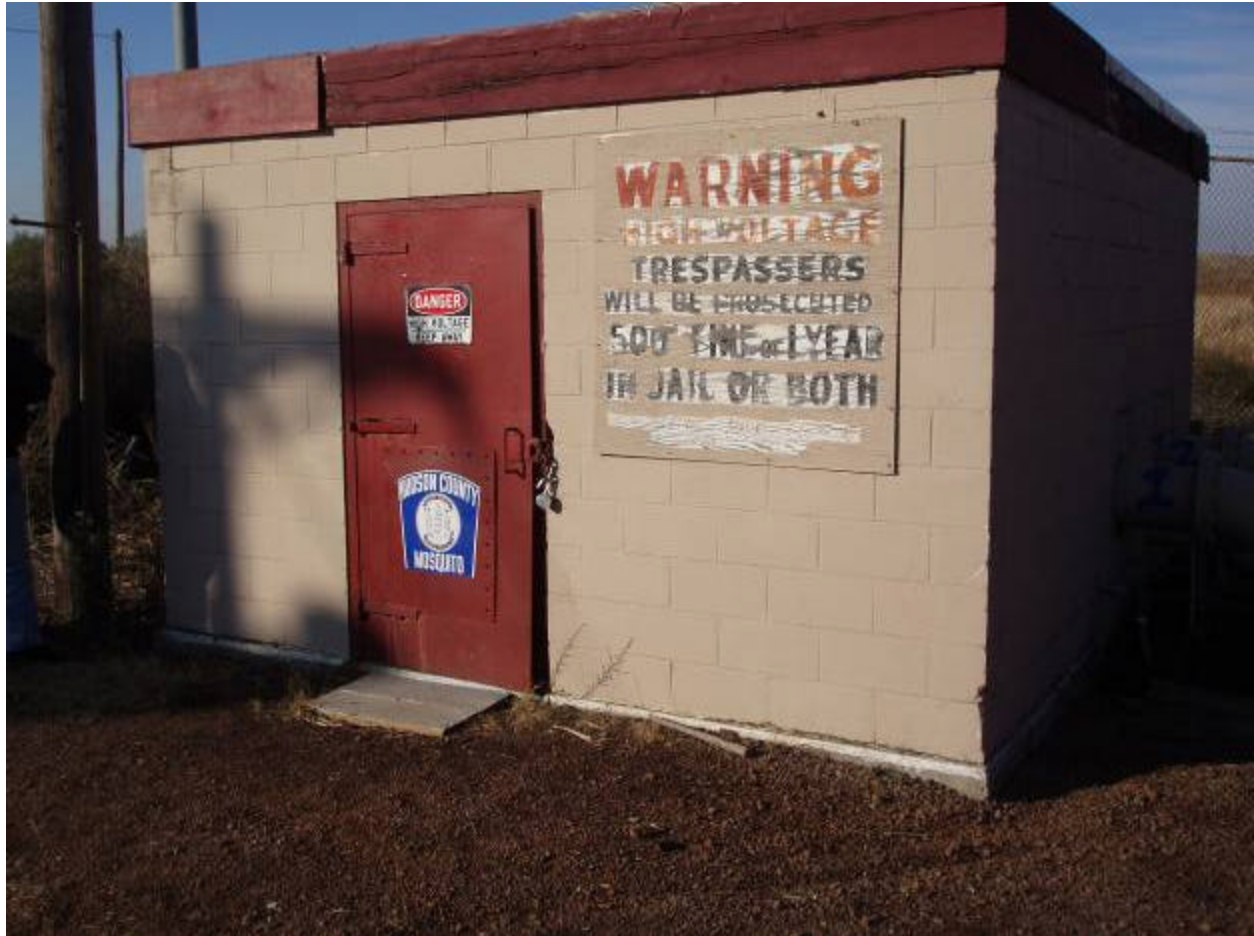
**Photo 3 Description: Pump station facility**

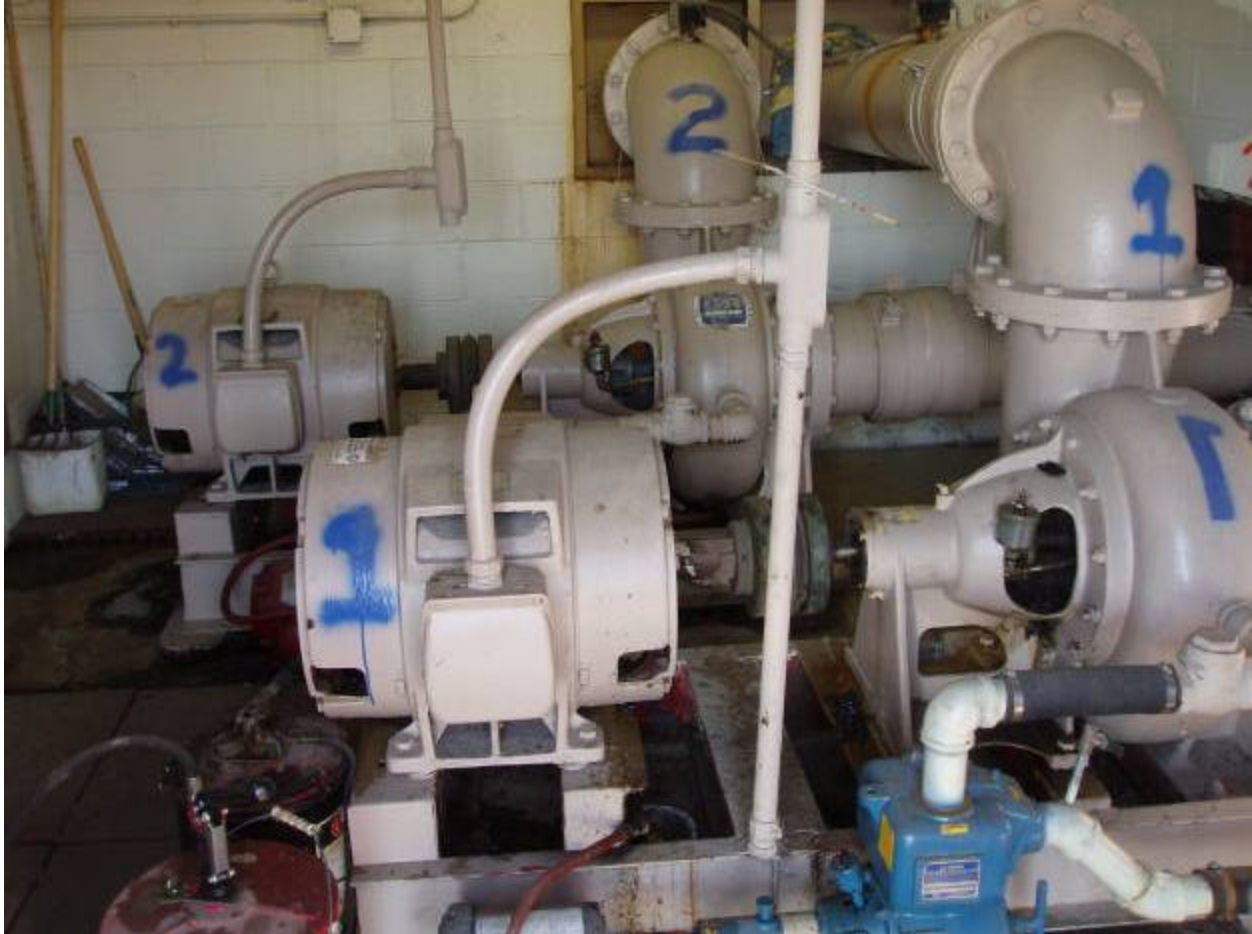
**Photo 4 Description: View of pumps**

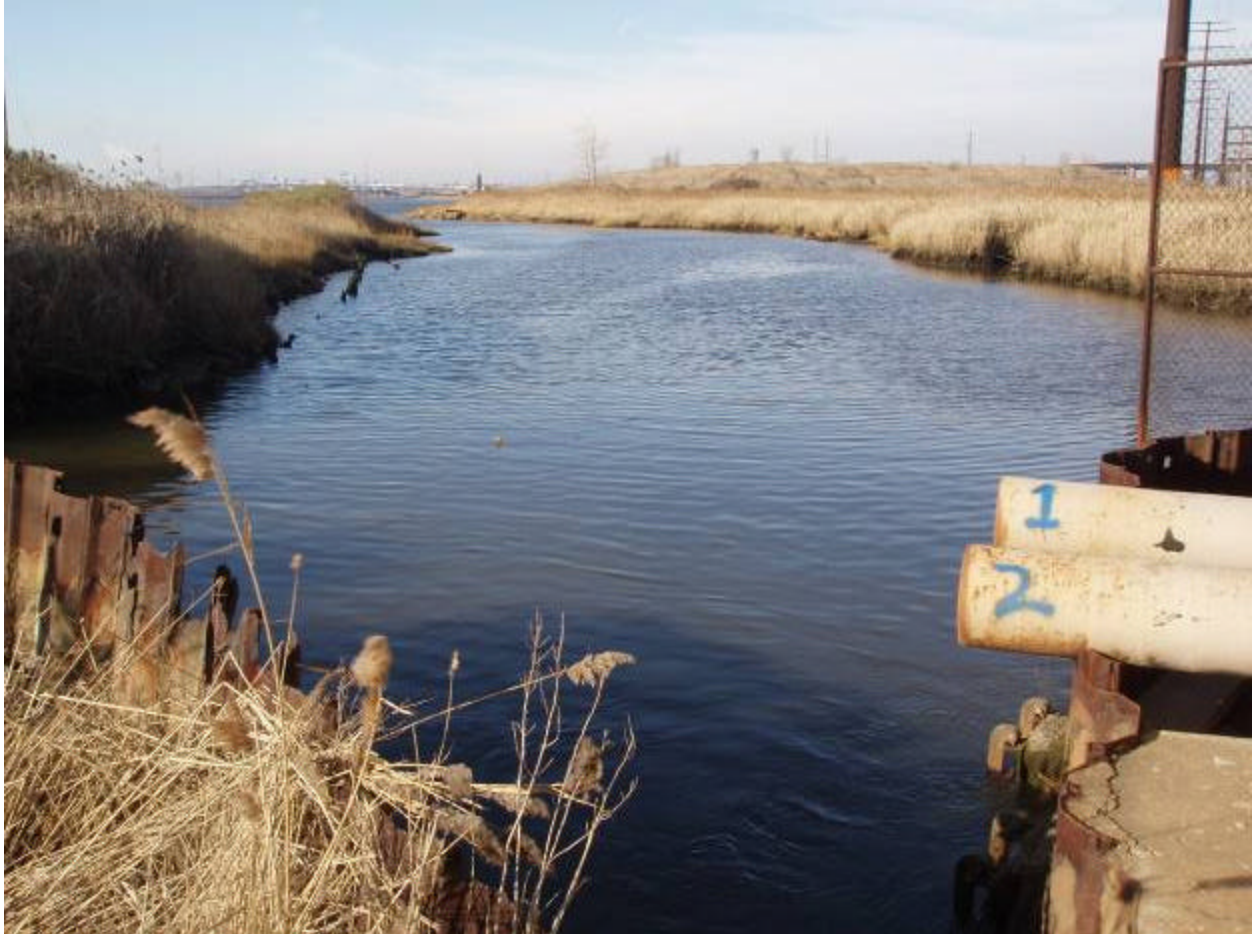
**Photo 5 Description: Downstream view from the pump station facility**

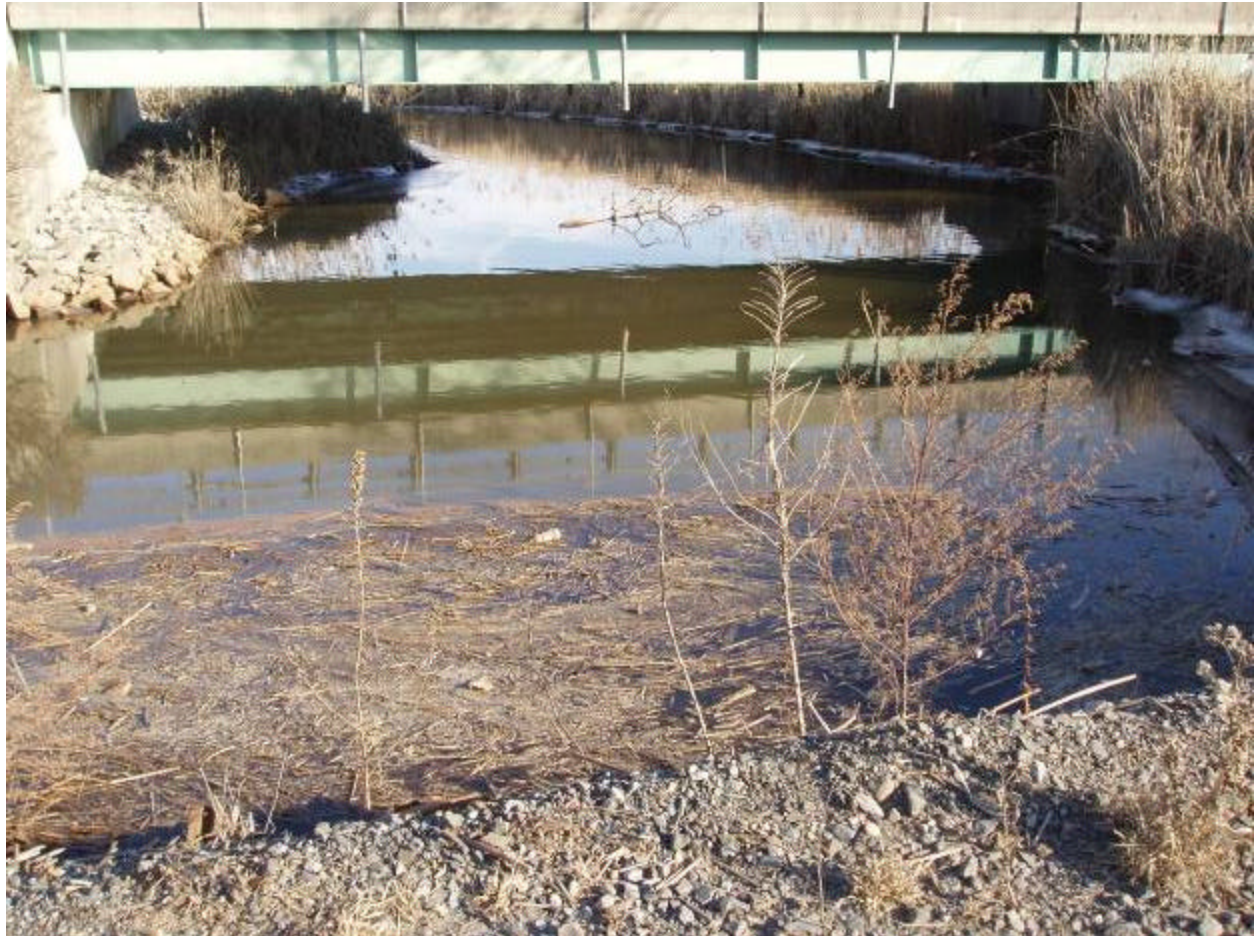
**Photo 6 Description:** Upstream view from the pump station facility

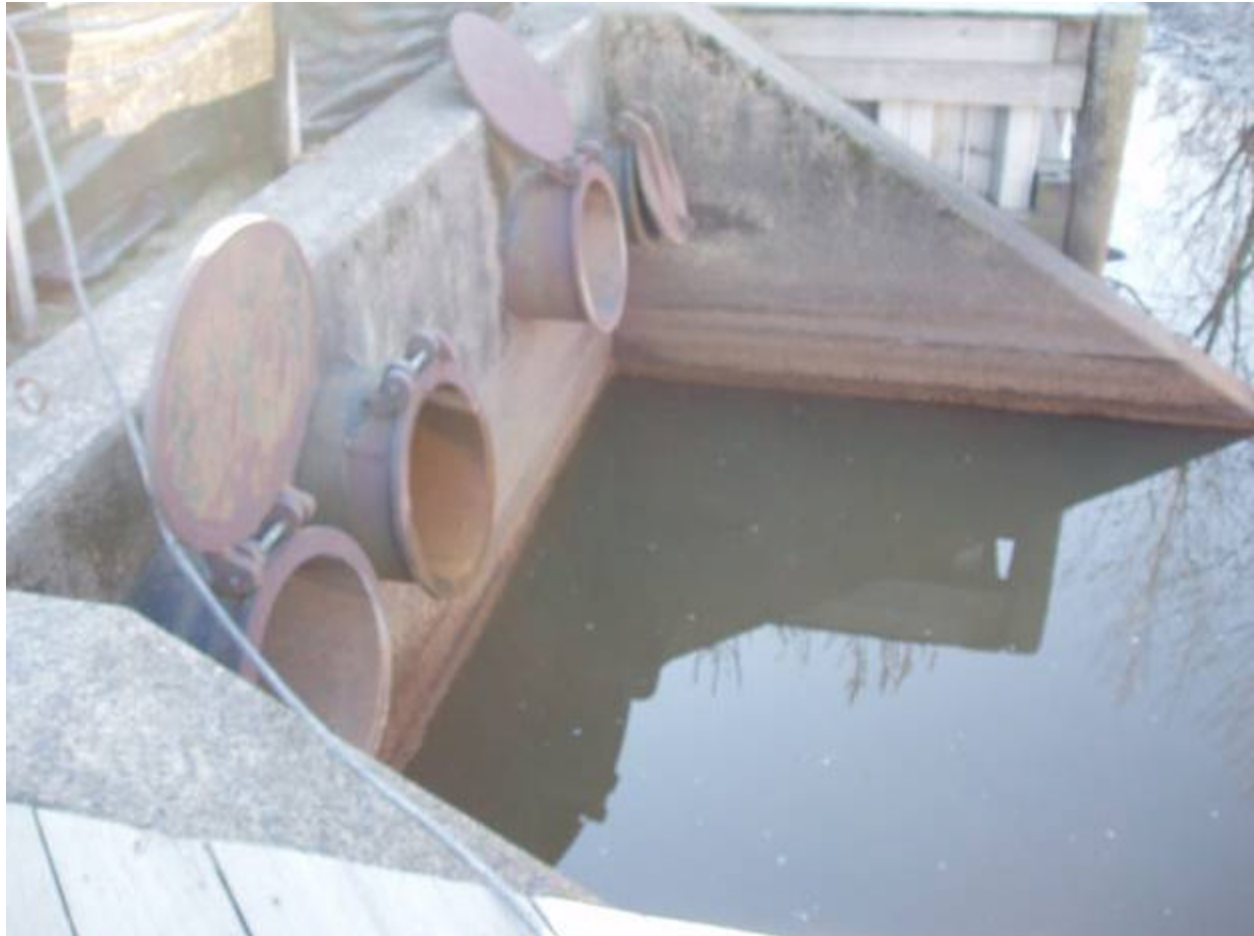
A new pump station is currently being constructed. The current conditions are: 3 out of 4 pumps function, 1 out of 4 tide gates function. The two tide gates that function at discharge are seating properly.

**Photo 1 Description:** Flap gates shown on outlet structure

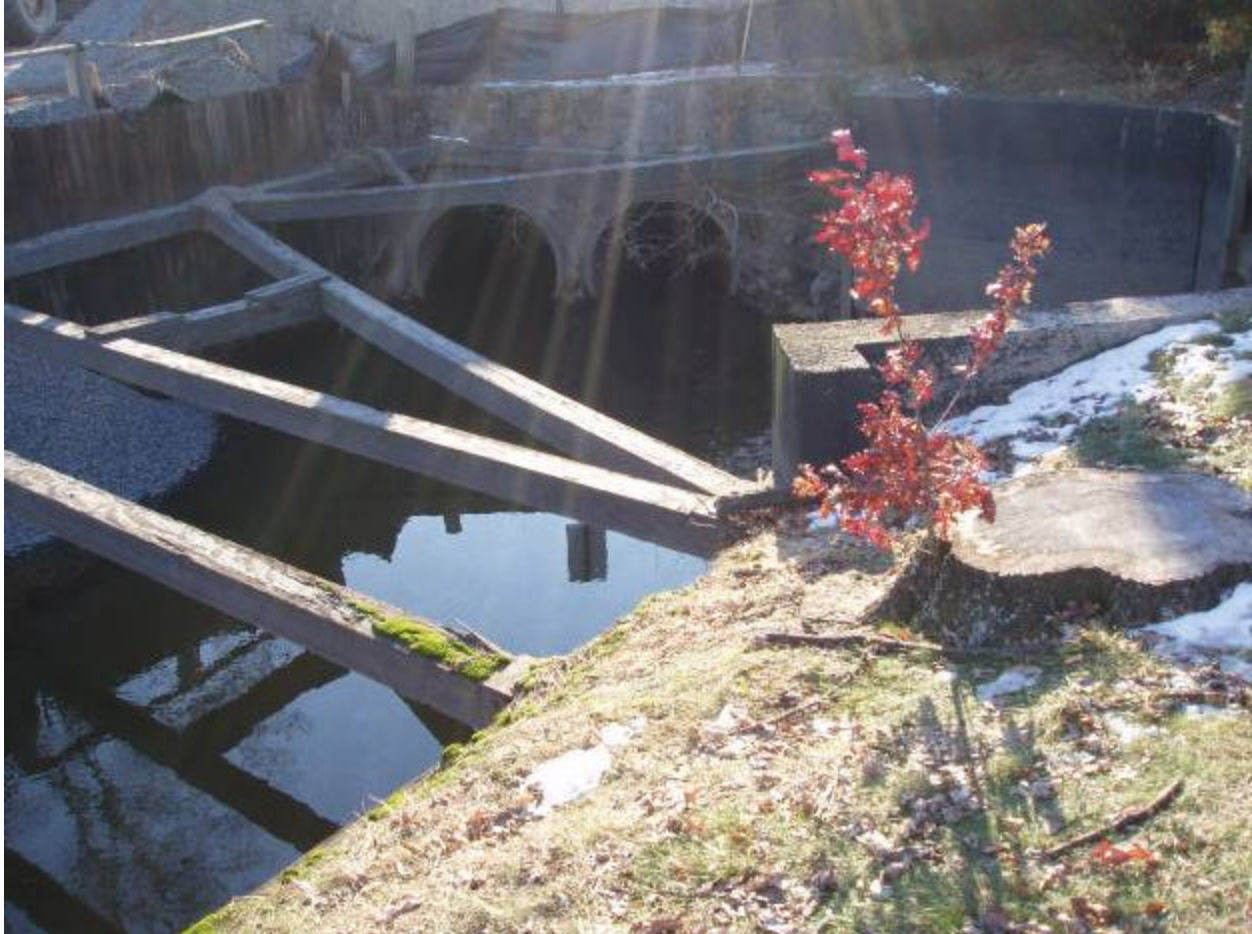
**Photo 2 Description: In-flow at pump station**

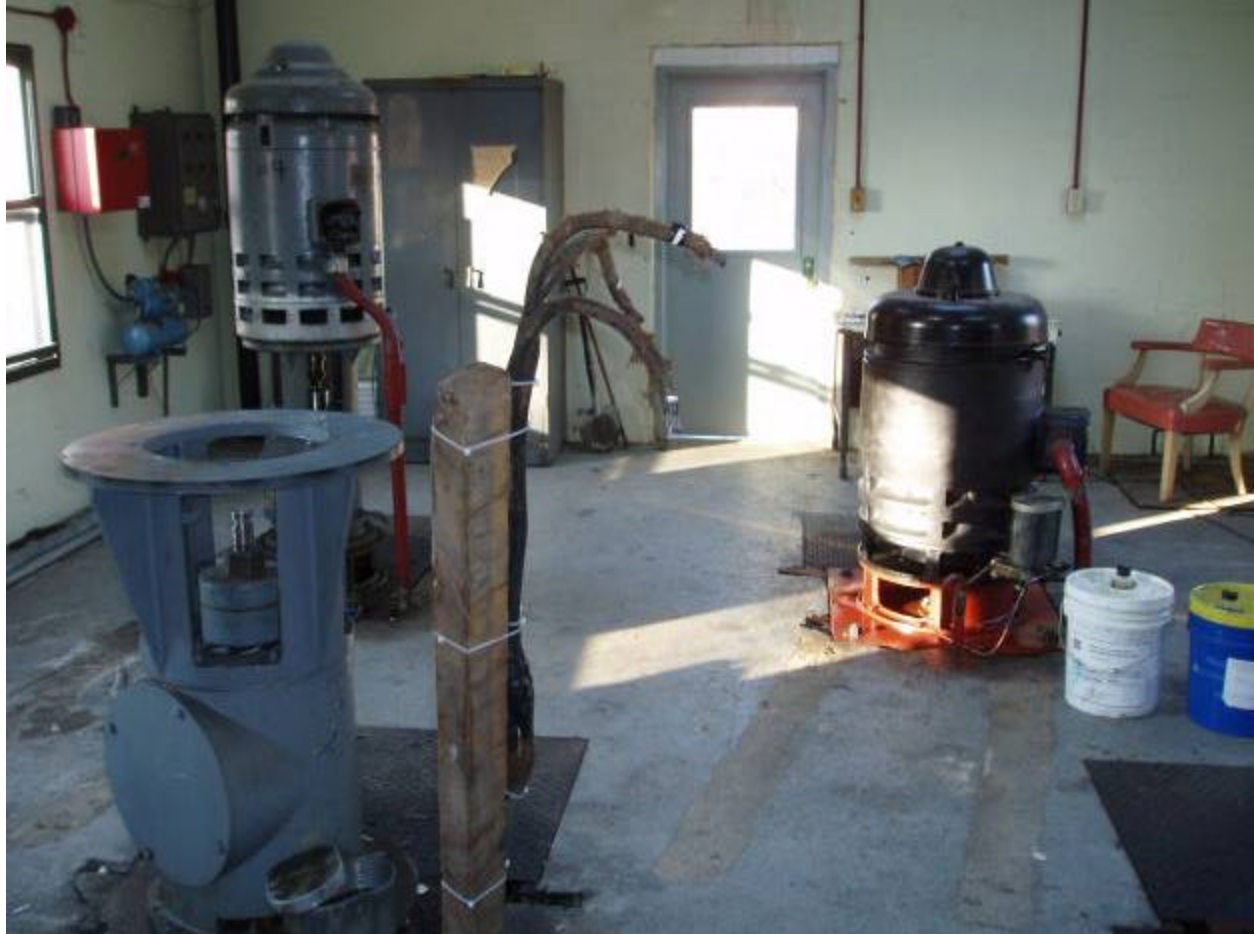
Trash racks are clean and are in good condition. The construction by-pass appears to be undersized. The pump house is in good condition with a functional alarm system. Access needs to be cleared to all system components. The pumps were maintained as follows: pump #1 in 2006, pump # 2 in 2005 and pump #3 in 2000.

**Photo 3 Description: View of pumps**

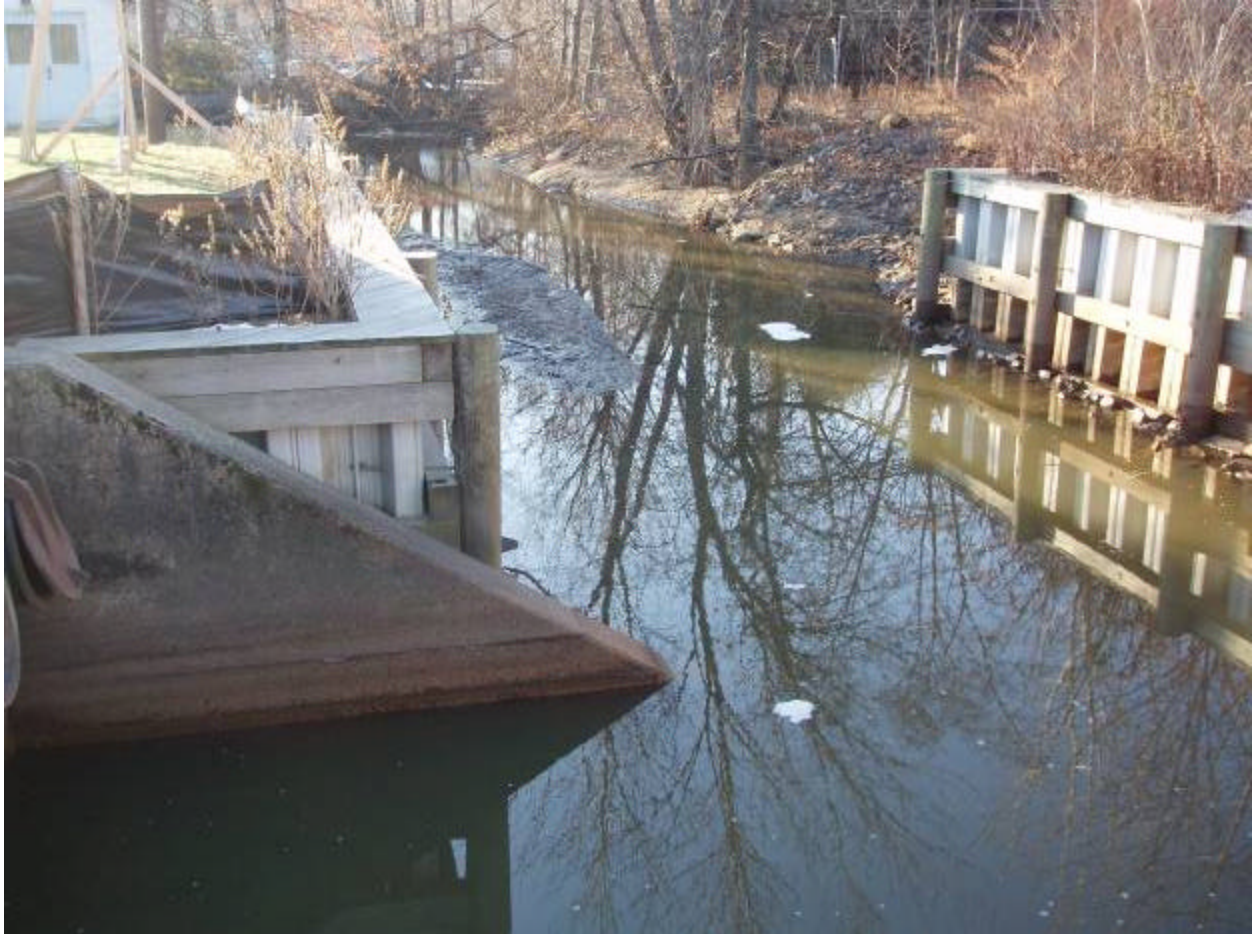
**Photo 4 Description: Downstream view from the pump station**

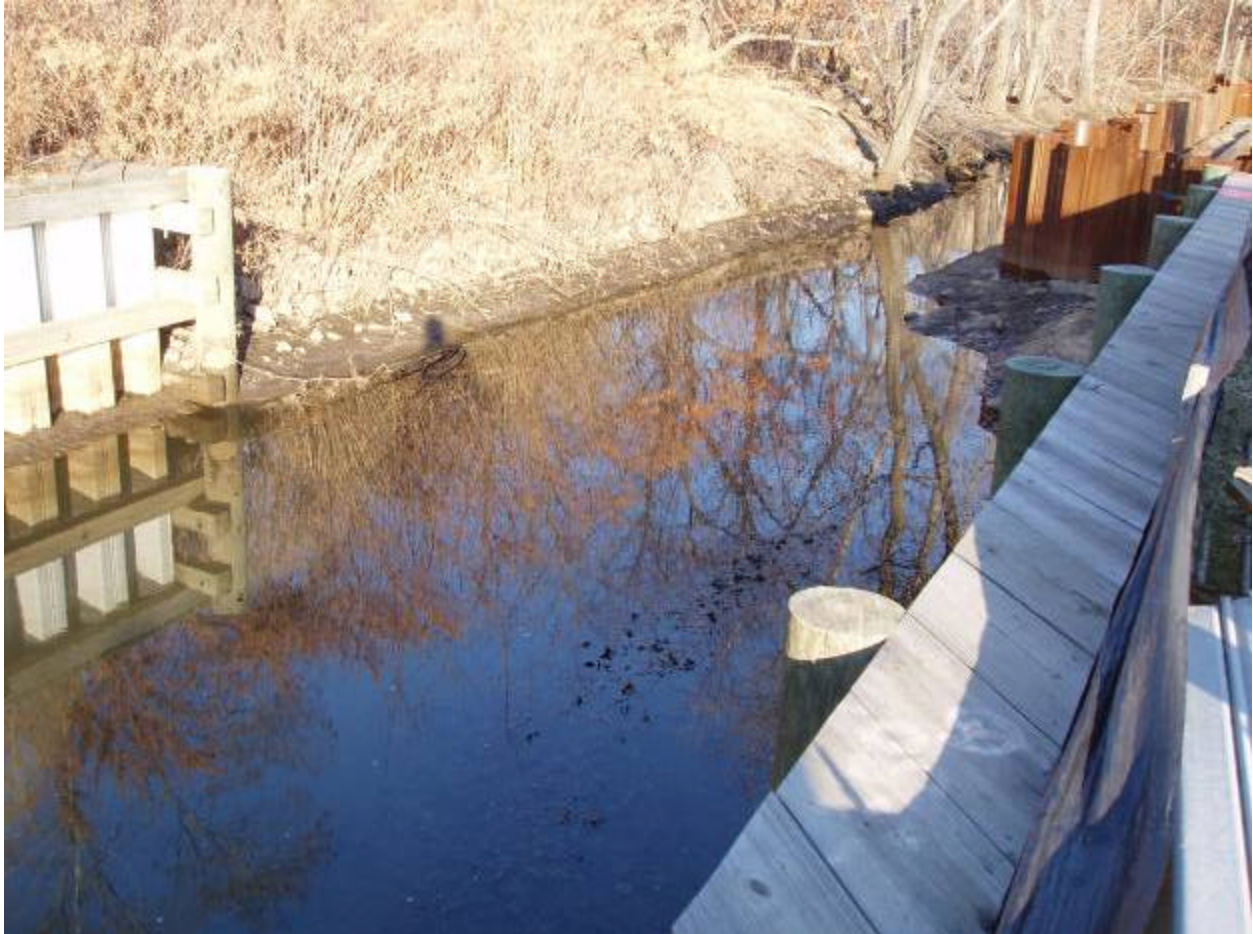
**Photo 5 Description:** Upstream view from the pump station
