Hackensack Meadowlands Floodplain Management Plan

The National Flood Insurance Program Community Rating System Activity 510 Guidelines

The New Jersey Meadowlands Commission One DeKorte Park Plaza Lyndhurst, New Jersey

October 24, 2005

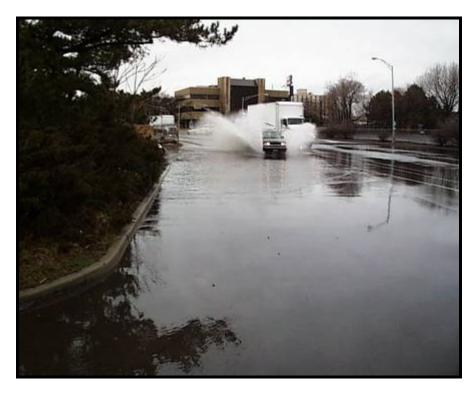
1. Looking North on Meadowlands Parkway near Broadcast Plaza (1/26/05)

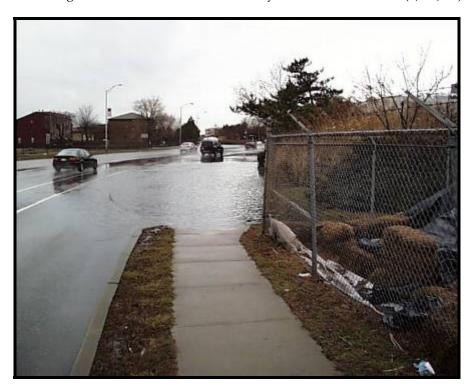
2. Looking South on Meadowlands Parkway near Broadcast Plaza (1/26/05)

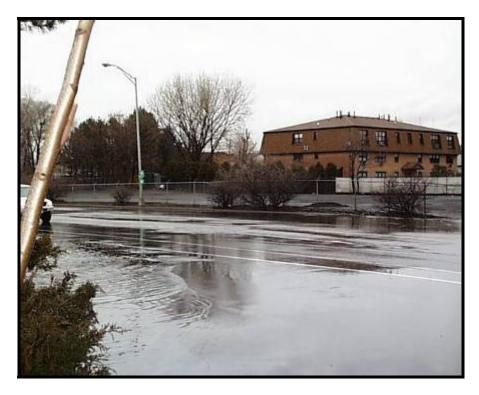
3. Looking Northeast on Meadowlands Parkway near Broadcast Plaza (1/26/05)

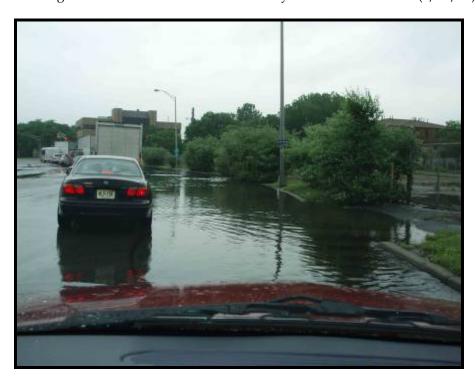
4. Looking South on Meadowlands Parkway near Broadcast Plaza (6/10/05)

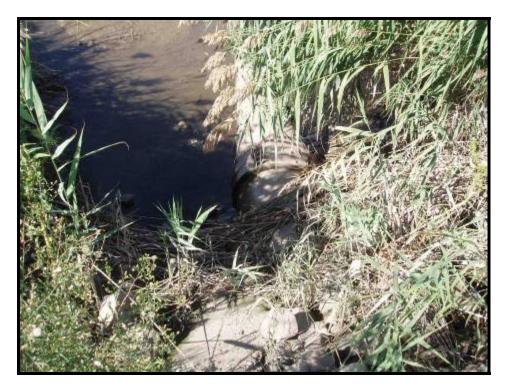
5. Looking at Meadowlands Parkway outfall near Route 3-East entrance ramp (10/03/05)

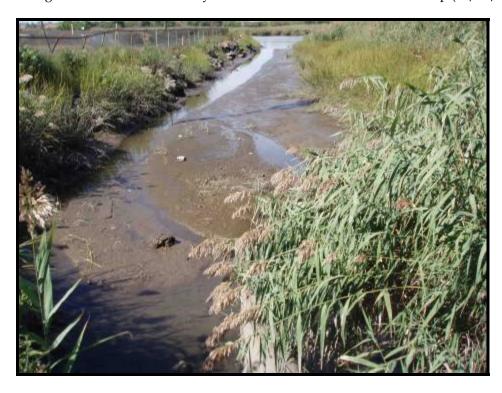
6. Discharge channel from above outfall to Hackensack River (10/03/05)

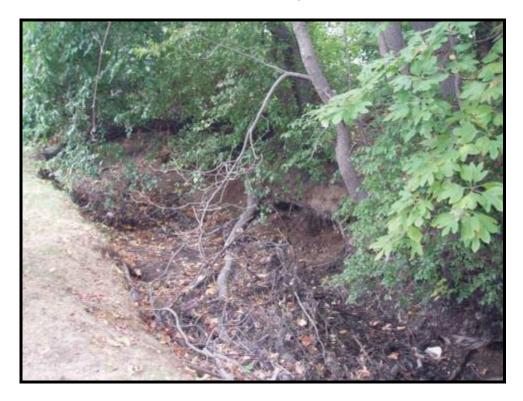
1. Drainage ditch at end of Carol Place (10/06/05)

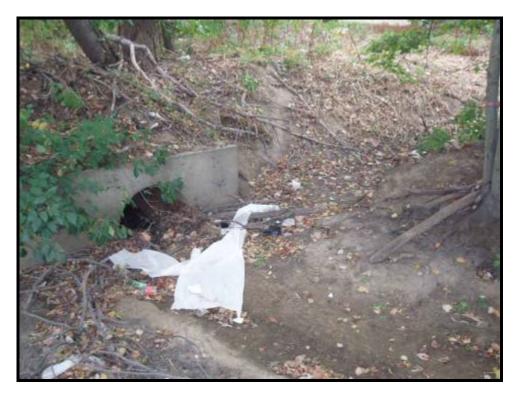
2. Drainage ditch at end of Carol Place (10/06/05)

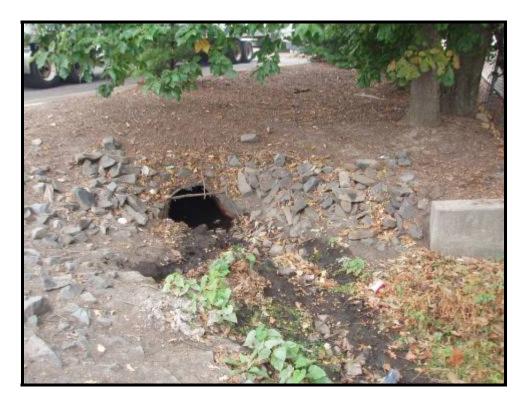
3. Detention basin located at 1 Carol Place (10/06/05)

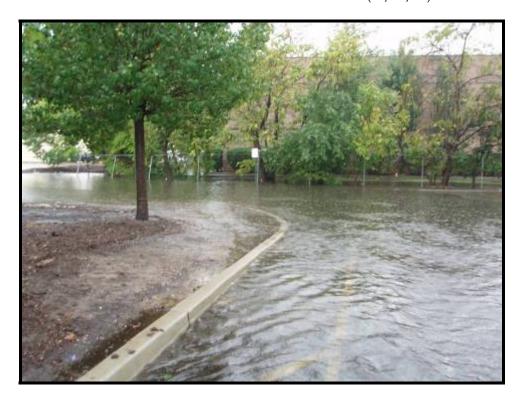
4. View of flooding in the parking lot at 1 Carol Place (10/12/05)

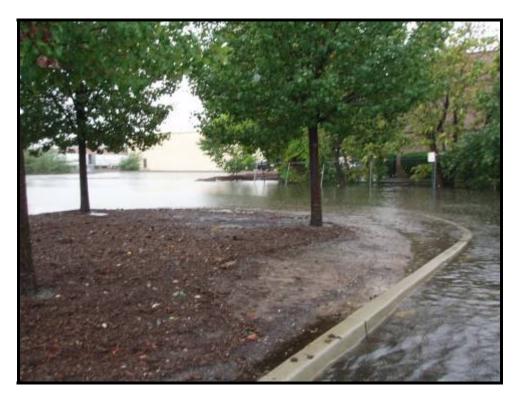
5. View of flooding in the parking lot at 1 Carol Place (10/12/05)

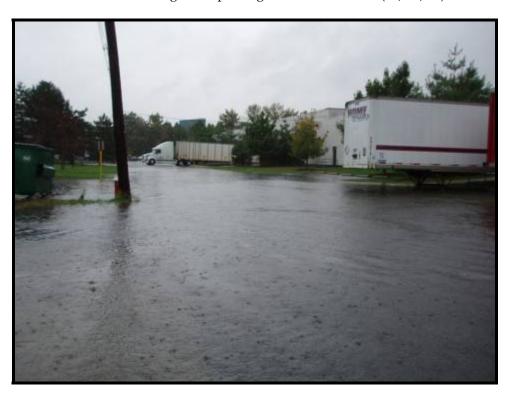
6. View of flooding at 1 Carol Place (10/12/05)

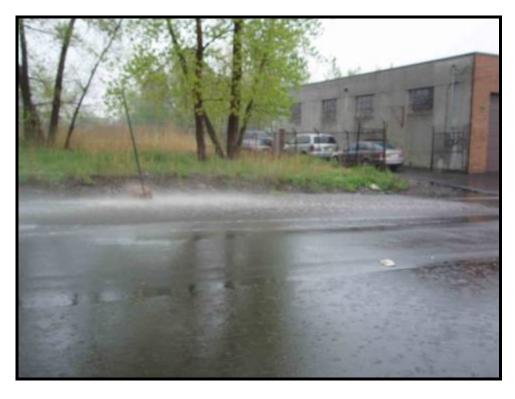
1. Looking Southeast on 16^{th} Street in front of Block 115, Lot 1 (4/25/05)

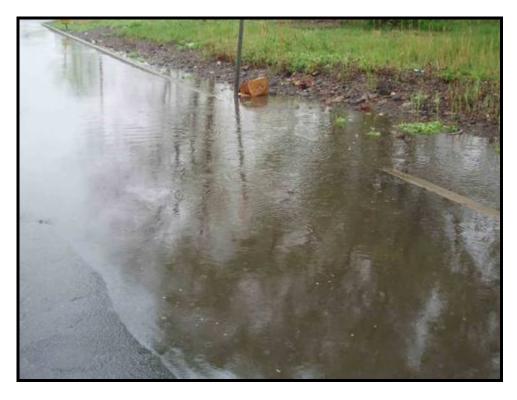
2. Looking Northeast on $16^{th}\,\text{Street}$ along side Block 116, Lot 1 (4/25/05)

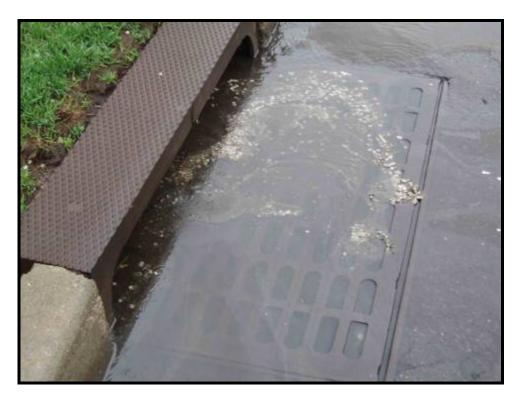
According to recent field inspections, several catch basins in the stormwater sewer system on 16th Street and Broad Street are either clogged or have failed (see Photo 3). The percentages of collapsed catch basins and catch basins clogged with silt and/or debris within the watershed are 14% and 25%, respectively, for a total of 39%. The condition of stormwater system outfall(s) could not be confirmed, as their location(s) is unknown.

3. Catch basin on 16^{th} Street at the intersection of Paterson Plank Road and 16^{th} Street (4/29/05)

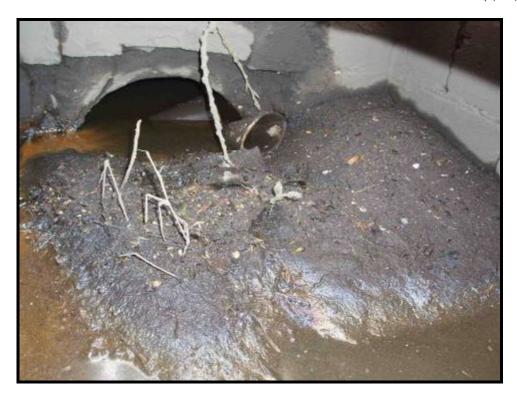
4. Interior of Photo No. 3 catch basin (4/29/05)

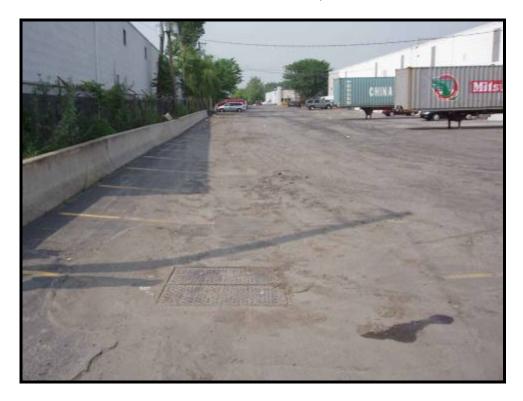
1. Looking Southwest from the back of the parking lot (6/15/05)

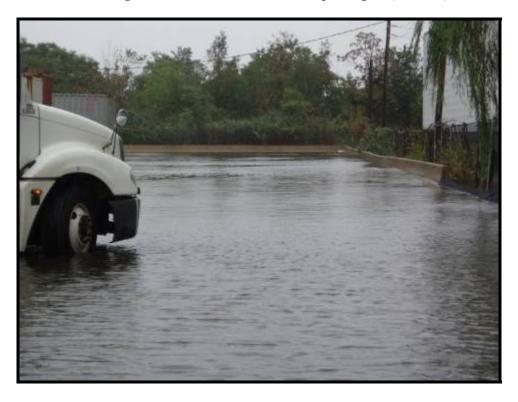
Flooding incidents have been reported to the NJMC in the vicinity of 40 Broad Street in Carlstadt, New Jersey (see Photos 2 and 4). The watershed is located in the western section of Carlstadt. The following table summarizes the flooding incidents:

2. Looking at Northeast corner of parking lot towards the floodwalls (10/14/05)

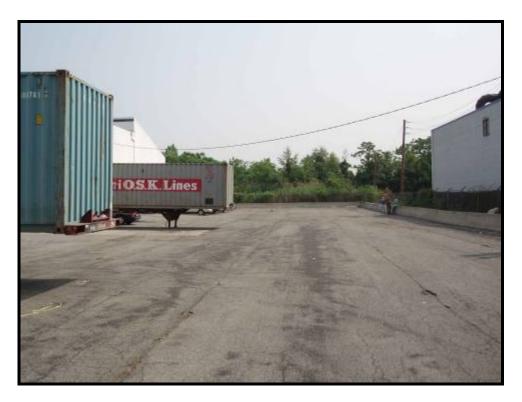
3. Looking Northeast of parking lot towards the floodwalls (6/15/05)

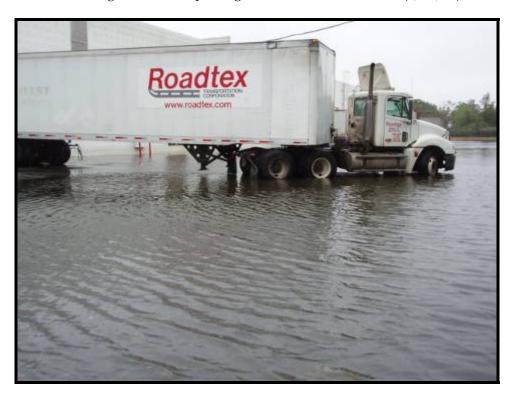
4. Flooded loading docks at 40 Broad Street (10/14/05)

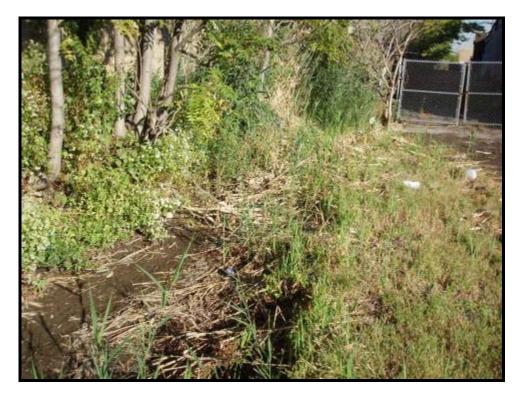
1. Looking downstream at drainage ditch behind 450 Barell Avenue (10/06/05)

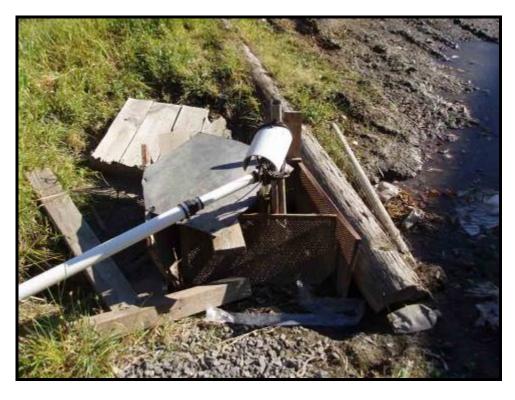
2. Make-shift pump system behind 462 Barell Avenue (10/06/05)

As a safety note, outdoor sump pumps constructed for flood relief by property owners north of the roadway should be dismantled and either abandoned or replaced with a system designed for safe outdoor use (see Photo 2).

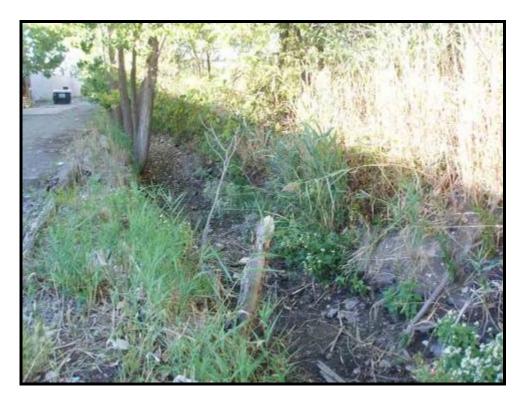
3. Looking upstream at drainage ditch behind 472 Barell Avenue (10/06/05)

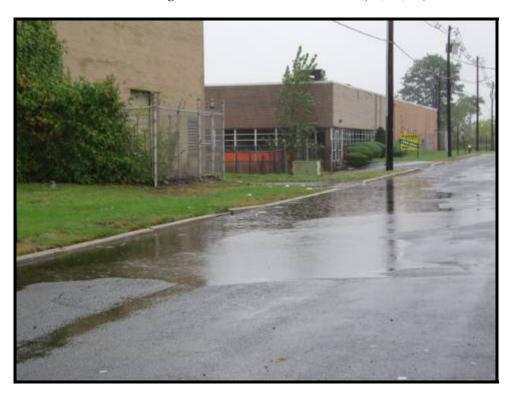
6. Looking Southeast on 472 Barell Avenue (10/14/05)

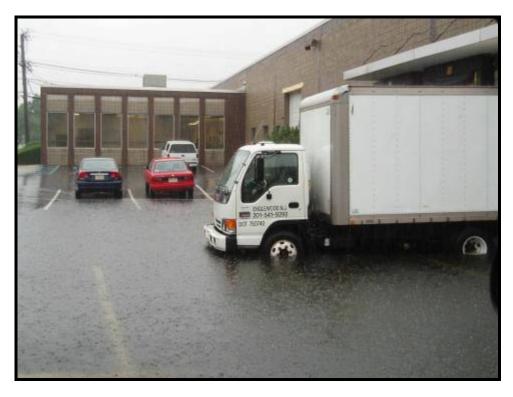
1. Looking Northwest at 120 Asia Place (6/10/05)

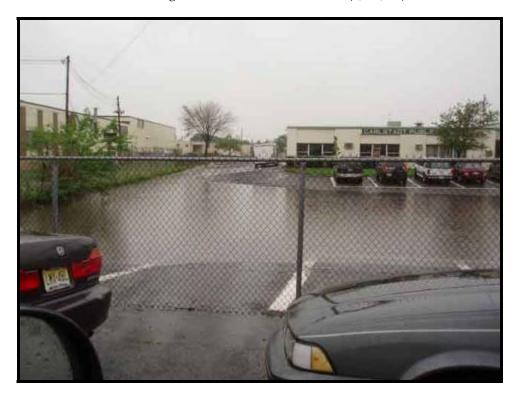
2. Looking Northeast at 105 Kero Road (7/08/05)

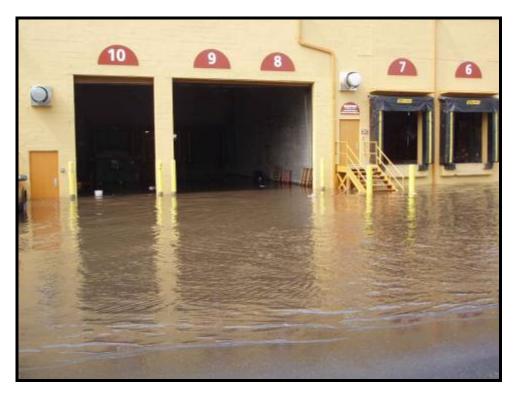
3. Looking Southwest at 135 Kero Road (7/08/05)

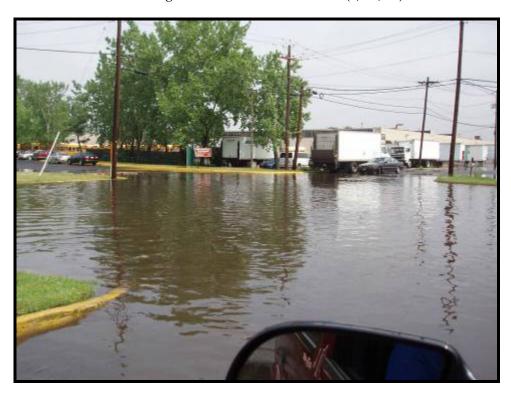
4. Looking Northeast from 140 Kero Road (7/08/05)

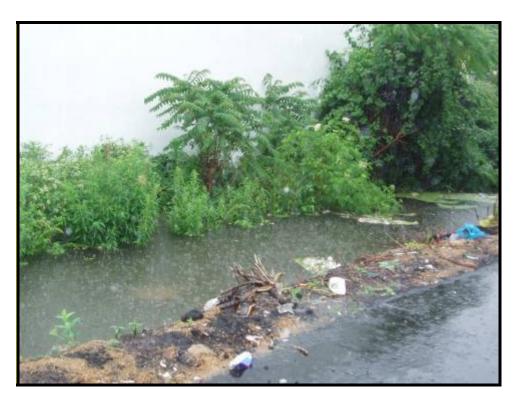
5. Drainage ditch behind 110 Asia Place (6/10/05)

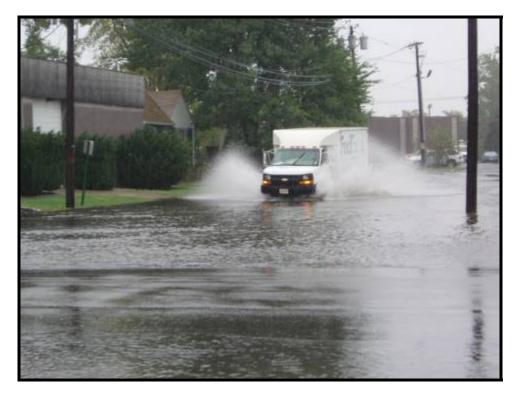
1. Flooding at the intersection of Grand Street and Moonachie Road (10/14/05)

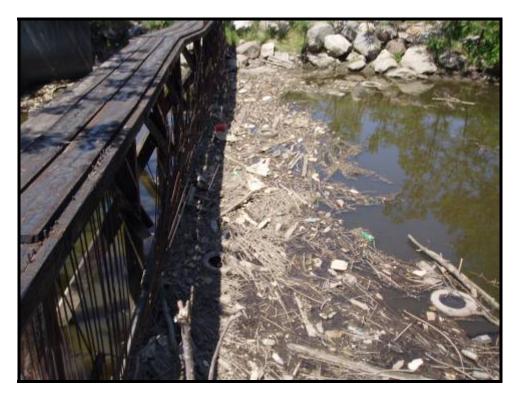
3. Trash rack for East Riser Tide Gate (5/17/05)

The East Riser Tide Gate is located to the south of the watershed. The condition of the tide gate is "good" per the 2004 NJMC field inspection report, but a clean out of the East Riser ditch and the East Riser Tide Gate's trash rack are necessary. The stream located to the west of Avenue C may be tidally influenced if the East Riser Tide Gate is not fully functional.

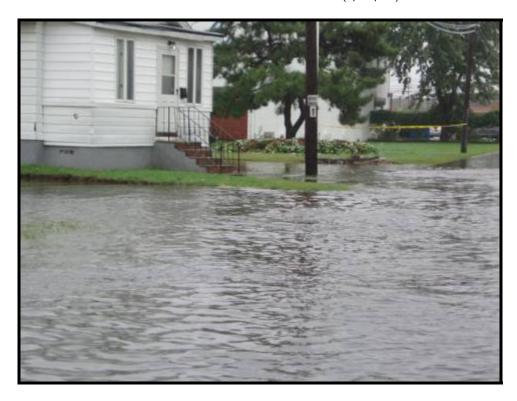
4. Flooding at the intersection of Grand Street and Anderson Avenue (10/14/05)

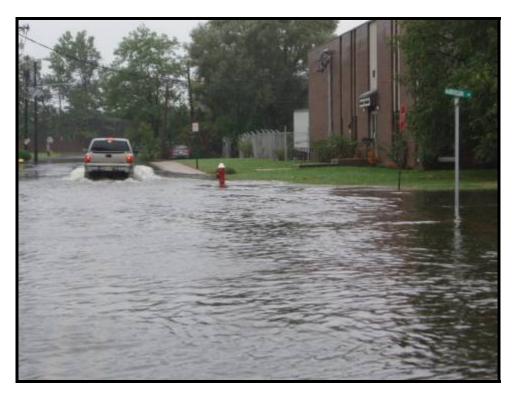
5. Flooding at the intersection of Grand Street and Anderson Avenue (10/14/05)

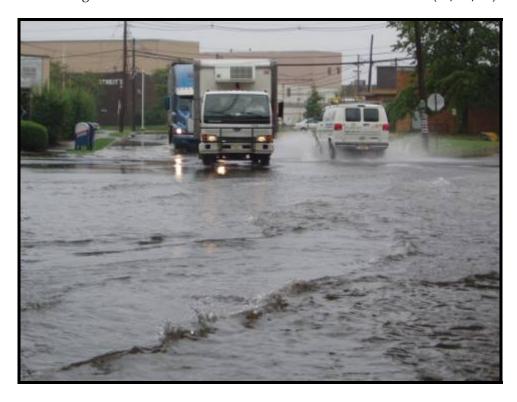
6. Flooding at the intersection of Grand Street and Christiana Avenue (10/14/05)

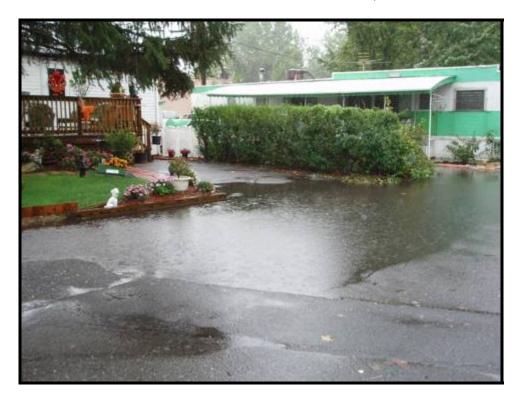
1. Looking southwest from the entrance to the mobile home area (10/14/05)

Additional hydrologic and hydraulic analyses will be needed to determine the appropriate system to protect the residential mobile home area from at least the 25-year storm. Due to the lower elevation of the residential mobile home area, a levee and pump system might be necessary to prevent tidal and/or fluvial flooding. Any pump system should have a redundancy, manual override, and power backup.

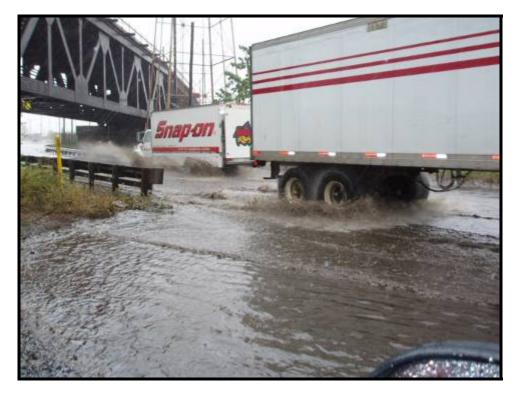
Incident #	Filed Complaint / Inspection Findings
FL-05-121	Flooding occurs under the Newark Turnpike Causeway. The road
	can flood approximately 3-4 feet.
FL-05-122	Flooding occurs under the Amtrak Bridge. Water can reach over a
	foot in depth.
	The old cobblestone Newark Turnpike floods. This is now a side
FL-05-216	street off the Route 7 Highway. The drainage for the road is tied to
1 ¹ L-03-210	the DOT drains by Owens Corning and in the middle of the wide
	traffic median that eventually drains to the Hackensack River.
FL-05-065	Two stormwater catch basins on the Route 7 west exit ramp to
	Belleville Turnpike are clogged at their outlet. The outfall needs to be
	unearthed. NJDOT is aware of the problem.
FL-05-121	Flooding occurs under the Newark Turnpike Causeway. The road
	can flood approximately 3-4 feet.

1. Looking Southwest along Fish House Road near the CSX rail bridge (10/14/05)

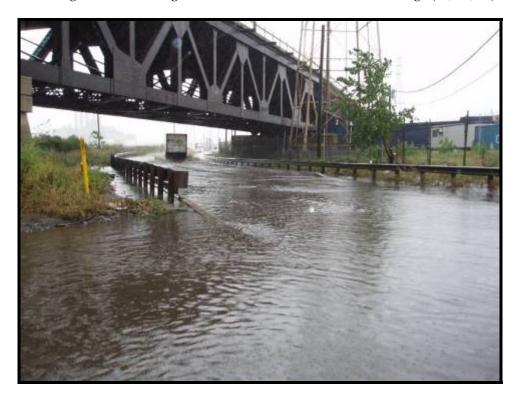
2. Looking Southwest along Fish House Road near CSX rail bridge (10/14/05)

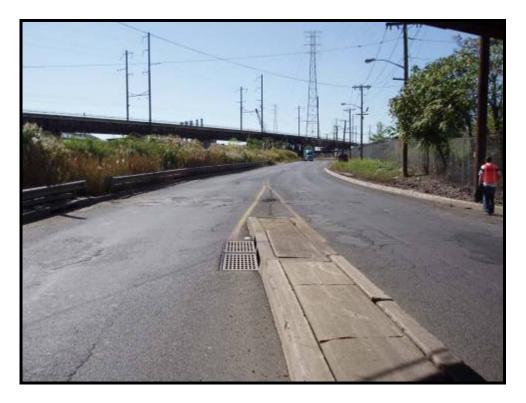
3. Looking West Along Fish House Road underneath the PATH bridge (10/06/05)

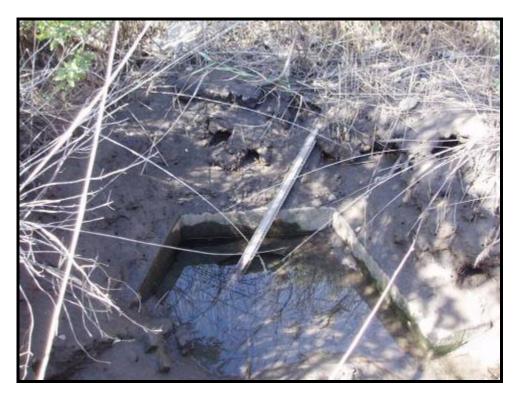
The first stormwater sewer system outfall is located east of Fish House Road immediately south of the PATH Bridge and the Route 7 Bridge. The concrete outfall pipe is 80% to 90% clogged with sediment (see Photo 4). A discharge channel conveys flows to the Hackensack River. The discharge channel is completely blocked with sediment and vegetation (see Photo 5).

4. Outlet located alongside Fish House Road near the PATH bridge (10/06/05)

Additional short-term needs include permanent access to the outfalls and the installation of a one-way valve on the outfall nearest the PATH bridge. It is noted that there is a natural gas pipeline warning marker near the outfall (see Photo 7). Riprap scour control should be designed and placed following the clean out.

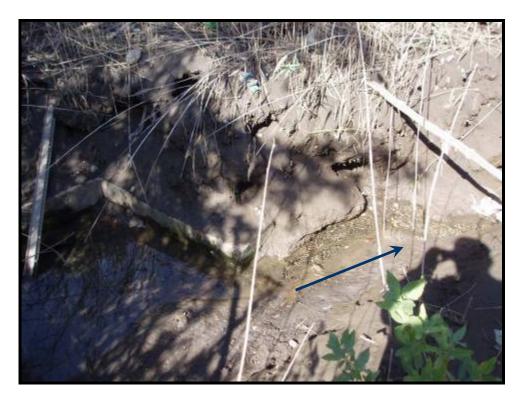
5. Drainage ditch serving system in Photo 4 (10/06/05)

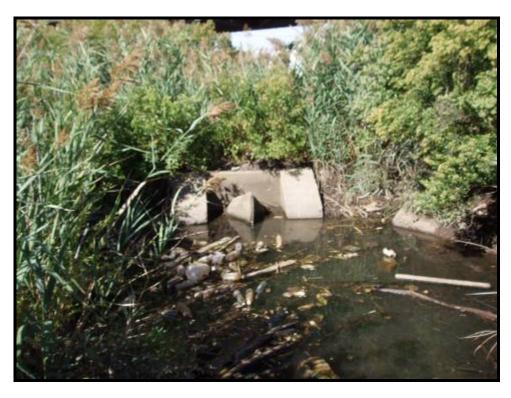
The second stormwater sewer system outfall is located east of Fish House Road near the CSX bridge and south of the above system. The outfall pipe is fitted with a TideFlex valve (see Photo 6). The associated discharge channel to the Hackensack River is completely clogged with sediment and vegetation (see Photo 7). Note that the Hudson County Division of Engineering does not think that this outfall is associated with the roadway but rather serves private property.

6. Second outfall with one-way valve system located alongside Fish House Road near CSX Rail Bridge (10/06/05)

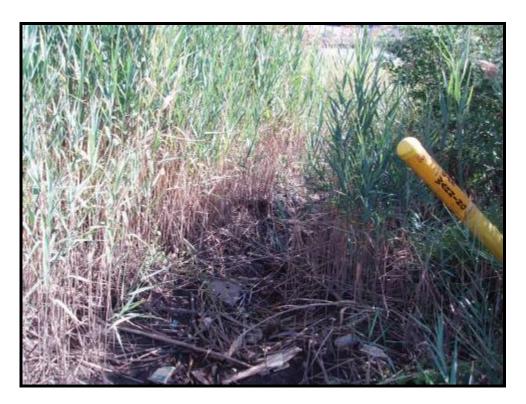
7. View of discharge channel to Hackensack River from above system (Photo 6) (10/06/05) (Note: Gas line warning marker at right)

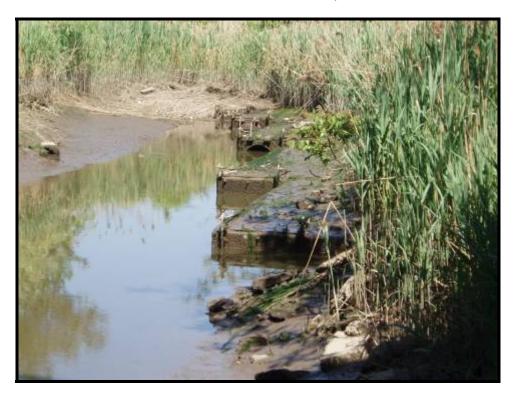
1. Looking Northwest at Rutherford Tide Gates outfalls (5/17/05)

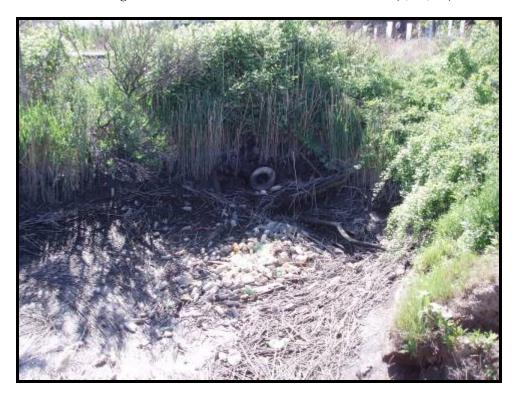
2. Upstream inlets (submerged) to the Rutherford Tide Gates (5/17/05)

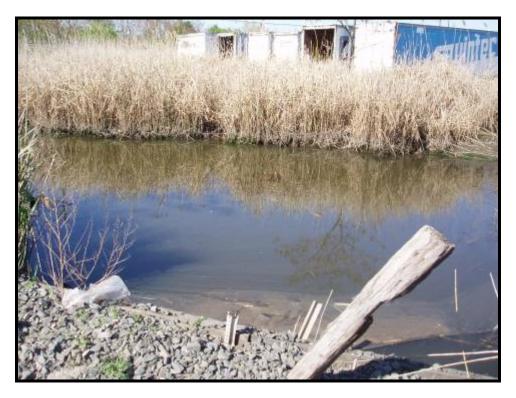
The upstream culverts noted above, two (2) 36-inch corrugated metal pipes, are completely collapsed. The embankment supporting a light industrial rail siding that passes over the culverts and connects to the Bergen County Line is showing signs of subsidence. Additionally, the drainage ditches upstream of the tide gates that run parallel to, and on each side of the Bergen County Line, are partially clogged and are in inadequate condition to convey stormwater from Route 17 (see Photo 4).

3. Entrance channel to collapsed twin culverts (5/17/05)

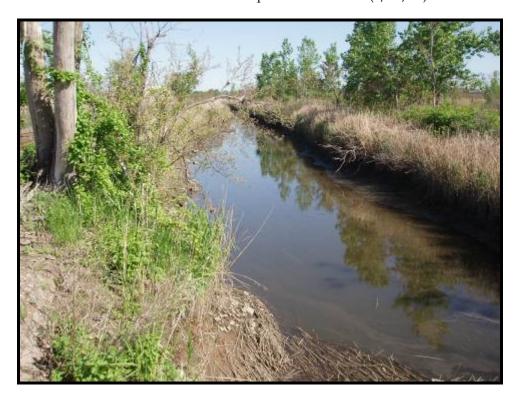
4. Drainage channel upstream of the Rutherford Tide Gates (5/17/05)

While the analysis and restoration of the tide gate system is underway, the stormwater sewer system within the watershed should be cleaned out immediately, including the removal of silt and debris from each catch basin and the removal of silt, debris, and/or vegetation from all outfalls. A one-way valve system installation at the outfall(s) should be considered as part of the drainage system cleanout.

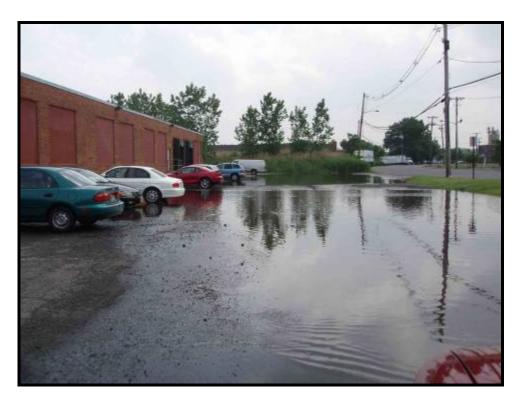
3. Looking Southeast from 140 East Union Avenue (6/10/05)

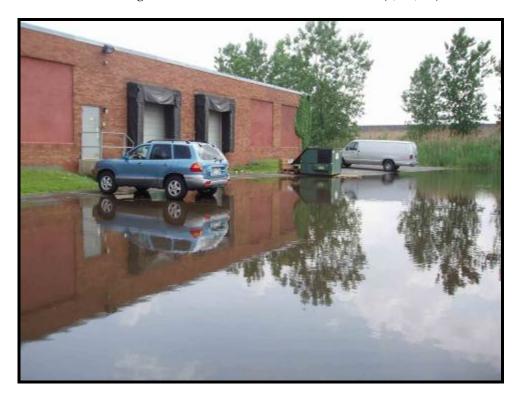
4. Looking Southeast from 140 East Union Avenue (6/10/05)

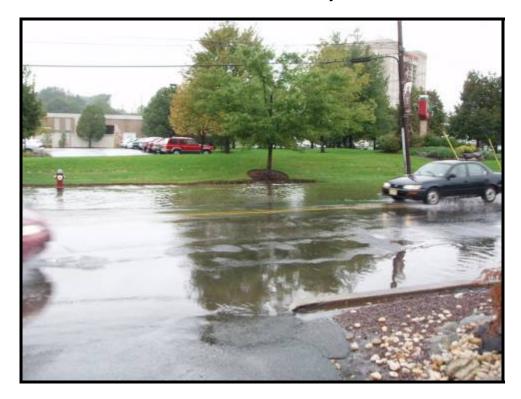
1. Looking West on Polito Avenue near intersection of Polito and Rutherford Avenues (10/14/05)

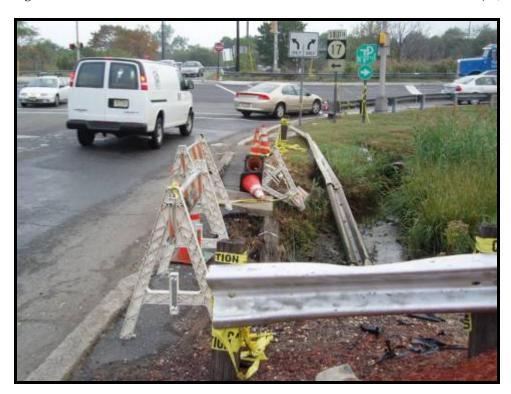
2. Collapsed catch basin located near the intersection of Polito and Rutherford Avenue (10/06/05)

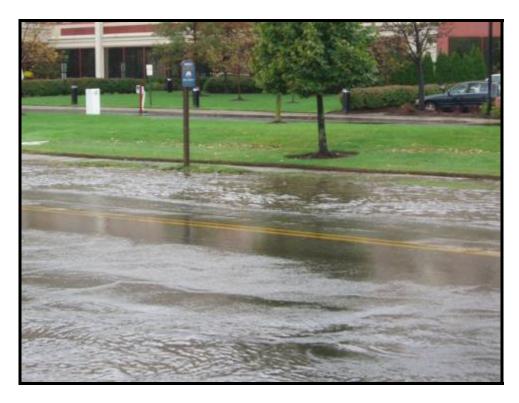
3. Looking West on Polito Avenue (10/14/05)

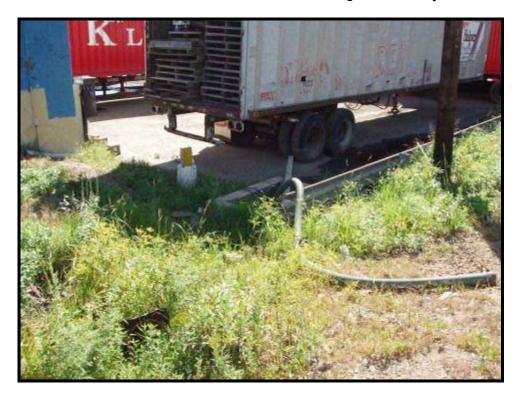
1. Make-shift pump system at 996 Belleville Turnpike (10/06/05)

Additionally, private property owners with pump systems should ensure that pump system components, including power supply, are intended for outdoor use to eliminate the threat of electrocution. All discharges should be directed to existing, clear channels and never up-slope or toward a neighbor. It is highly recommended that outflow be directed to an open-water system as stormwater sewers in flat areas have limited capacity and tend to clog during large storm events. All privately-owned catch basins and stormwater sewer pipes should also be cleaned out. Associated outfalls should be cleared and one-way valves installed. Prior to any system restorations, a licensed Professional Engineer should be consulted to see if the system is adequate and should be restored in-kind.

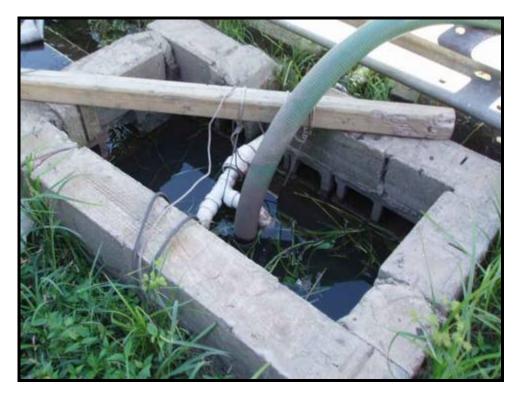
2. Sump pit for make-shift pump system at 996 Belleville Turnpike (10/06/05)

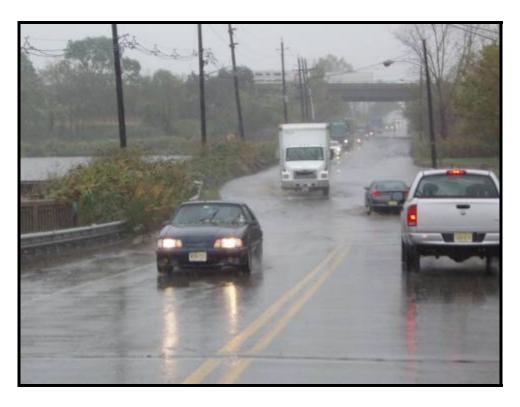
5. Looking east on Route 7 / Belleville Turnpike looking towards the Western Spur of the New Jersey Turnpike (10/14/05)

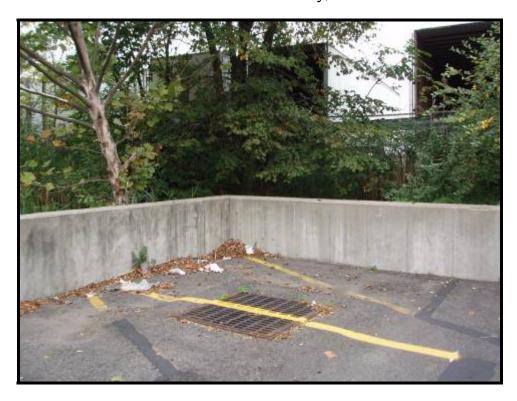
1. Inlet and floodwall at 430 Gotham Parkway (10/06/05)

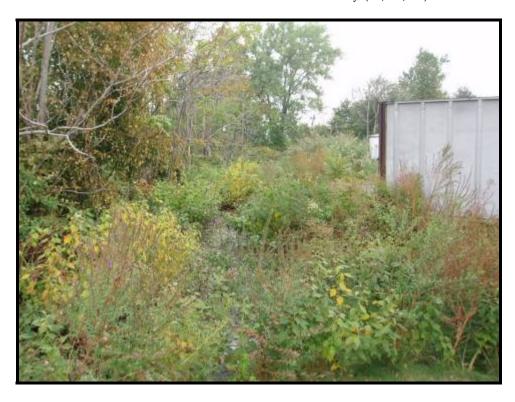
2. Upstream of confluence point with Peach Island Tide Gate (10/06/05)

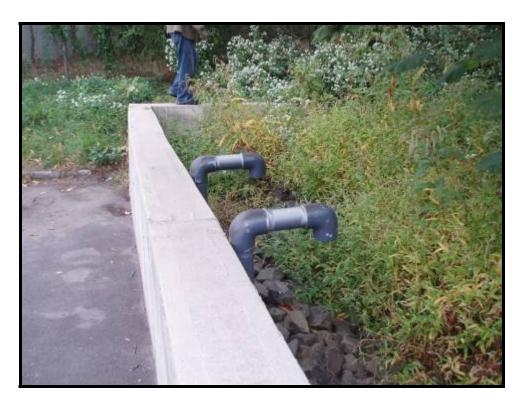
3. Outfall pipes from pump station at 480 Gotham Parkway (10/06/05)

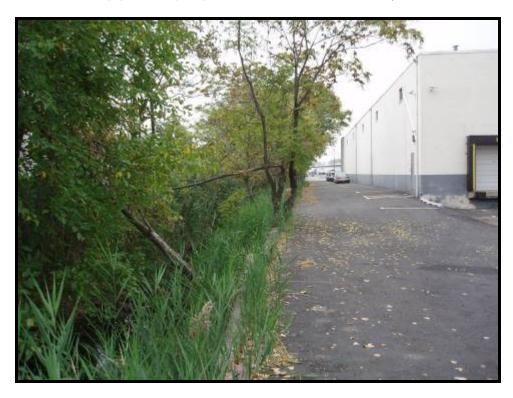
A detailed field inspection has identified the primary causes of local flooding. A drainage ditch parallel to and west of Gotham Parkway follows the rear of each property. The ditch, though well-maintained and clean in sections, has been completely severed in others and will not function in a storm event.

4. Looking downstream at rear of 725 Dell Road (ditch at far left) (10/06/05)

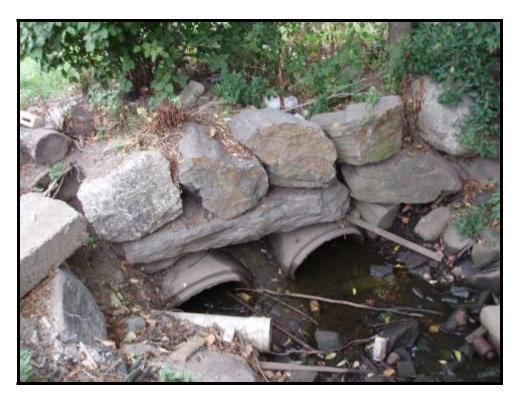
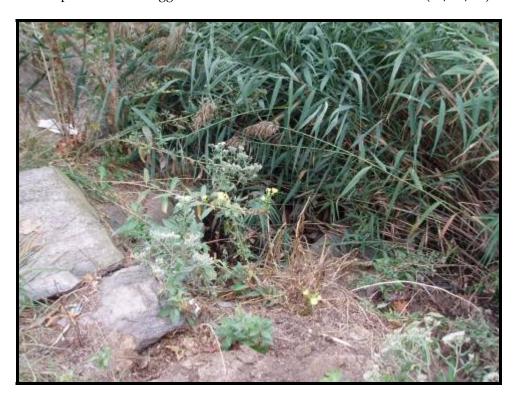
Upstream of these buildings, the system moves through a culvert beneath Starke Road. The culvert appears to be functional and is protected by a trash rack. The drainage ditches above the culvert are in good condition. However, elliptical concrete culverts 2,200 feet upstream of Starke Road beneath an abandoned CSX rail are in need of cleanout or repair (see Photos 5 to 7). As the system upstream of the rail is stagnant, vegetation has choked the drainage ditch system.

5. Elliptical culvert clogged with debris at the rear of 545 Dell Road (10/06/05)

6. Elliptical culvert clogged with debris and vegetation at the rear of 545 Dell Road (10/06/05)

No engineering analysis appears to be necessary at this time. Once the maintenance project is complete, the flooding issues within the watershed should be completely alleviated during small storms. However, the local catch basins must remain clear of debris and sediment for the entire system to function. A NJDEP Stream Encroachment Permit will be required for this maintenance cleanout.

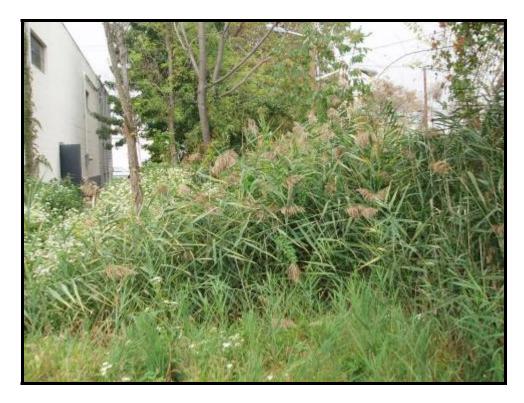
7. Drainage ditch at the rear of 654 Gotham Parkway (10/06/05)

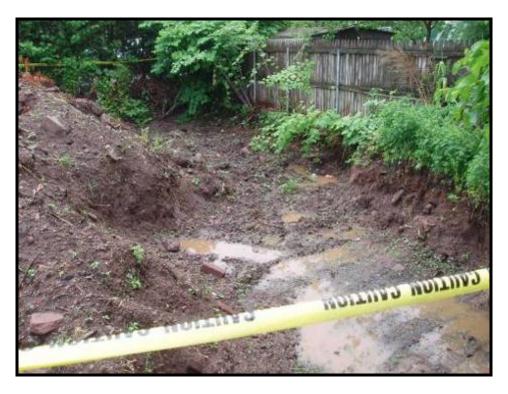
The NJMC, following an inspection in 2004 confirming the above condition, asked the neighboring developer (1600) to create an infiltration basin at the rear of 1089 to improve sheet flow runoff during storm events. The basin was constructed and, per follow-up inspections, temporarily alleviated the flooding in the area (see Photos 1 and 2). Once 1600 Paterson Plank Road has been built upon, this system can be abandoned and a permanent stormwater system must be constructed. **As such, this matter is considered temporarily closed.**

1. Infiltration basin located at 1600 Paterson Plank Road behind 1089 Farm Road (right) (6/10/05)

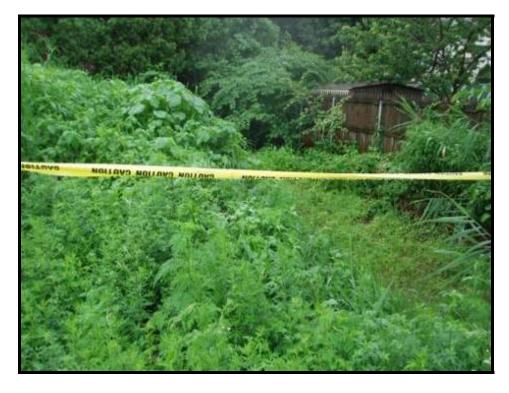
2. Same location at Photo 1, following one growing season. (7/08/05)

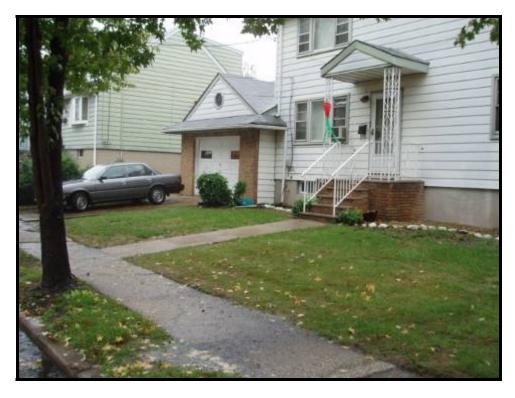
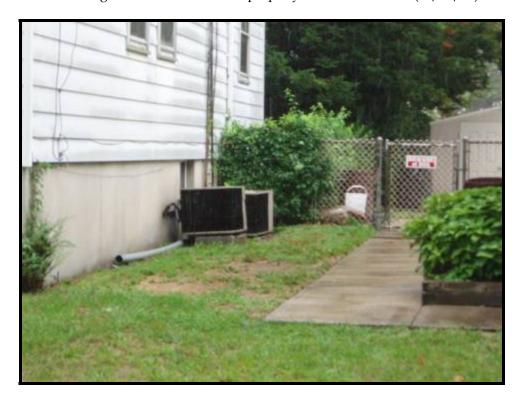
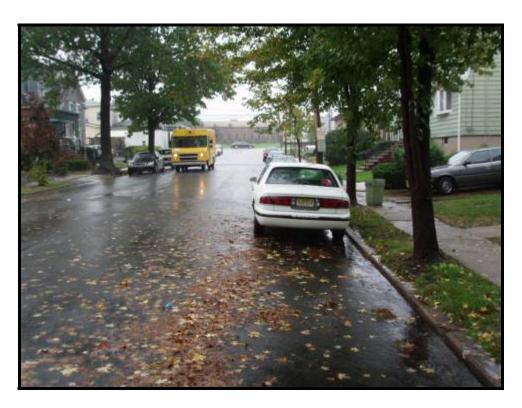
Based on a recent field inspection, the inlets to the Louis Street stormwater sewer system are clear. The Louis Street profile appears to have sufficient slope to carry stormwater runoff to the inlets and away from the home. No ponding or flooding conditions were observed during the field inspection on Louis Street during heavy rains. The NJMC believes this flooding complaint is not a regional problem.

1. Looking at the south side of the property at 176 Louis Street (10/14/05)

2. Looking at the east side of the property at 176 Louis Street (10/14/05)

3. Looking west in front of 176 Louis Street (10/14/05)

The NJMC has recommended that the property owner solicit the assistance of a contractor familiar with basement flood-proofing and exterior residential stormwater systems. The property owner has contacted such a professional and will report back on the findings. As such, this matter is considered **temporarily closed**.

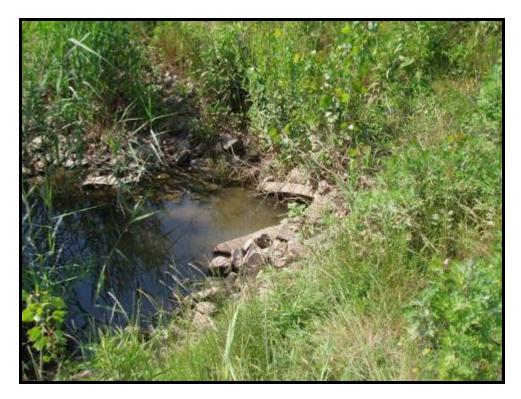
1. Looking at outfall that is connected to the inlet at 758 Paterson Plank Road (6/22/05)

NJMC staff, following the inspection listed above (FL-05-139), requested that the neighboring property owner (2-100 Murray Hill Parkway) install a one-way valve (flap gate). Additionally, the owner of 758 Paterson Plank Road was issued a Zoning Certificate by the NJMC on October 6, 2003 to construct stormwater drainage improvements. These improvements, as of the date of this document, are under construction. **As such, this matter is temporarily closed.**

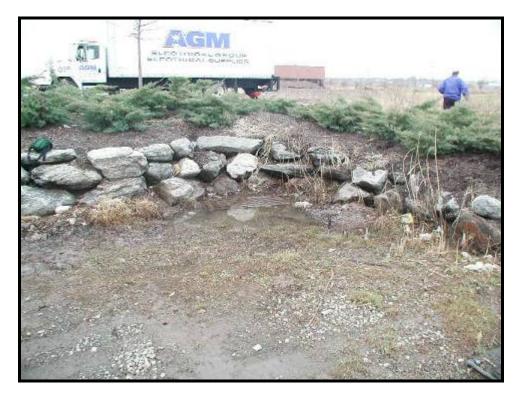
a detention basin, it flooded the entire lot. The rear of the lot had been under 2+ feet of water. With the water drained, it was apparent that the detention basin was the source of the floodwaters based on the similar sediment stains located in both the basin and at the area around the catch basin.

2. Inlet on 758 Paterson Plank Road discharging to above outlet (Photo 1) (3/21/05)

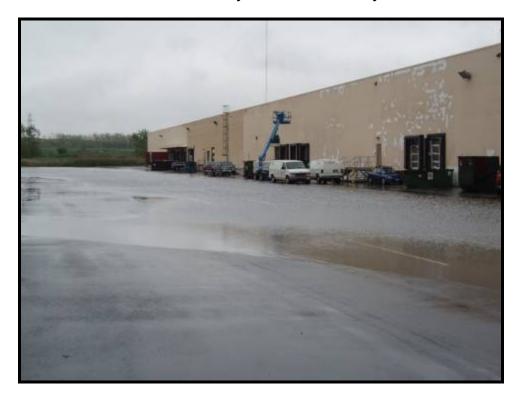
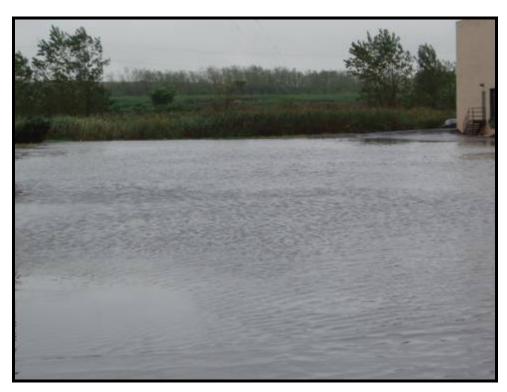
1. Looking southeast towards ditch at rear of property (10/14/05)

2. Looking southeast towards ditch at rear of property (10/14/05)

In the short-term, a Professional Engineer should be hired to survey the existing drainage system, and to evaluate feasible alternatives to increase its capacity. This evaluation should consider the proposed improvements associated with the EnCap re-development project bordering the rear of the property. The EnCap project will increase the capacity of downstream culverts beneath Valley Brook Avenue. Unless the capacity of the municipal system on Valley Brook Avenue can be verified, it is preferable to send stormwater flows to the rear of the property to an open channel system. Consideration should be made for the tidal nature of Berry's Creek.

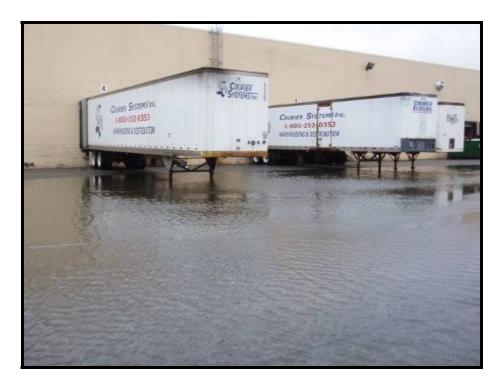
3. Looking southwest towards loading docks (10/14/05)

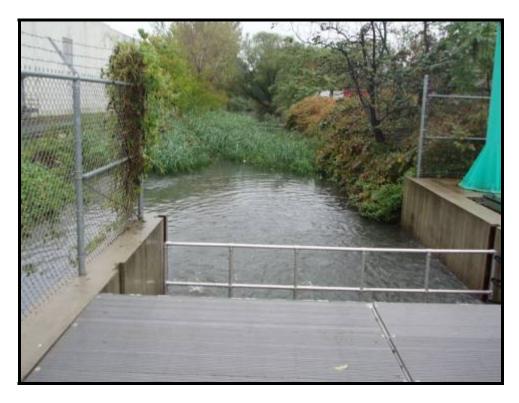
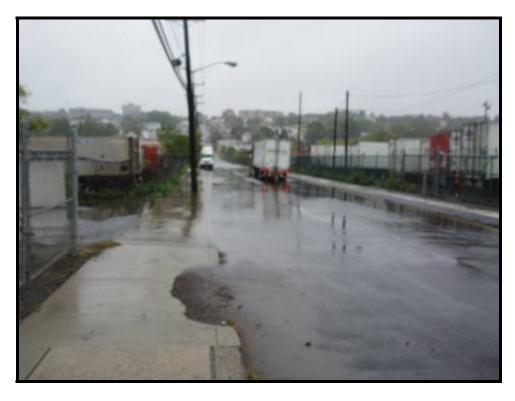
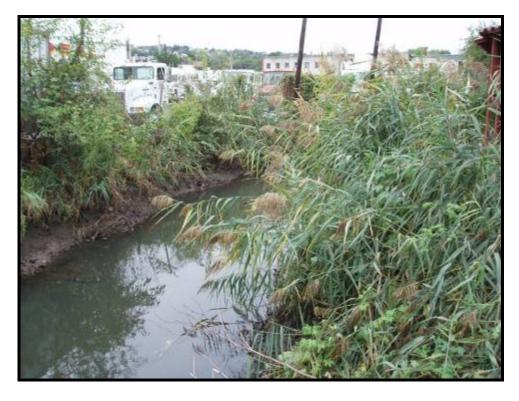
Bellman's Creek is located in North Bergen and discharges to the Hackensack River. Bellman's Creek begins at 91st Street, travels through Fairview Avenue, and converges with Wolf Creek, and then meanders to the Hackensack River (see Photos 1 and 4). With high tide conditions and a low intensity storm event, Bellman's Creek floods the surrounding streets. 83rd Street, 85th Street, 88th Street, 90th Street, and 91st Street are all within a low flat area where the drainage pipes does not have sufficient slope to convey the flow effectively. Another issue with respect to the North Bergen drainage system is that it is a combined stormwater and sewer system. Such combined systems tend to be significantly overburdened during large storms (see Photo 3).

1. Looking downstream of Bellman's Creek at 91st Street (10/14/05)

2. Looking east towards Route 1&9 at 91st Street (10/14/05)

4. Looking upstream of Bellman's Creek at Fairview Avenue (10/06/05)

The preliminary recommendation for remediating the flooding conditions surrounding Bellman's Creek is to prepare a NJDEP Minor Stream Encroachment Permit for the maintenance cleanout of the Bellman's Creek drainage system. In addition, the stormwater sewer systems on 83rd Street, 85th Street, 88th Street, 90th Street, and 91st Street will need to be cleaned out. Clean out should include the removal of silt and debris from each catch basin and the associated pipe network and outfall(s). Vegetation may need to be removed at the outfall(s). Installation of a one-way valve system at the outfalls is encouraged as part of the drainage system maintenance.

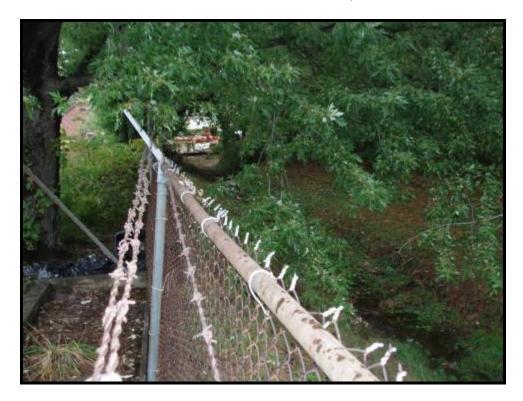
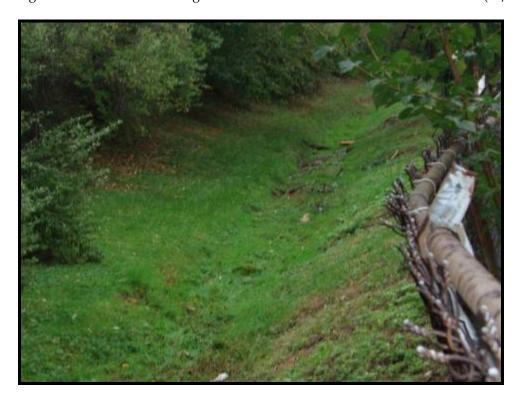
The findings of NJMC staff, specific to 694 Minnie Place South, include the following: the Golden Avenue Pump Station is currently being upgraded downstream of the drainage ditch adjacent to Minnie Place South. The NJMC has requested that the Golden Avenue Pump Station incorporate flows from the Minnie Place South drainage ditch. Once the Minnie Place South system is added to the Golden Avenue Pump Station upgrade, the flooding situation should be alleviated. As such, this flood incident is temporarily closed.

1. Looking downstream of the drainage ditch located at the end of Minnie Place South (10/11/05)

2. Looking upstream of the drainage ditch located at the end of Minnie Place South (10/11/05)

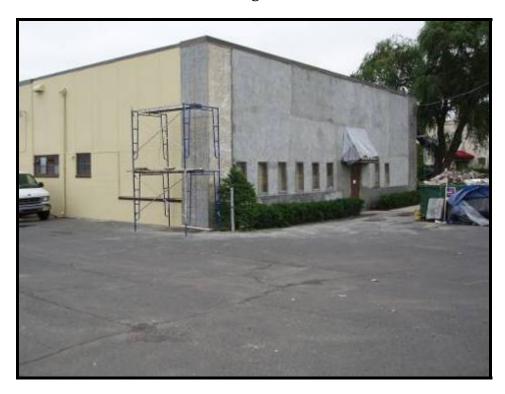
1. Looking at the front of 325 Washington Avenue (10/06/05)

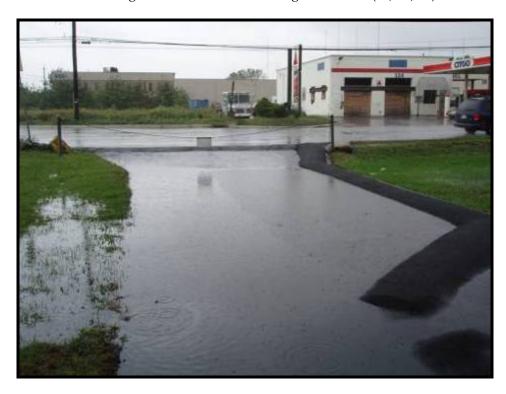
2. Looking at the raised berm and ponding of the driveway located at the south end of property (10/12/05)

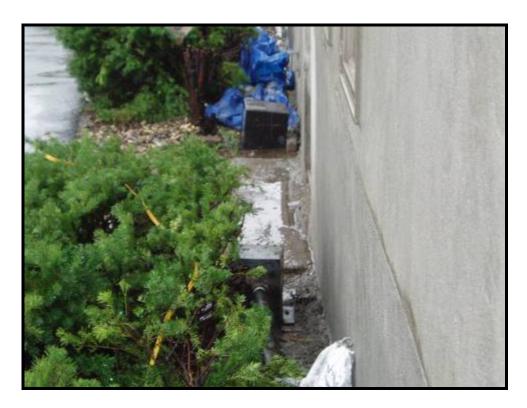
3. Two pump systems located in front of the building of 325 Washington Avenue (10/06/05)

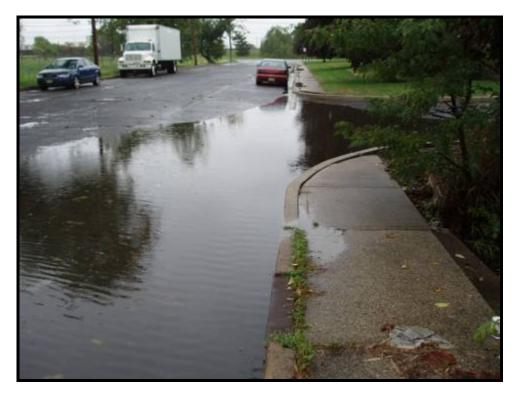
4. Looking West at the clogged inlet on the Michelle Avenue culvert (downstream on left) (10/12/05)

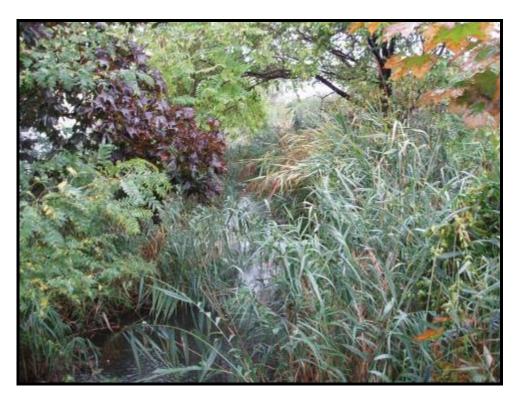
5. Looking upstream at the Michelle Avenue culvert (10/06/05)

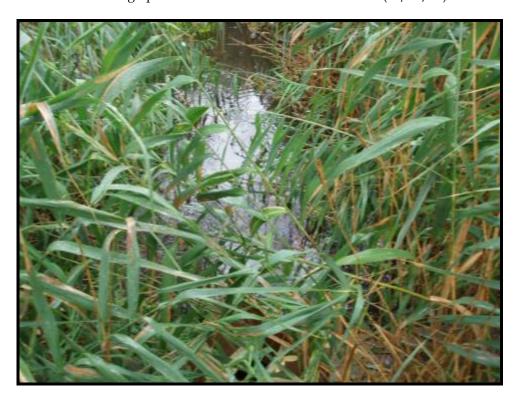
6. Looking downstream at the Michelle Avenue culvert (10/06/05)

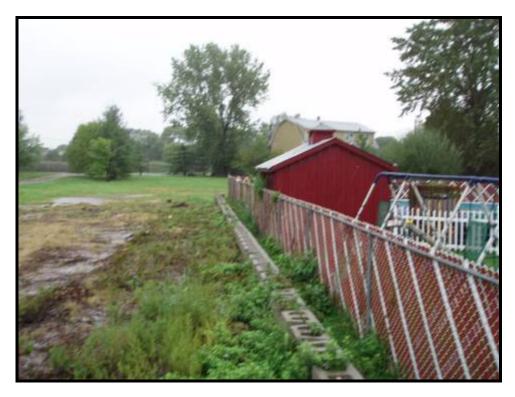
From a recent field inspection, a retaining wall was found at the rear of the property located on 64 Maiden Lane (see Photo 2). The runoff from the backyard of 64 Maiden Lane has no flow path to drain properly to a pump station that has been installed down-gradient of the property (see Photos 3 and 4). As such, the water ponds within the property.

2. View of the retaining wall behind 64 Maiden Lane (10/12/05)

It is recommended that the party responsible for the construction of the retaining wall modify the existing site grading to provide positive flow away from 64 Maiden Lane. This could be accomplished with a drainage ditch or pipe connection to the pump station behind the property. The NJMC will provide assistance in making the determination of ownership.

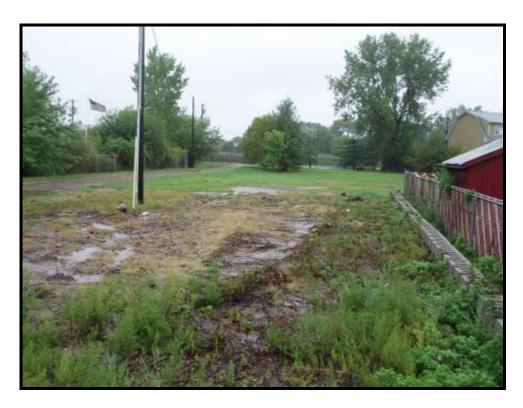
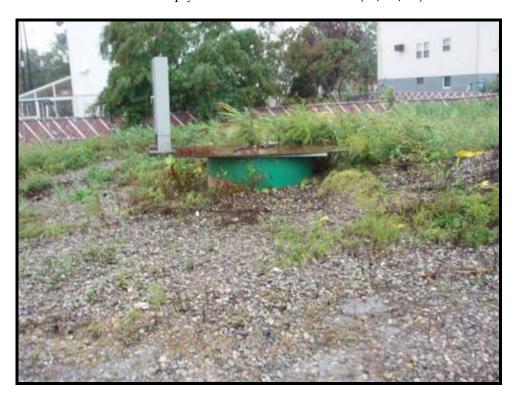
3. View of empty lot behind 64 Maiden Lane (10/12/05)

4. View of stormwater pump system located in the lot behind 64 Maiden Lane (10/12/05)
