Hackensack Meadowlands Floodplain Management Plan

The National Flood Insurance Program Community Rating System Activity 510 Guidelines

The New Jersey Meadowlands Commission One DeKorte Park Plaza Lyndhurst, New Jersey

October 24, 2005

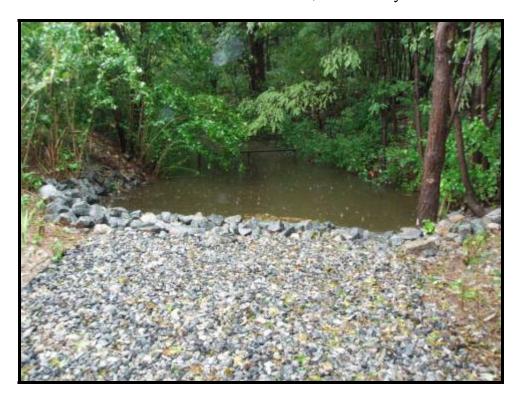
1. Looking upstream of the intake to the DePeyster Pump Station (10/11/05)

recommends that this study form the basis of the analysis of an additional pump system. The NJMC also recommends that access to the upstream trash rack be improved. A Little Ferry Department of Public Works employee should be able to clean off the rack via a pathway (see Photo 1). The NJMC has accepted the 25-year flood elevation (4.1 feet NAVD88) determined by the report. Water above this elevation leaves the watershed and enters the Losen Slote system.

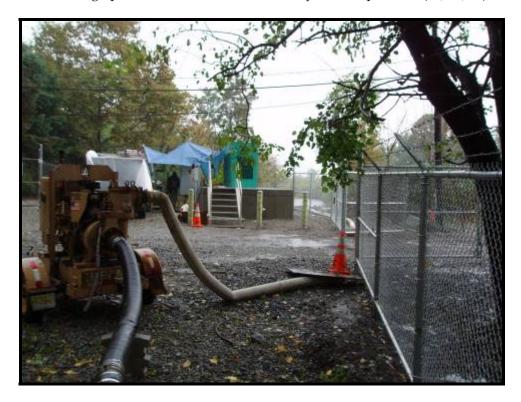
From a recent field inspection, the DePeyster Creek Pump Station is in the process of being repaired at the end of Dietrich Street. A bypass system is temporarily pumping water while the new pump station is being constructed (see Photo 2). According to a hydrologic and hydraulic analysis of the watershed completed by Mianecki Consulting Engineers, the new pump station is unable to outpace projected peak flows from a two-year storm event. During larger storm events, it is likely that the pump station will be inundated and that the upstream channel will backup into the residential neighborhood.

2. View of bypass pump system and new DePeyster Pump Station (10/11/05)

The NJMC recommends that a hydrologic and hydraulic analysis be prepared that analyzes the need for an additional pump system to adequately discharge the 25-year storm during mean high water (MHW) conditions. Note that a detailed hydrologic and hydraulic analysis of the existing and proposed pump station during the 25-year event has already been completed by Mianecki Consulting Engineers. NJMC

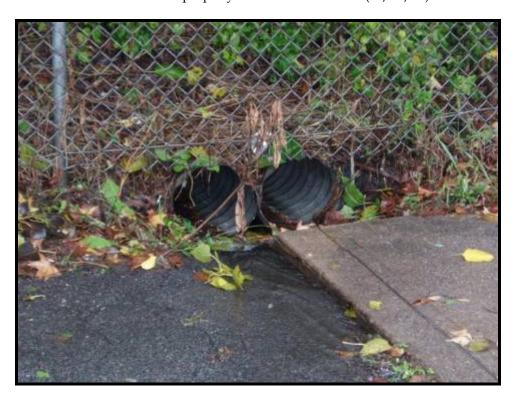
4. Hartwick Street pipe outlet flowing to drainage ditch towards DePeyster Pump Station (10/14/05)

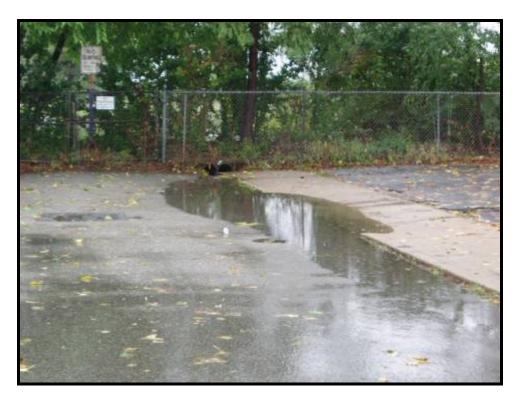
5. Ponding in front of the property at 37 Hartwick Street (10/14/05)

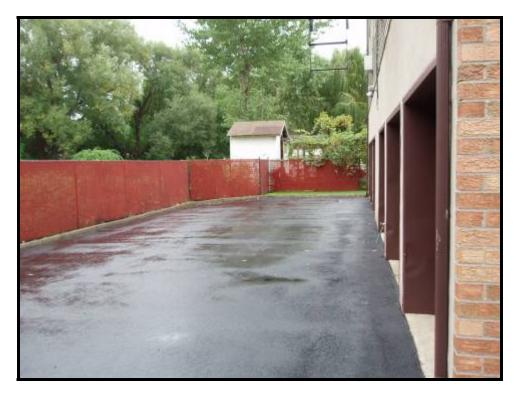
1. Parking area for the residence of 1138B Farm Road where flooding occurs (10/11/05)

The preliminary recommendation to mitigate the flood conditions in the vicinity of 1138B Farm Road is to clean out the stormwater sewer system on Farm Road and install a flap gate system at each outfall. Additionally, the slopes and elevations of the Farm Road stormwater sewer system should be verified to ensure adequate flow velocity. In conjunction with this survey, the NJMC recommends the preparation of a NJDEP Minor Stream Encroachment Permit for the maintenance cleanout of the drainage system leading to the system's outfall.

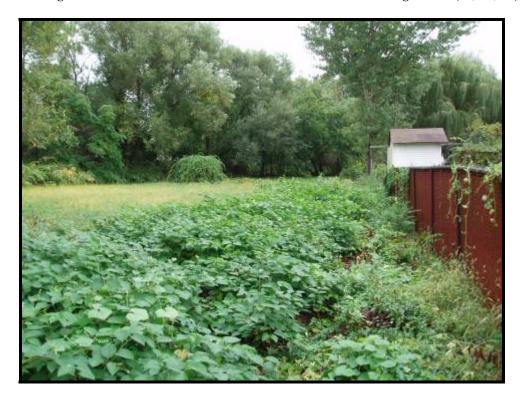
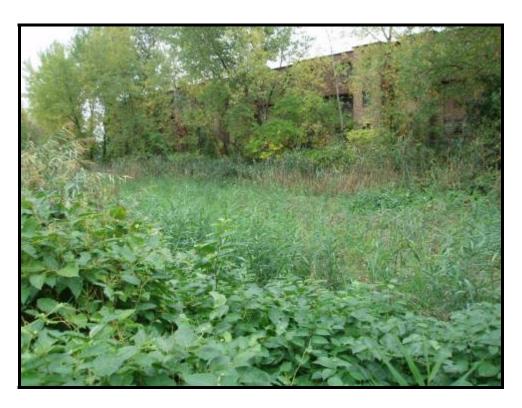
From a recent field inspection, the lot behind the flooded property appears to act as a detention basin because the drainage ditch leading to an outlet on the Hackensack River has been heavily vegetated (see Photos 2 and 3). Due to heavy vegetation, the NJMC inspection team was unable to determine whether the system outfall was the Acorn Road Tide Gates, which also discharge in the immediate area to the Hackensack River (see Photo 4). According to a Secaucus official, the outfall is not the Acorn Road Tide Gates and does not have a one-way valve. Additionally, Secaucus is recommending that a pump station be installed on its property at this location, 236 Meadow Lane, to service both the above ditch and the flow collected by the Acorn Road Tide Gates.

2. Looking south at the detention basin/drainage ditch behind 1138B Farm Road (10/11/05)

3. Looking north at the detention basin/drainage ditch behind the property of 1138B Farm Road (10/11/05)
